# Palmerston North City Council

## Notable Tree Survey March and April 2011

<b>Address</b>	80 Albert Street	
<b>Tree name</b>	Rata ( <i>Metrosideros robusta</i> )	
<b>Location of the tree on the site</b>	At the entrance/ start of a RoW to a rear site subdivision	
<b>Owner's name</b>		
<b>Date of STEM Assessment</b>	29 March 2011	<b>Inspected by</b> John Wakeling

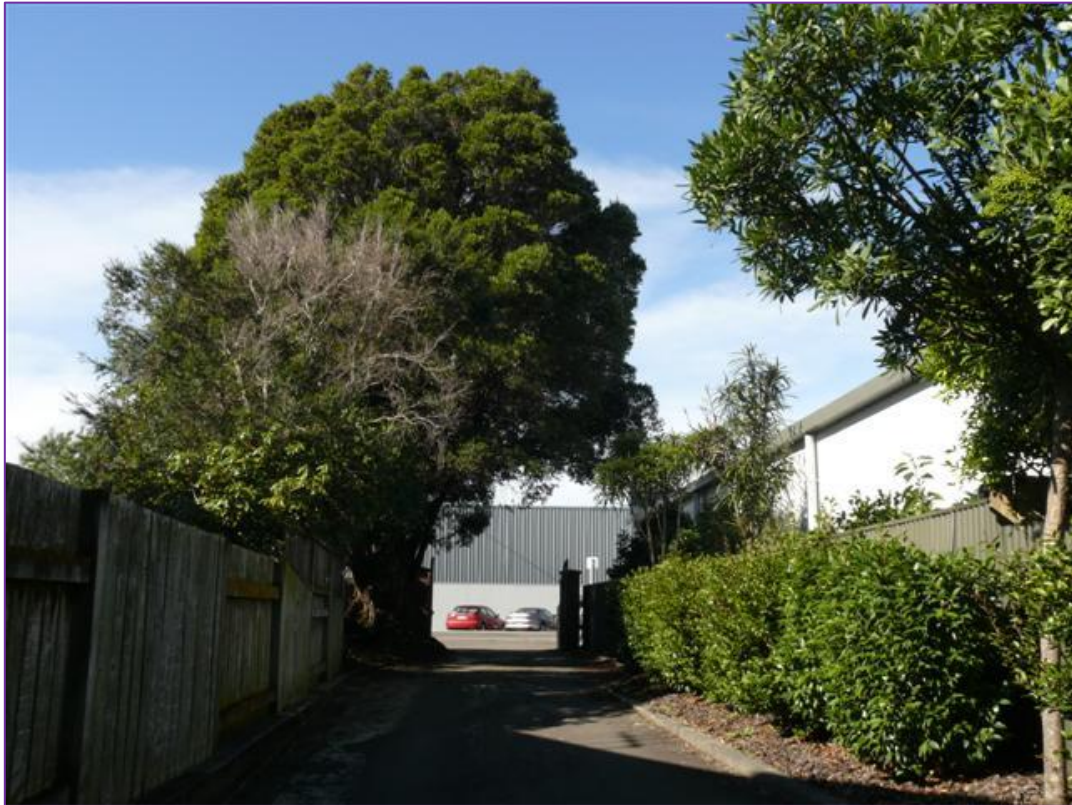
Figure 1.on exit from the drive

Category	Priority	Recommended Action	Timing (from April 2011)	Actioned	Completed
<b>Amenity</b>	routine	Lift crown over driveway to allow eg fire engines, removal vehicles	From now on		
<b>Health</b>	-				
<b>Safety</b>	-				
<b>Overhanging b'dry</b>	-

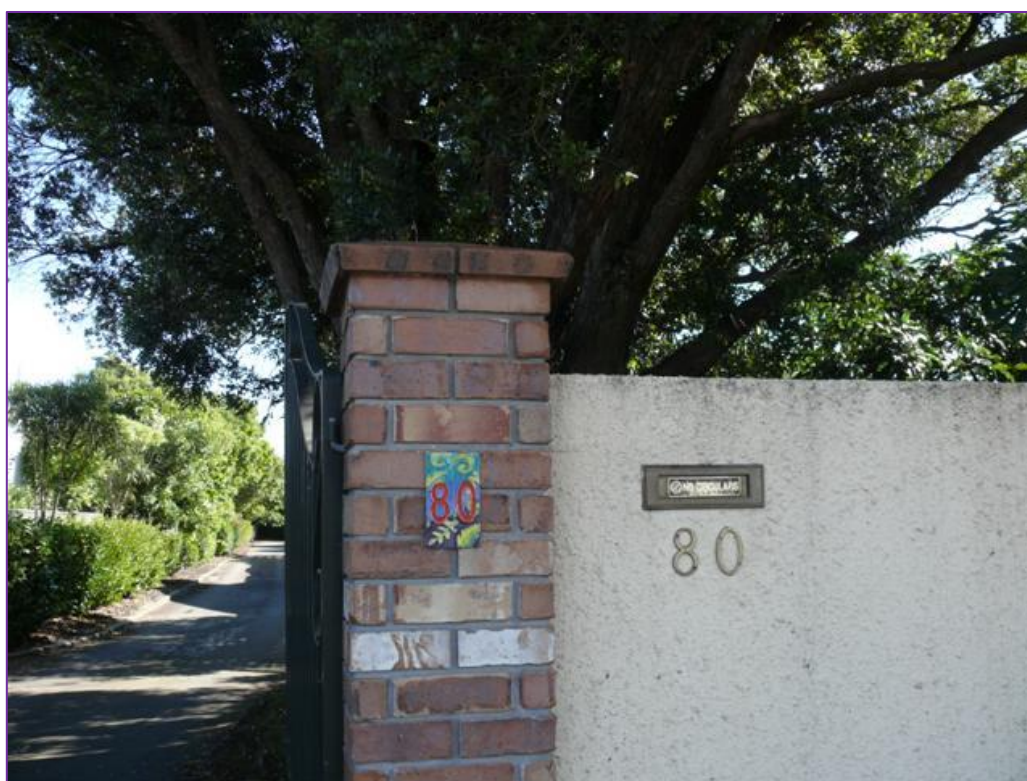
Figure 5. It is likely the gatepost and wall will need repairs every 10 years or so

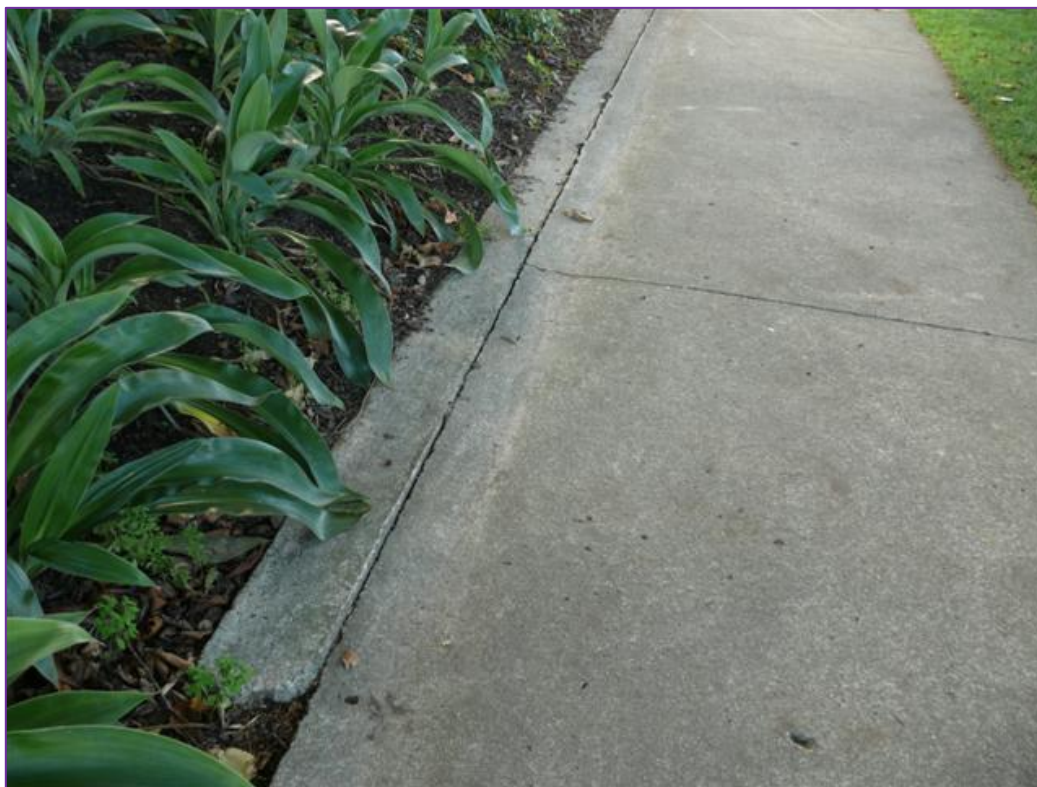
Figure 1, the footpath is intact.

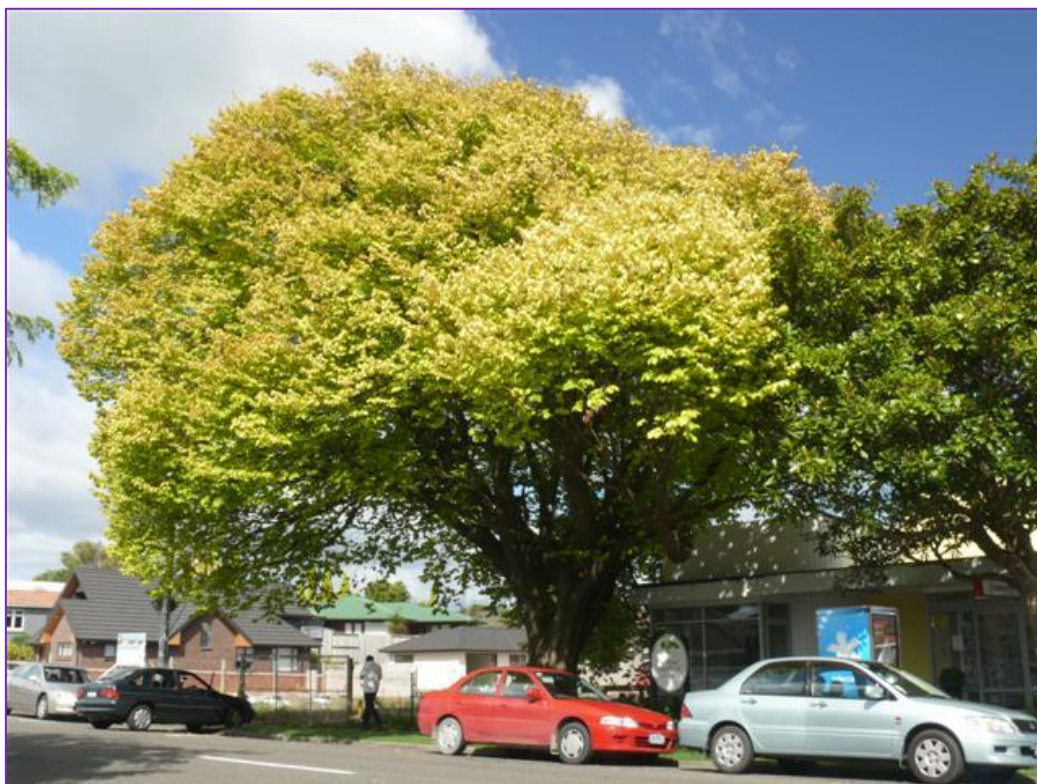
Figure 2, the shape of the crown is influenced by wind; the evergreen magnolia and elm shade the shop.

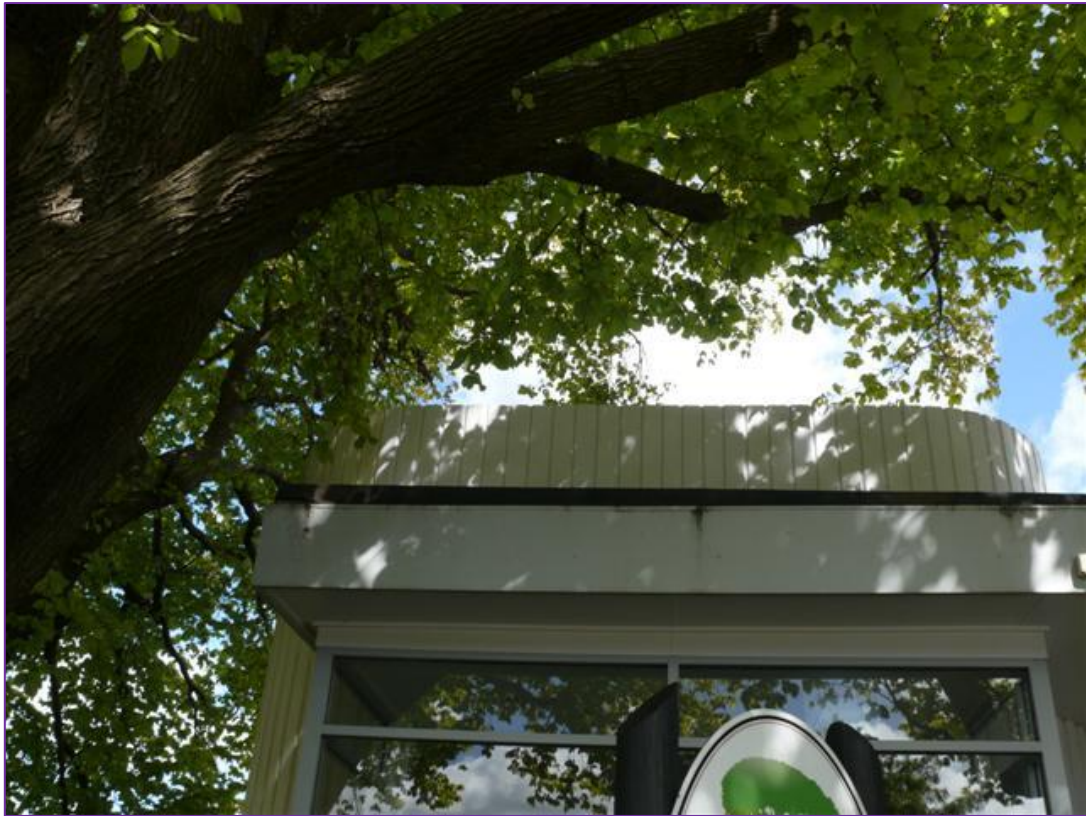
Figure 5, some crown lifting needed here

Category	Priority	Recommended Action	Timing (from April 2011)	Actioned	Completed
<b>Amenity</b>	routine	Raise the lower limbs over the road whenever necessary, remove dead wood	Within 5 years		
<b>Health</b>					
<b>Safety</b>		See above			
<b>Overhanging b'dry</b>	routine	Prepare to shorten the outer branches and crown lift/	As requested no more than once in 5 years.

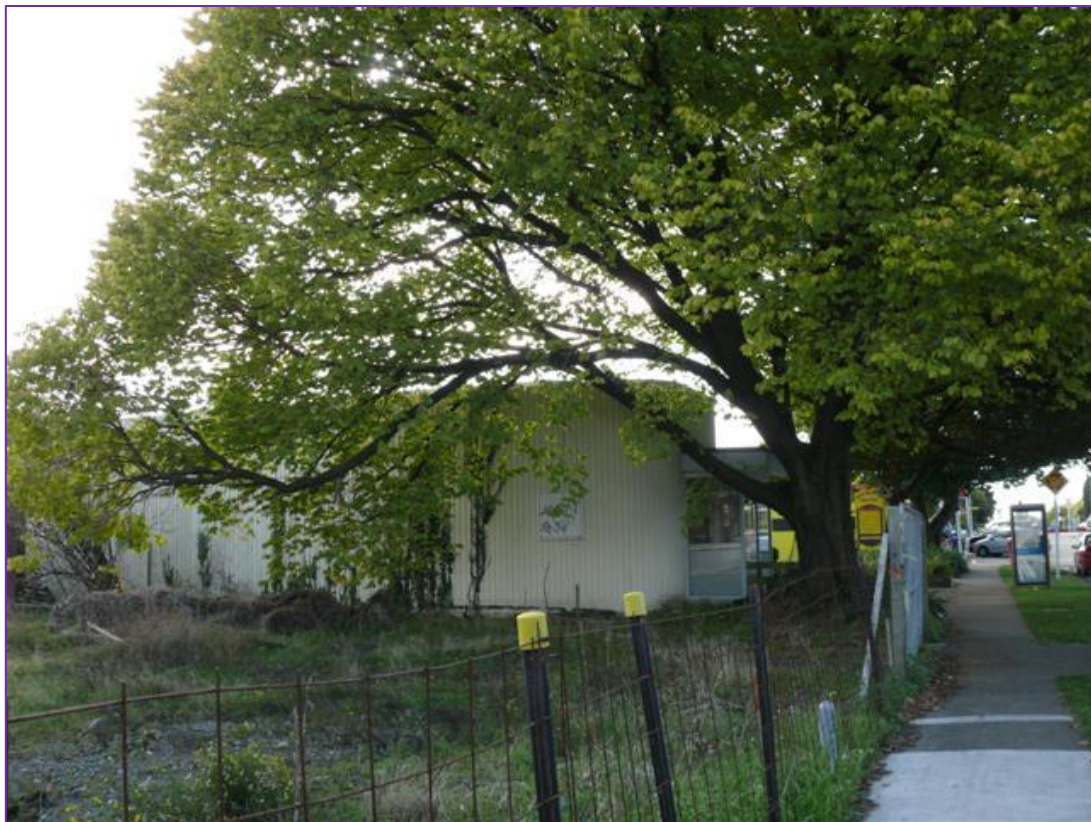
Figure 6, the low branches soften the building's outline, but maybe come a bit too far into the section.

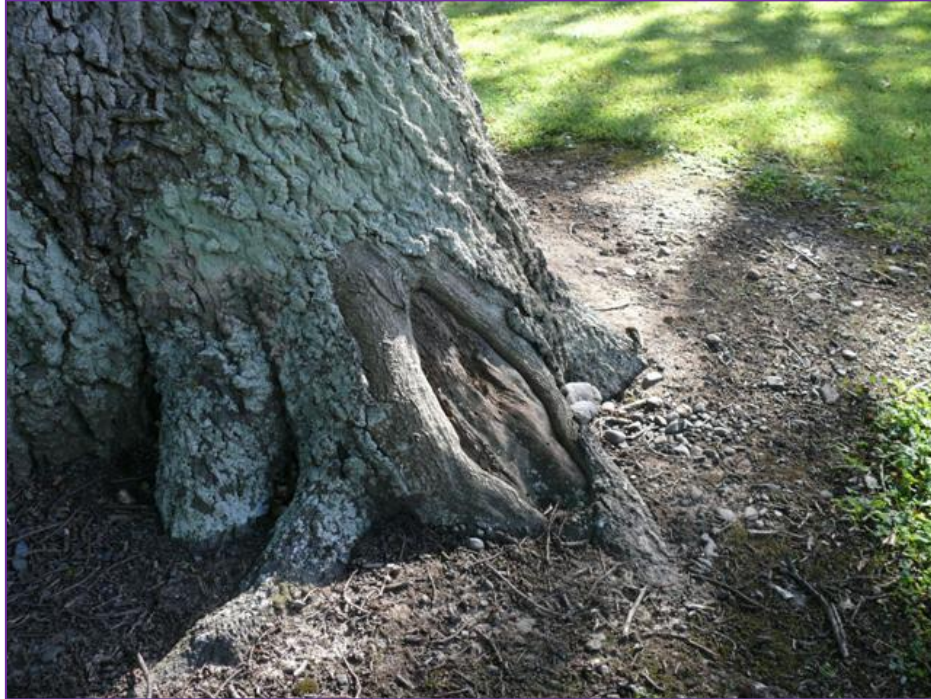
Figure 1. old mower damage.

Category	Priority	Recommended Action	Timing (from April 2011)	Actioned	Completed
Amenity	Required earliest	Reduce width of the crown to offer less w2ind resistance, and to lighten load on branches	Now and re-check in 5 years		
Health		It would be good to see a bed of mulch and low shrubs around the base of the tree	Starting now, apply mulch annually.		
Safety	See above				
Overhanging b'dry	-

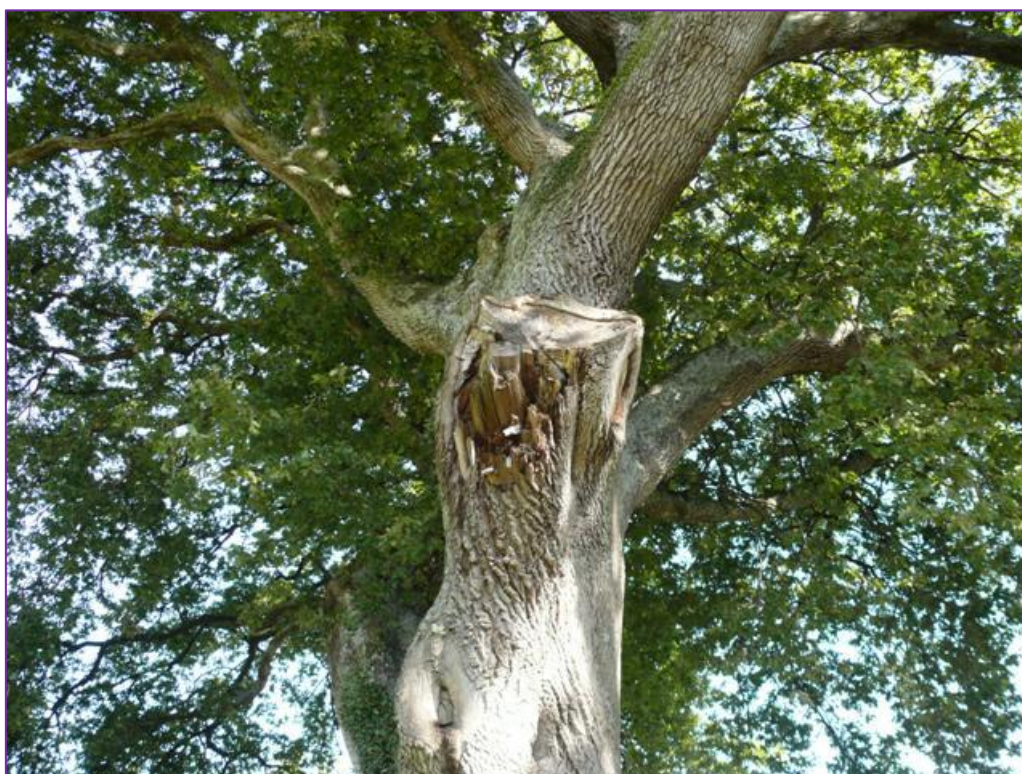
Requested for/by	Routine	Storm Damage	Owner	Developer	DP Review
Pruning History	A very large branch fell off a few (4?) years ago. This has been tidied up.				
Built Environment	Small tight dev'pment	Standard suburban	Large house and grounds	Large research facioity	
Garden environment	Solo tree	Few trees	Many trees	Mainly exotic/native	
Local Environment	Few trees	Some trees	Well treed neighbourhood		
Age Class	young	Semi mature	Mature	Post mature	
Special value	Horticultural	Landscape	Specimen	Historical	Botanical
Structural Character	Single leader	Double leader	Multi-stemmed	Included bark unions	Typical Atypical
Form	Refer to STEM scoresheet				
Crown Shape	Typical	Atypical in that it is larger than any other	Wide/spreading/low crown	Influenced by wind	Affected by other trees
Foliage Health	Good	Poor, if so, explain			
Limb Structure	Typical or sound	Atypical, if so, explain			
Trunk character	Tall, reasonably straight, well buttressed

Root Zone	Garden	Natural	Lawn/paddock	U/g services apparent?	Hard surface, if so, explain
Comments	The huge crown has shed one v. large llimb in the last short while. This will happen more frequently unless some remedial shortening is undertaken.

Figure 4. Large wound cause d by falling branch

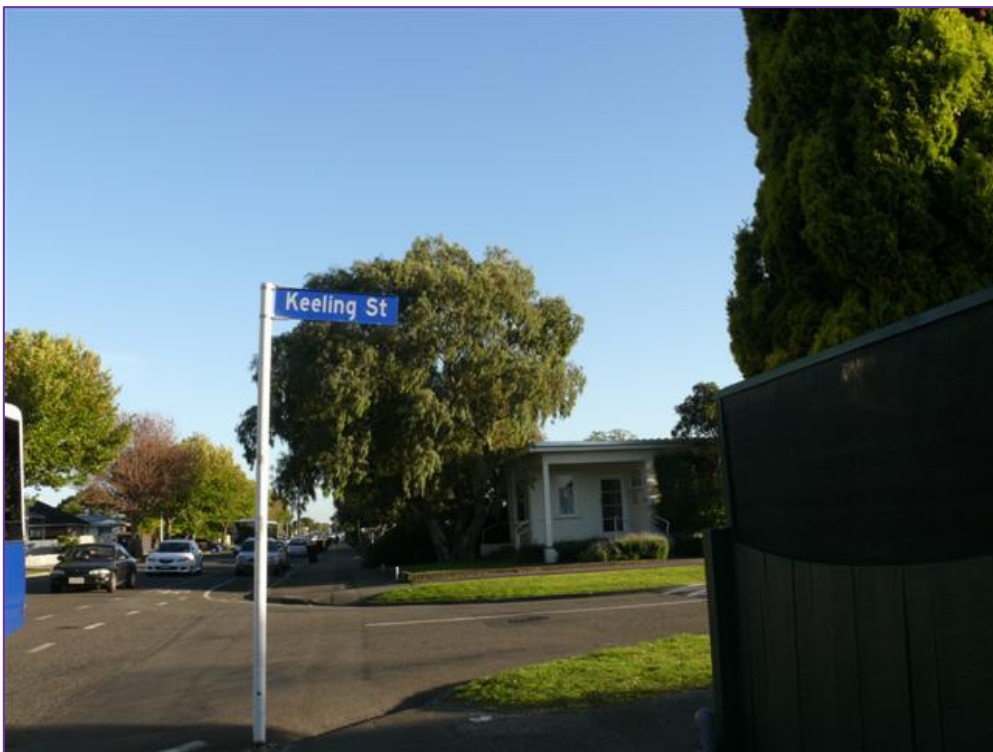
Figure 2. the tree is surprisingly large – healthy foliage, too

Category	Priority	Recommended Action	Timing (from April 2011)	Actioned	Completed
Amenity	routine				
Health	~				
Safety	Regular checks	The long, spreading limbs are putting a great strain on the unions at the base. Consider reduction of the crown width	Within 2 years, then 5 yearly		
Overhanging b'dry	~

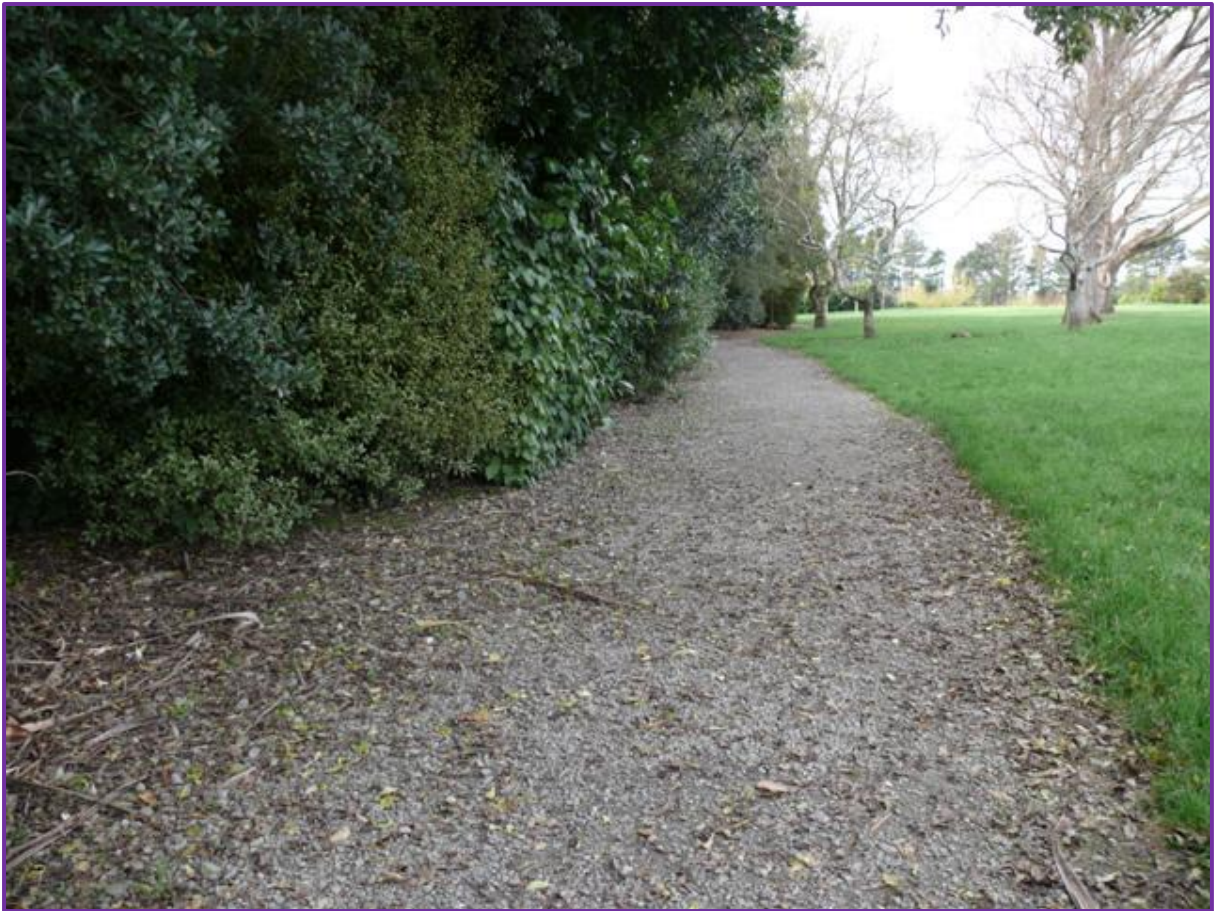
Figure 1, the dense edge effectively reduces weed ingress
