Palmerston North City Council

Notable Tree Survey March and April 2011

Address	9 Featherston Street	
Tree name	Norfolk Island Pine(<i>Araucaria heterophylla</i>)	
Location of the tree on the site	Front garden	
Owner's name		
Date of STEM Assessment	28 June 2014	Inspected by John Wakeling

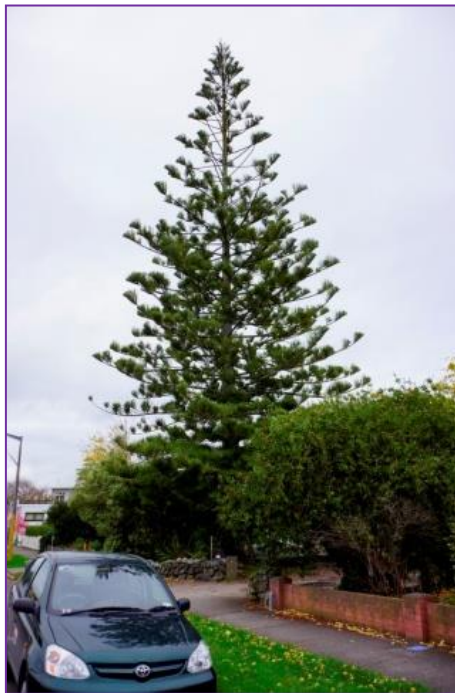
Figure 1, the silhouette of the tree. Note the conical apex

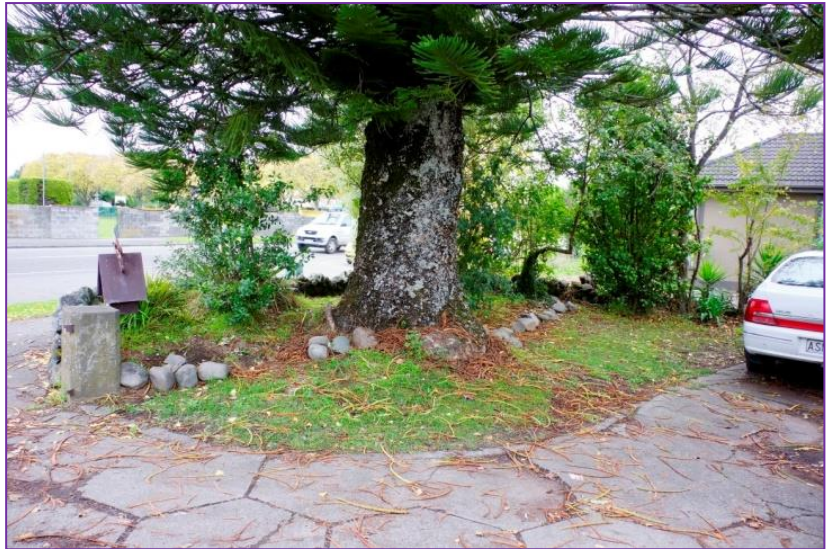
Figure 2, front yard where the tree takes up a lot of the garden

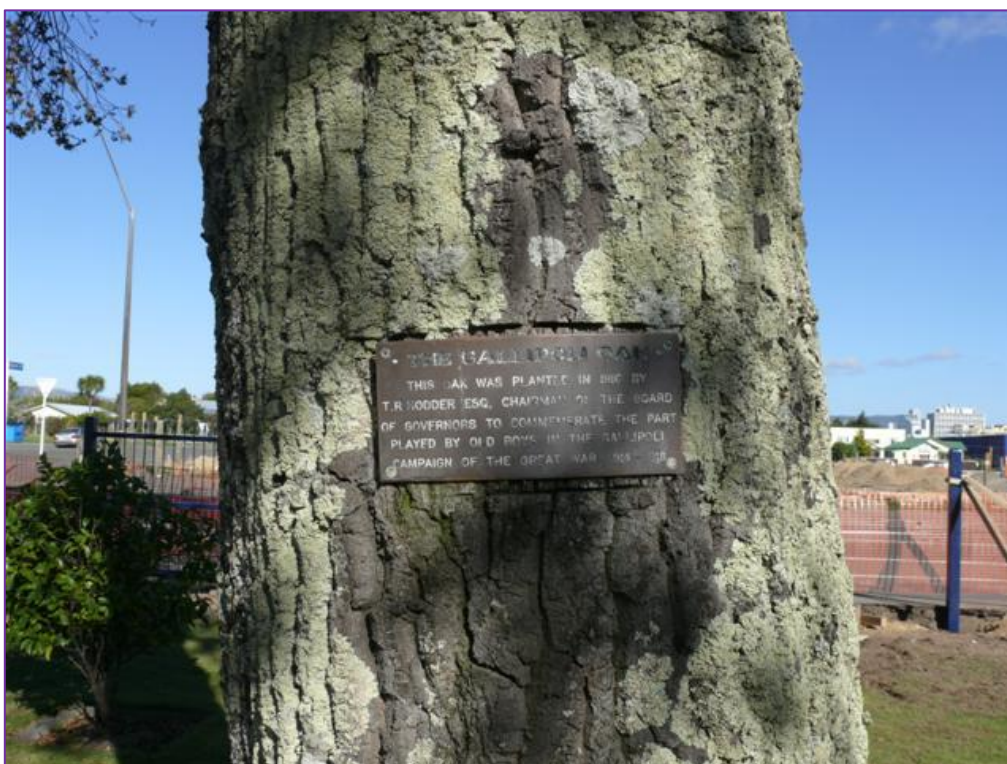
Figure 2. Please remove this plaque from the living tree.

Category	Priority	Recommended Action	Timing (from April 2011)	Actioned	Completed
Amenity	One off	Remove the metal plaque from the trunk of the tree			
Health	routine	Install a mulch layer around the tree, and perhaps plant shrubs around the base of the tree (perhaps transplant the commemorative camellias nearby)	Annually if possible		
Safety	-				
Overhanging b'dry

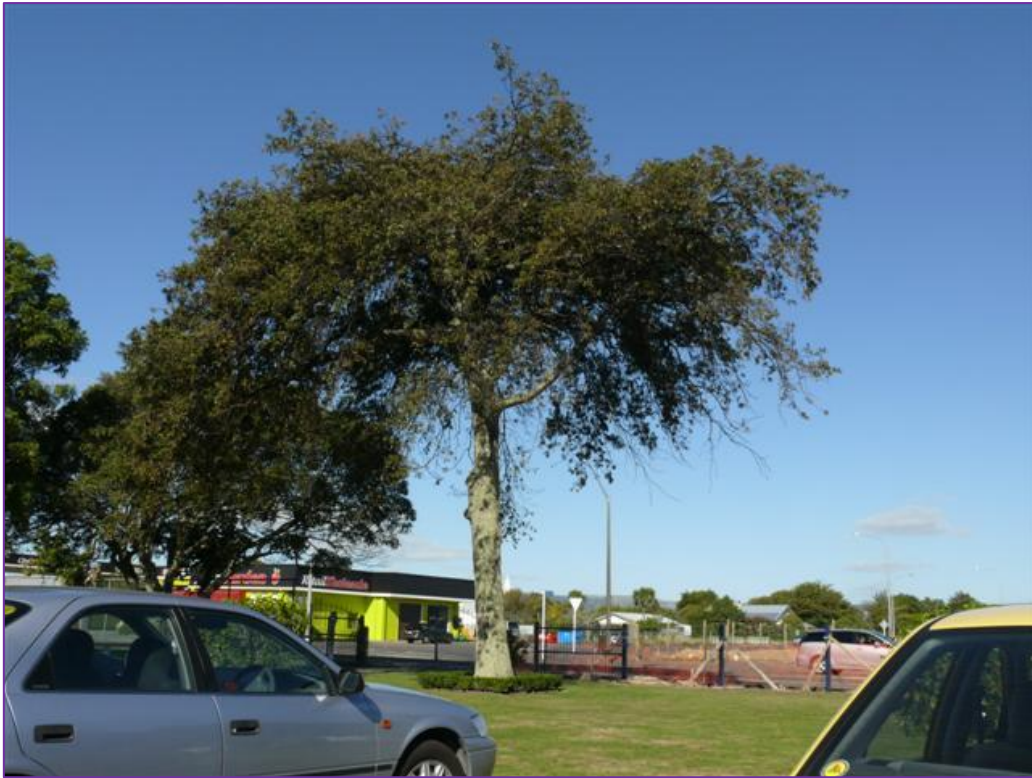
Figure 3. This is not a typical shape for a Turkey Oak

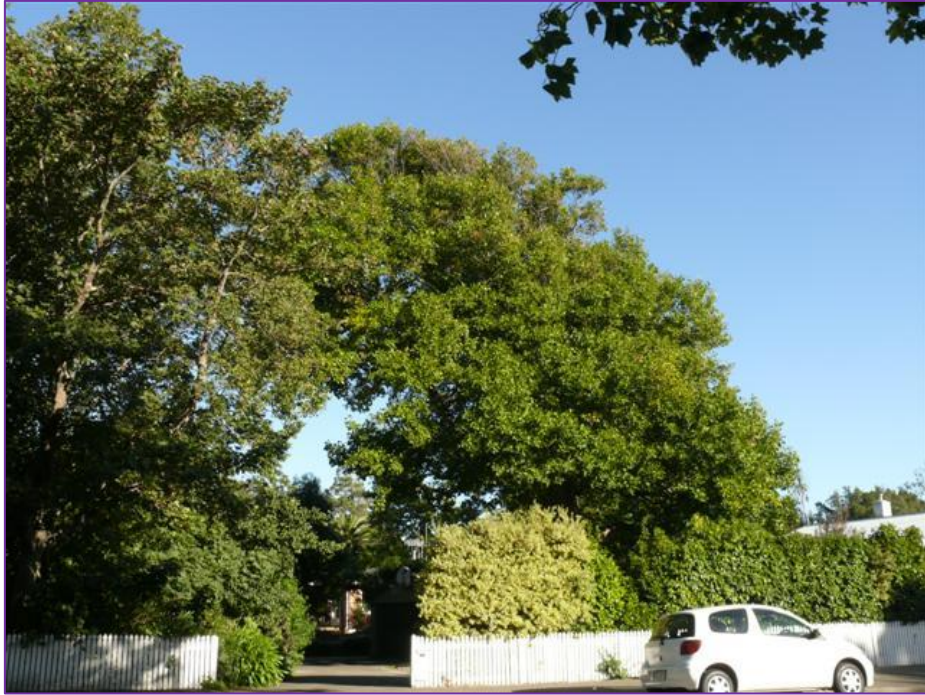
Comments	The tree is a very vigorous specimen. The crown has been wind pruned, thus the leeward side of the crown has grown faster, putting it rather out of balance. Recommend that the leeward side is pruned.

Figure 1. shows the influence of the westerly winds

Category	Priority	Recommended Action	Timing (from April 2011)	Actioned	Completed
Amenity	Routine	Prune windward side of the crown. Reduce weight of longest limbs by up to three metres, retin the shape of the tree.	Within 2 years then normal dead wooding every 5 years or so		
Health	optional	Mulch the base of the tree			
Safety	See Amenity section above.				
Overhanging b'dry

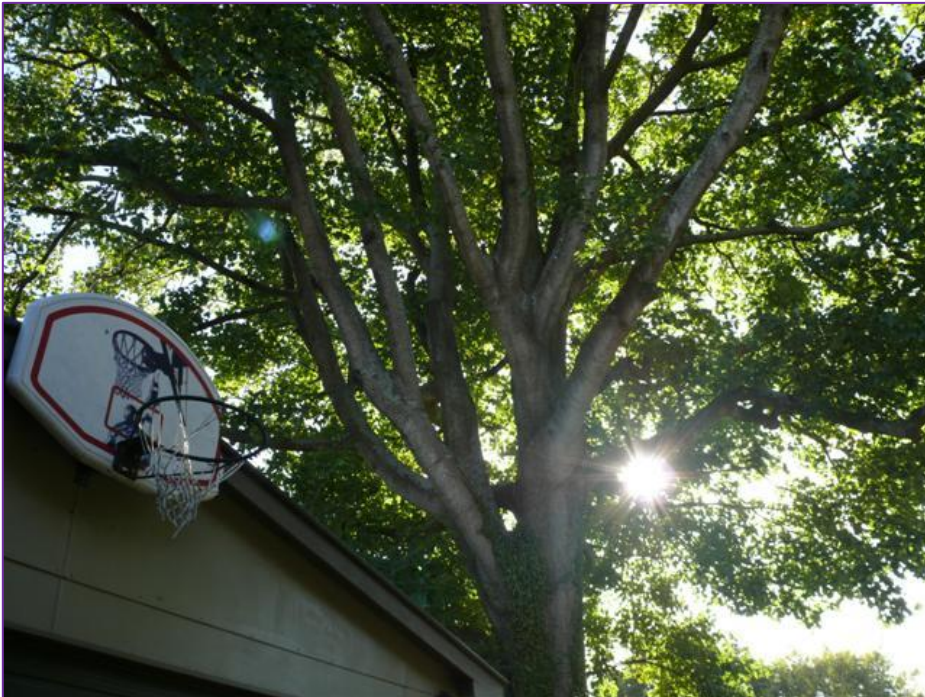
Figure 2. The crown overhangs the garage

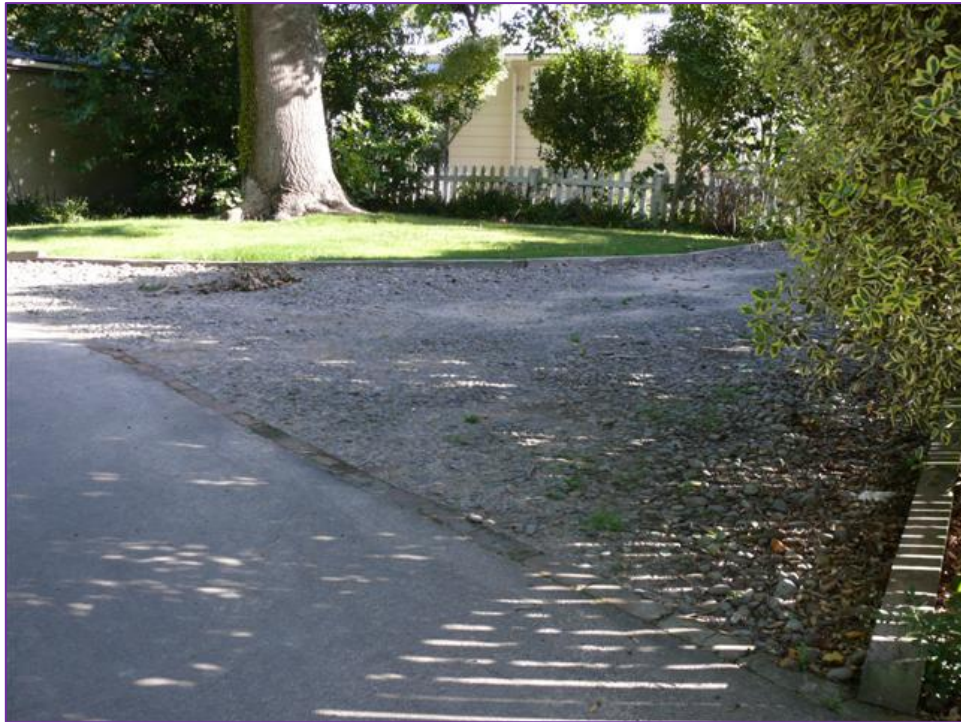
Figure 3. permeable standing is good for root development and water percolation.

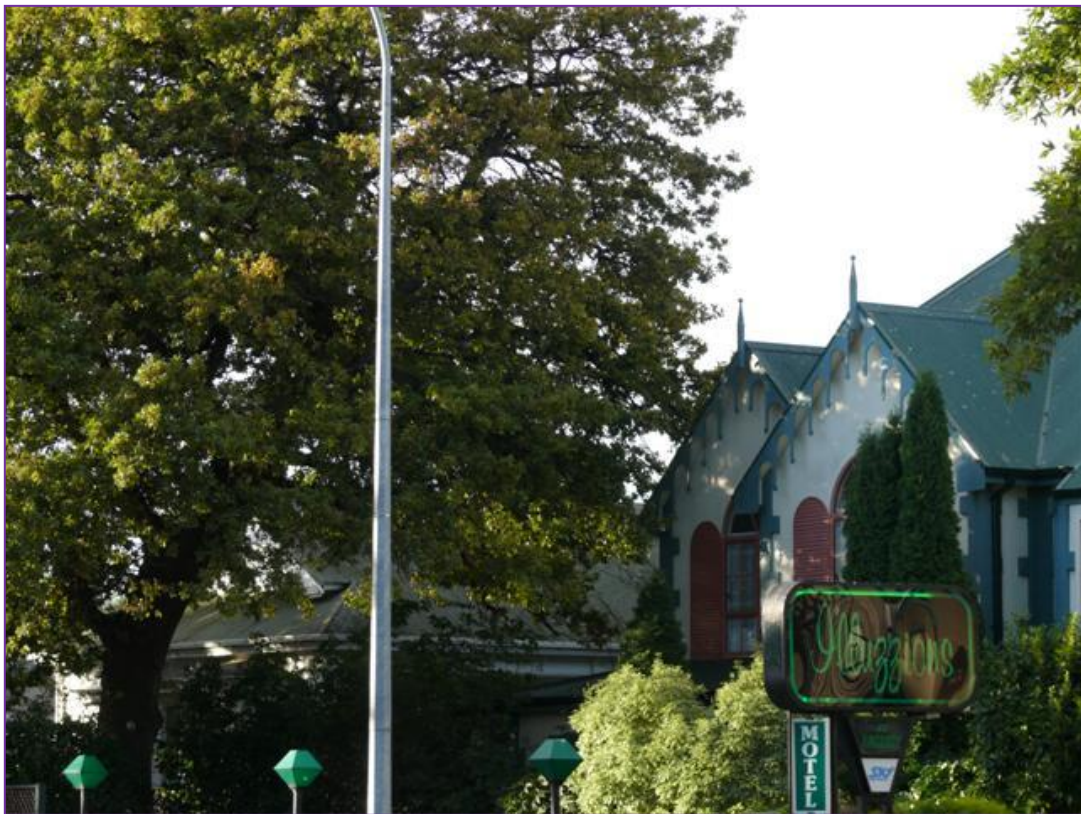
Figure 3. The overhanging branches could be reduced to give more clearance from the windows.

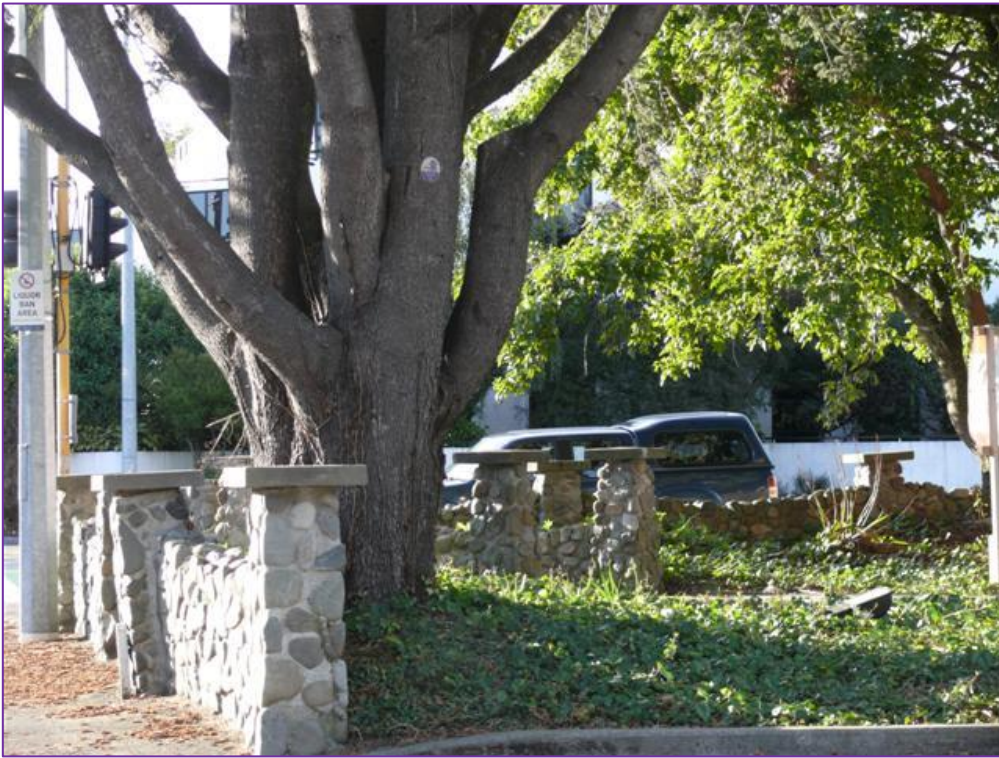
Trunk character	Very short, with many side branches				
Root Zone	Garden	Natural	Lawn/paddock	U/g services apparent?	Hard surface, if so, explain foot path and cobblestone wall
Comments	The tree has improved in health – when the site was first developed, the tree went through a period when it looked very poorly. Now it is thriving in the semi-natural ground conditions. The pressures from root growth are pushing the riverstone wall apart. This will have to be addressed by some form of rebuilding – using piles and bridge over the roots or similar.

Figure 1 The tree is pushing the wall over (root growth activity)

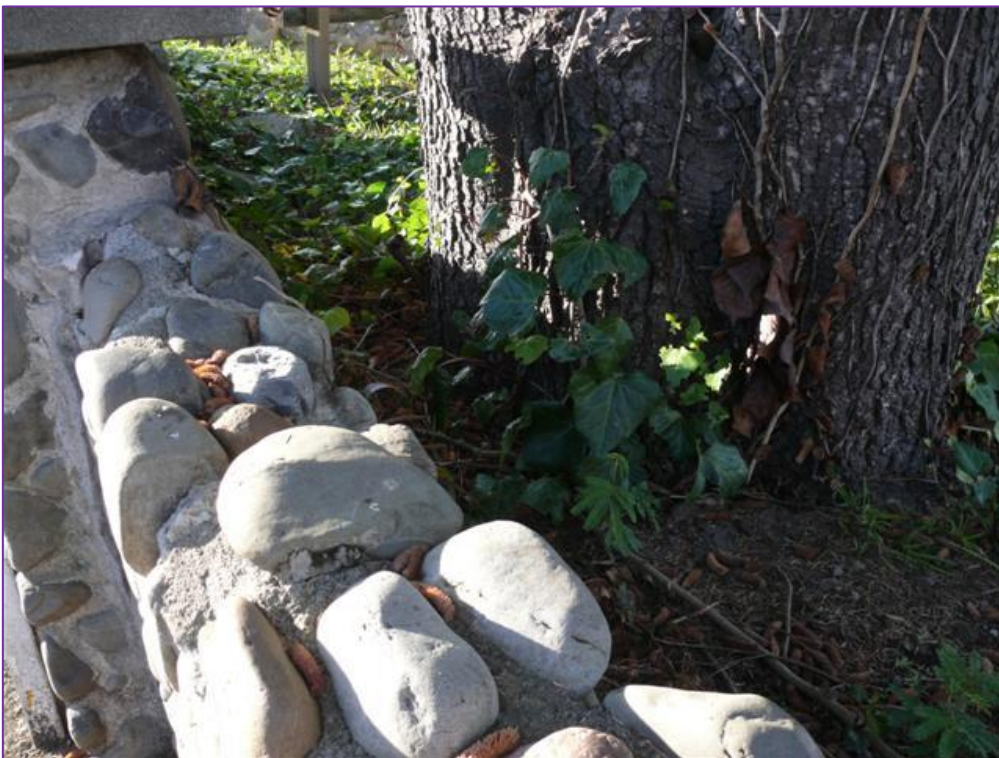
Figure 2. Detail of wall

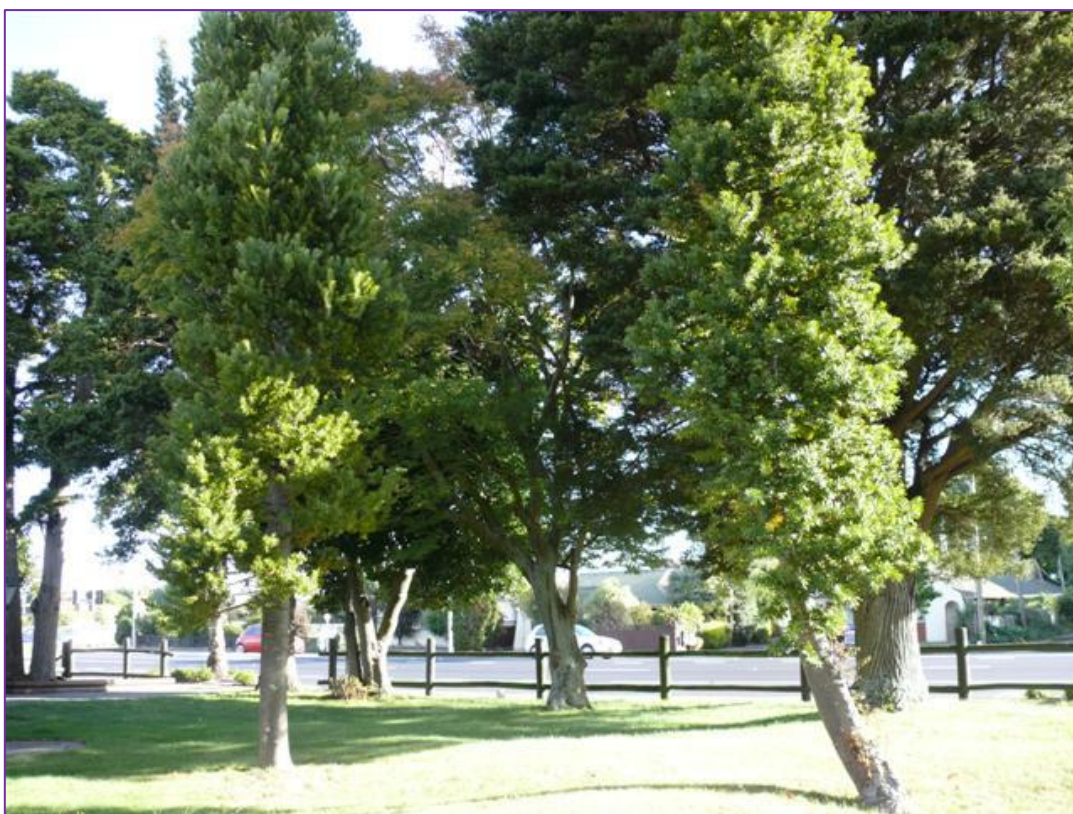
Figure 3, the two kauri are not part of the group

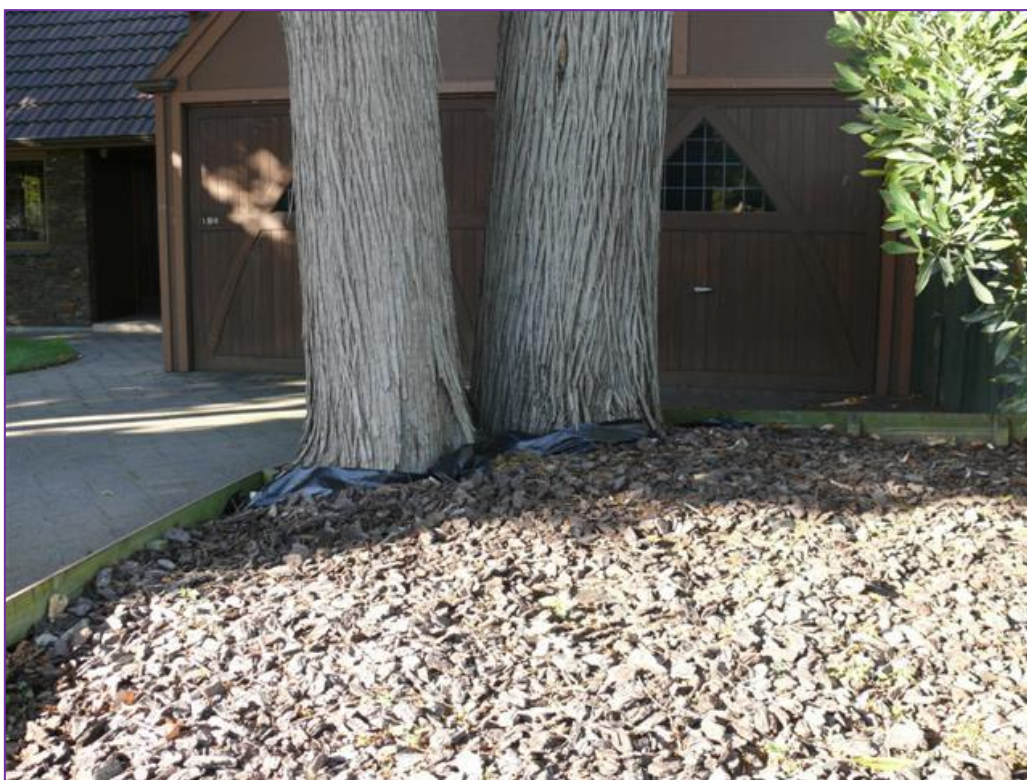
Figure 6, two totara very heavily compromised during construction, and seem to have adapted to the new conditions

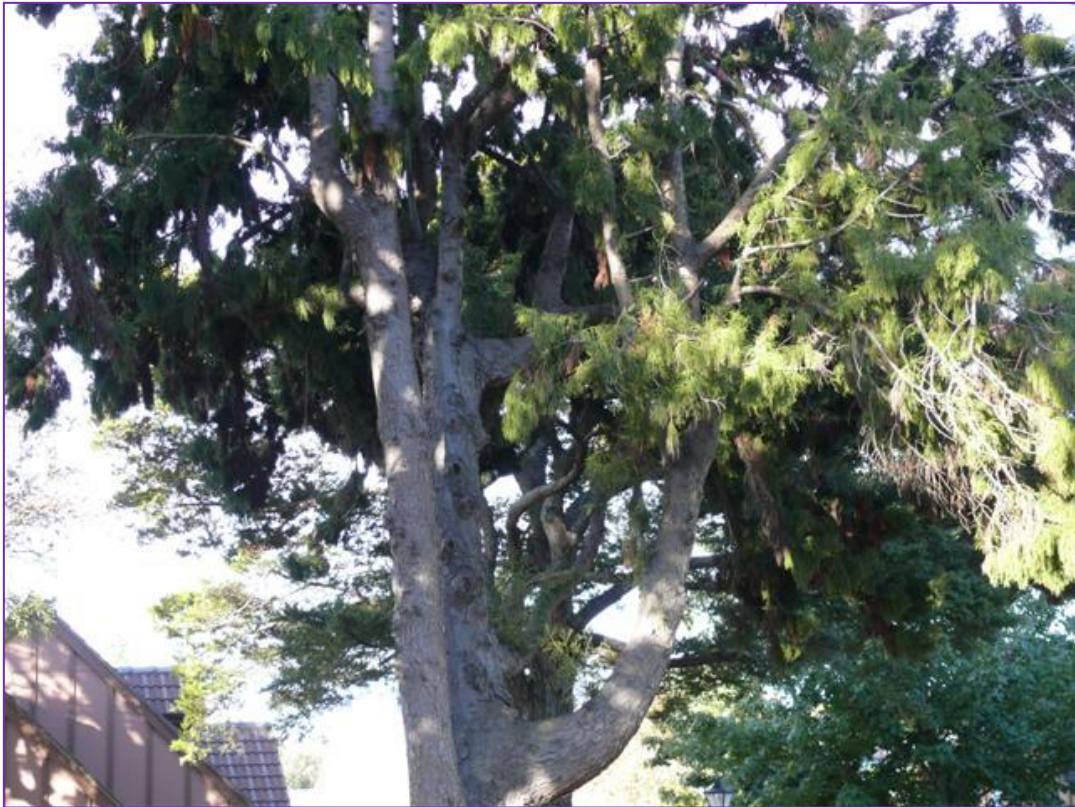
Figure 1, the rimu had been topped, but has adapted well.

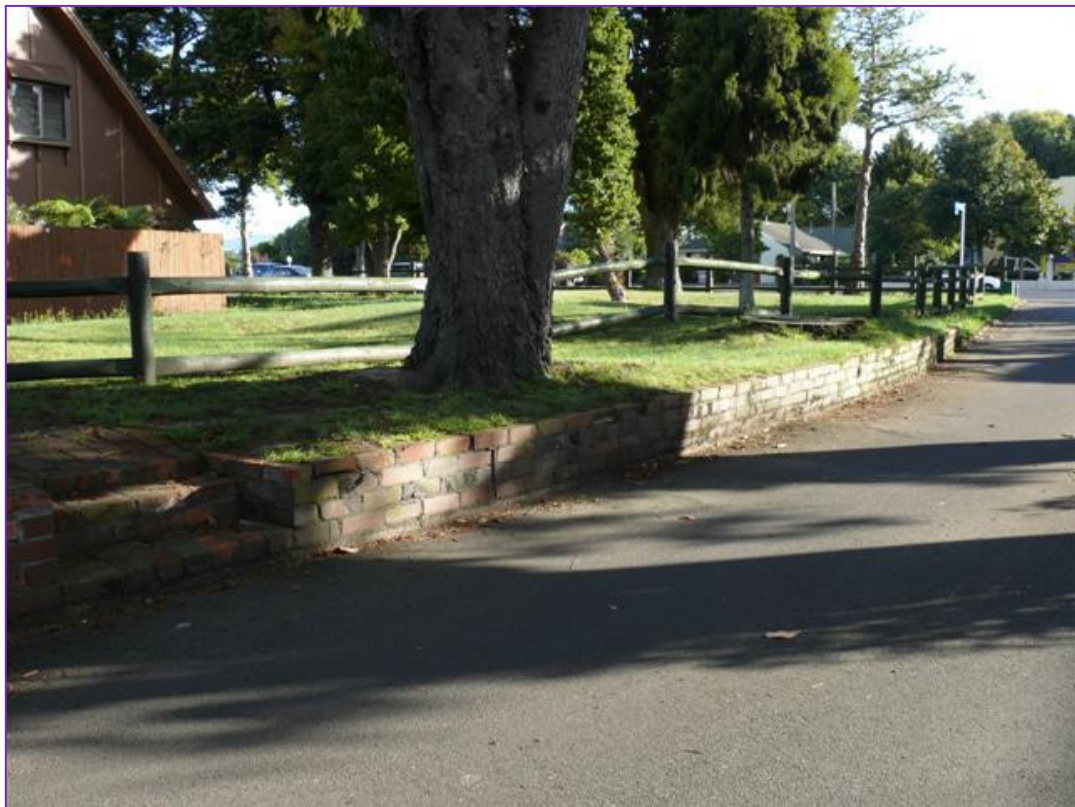
Figure 2, the new road comes very close to the trunk of the rimu – many roots have been severed.

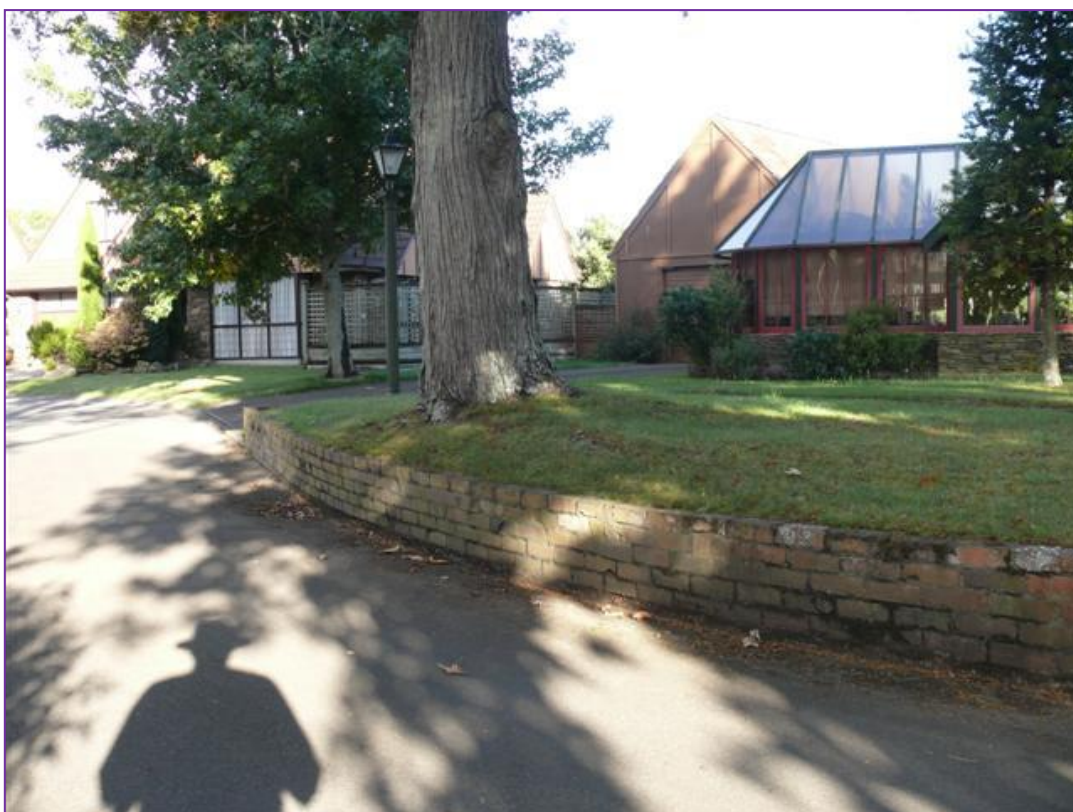
Figure 3, road is close to the totara trunk

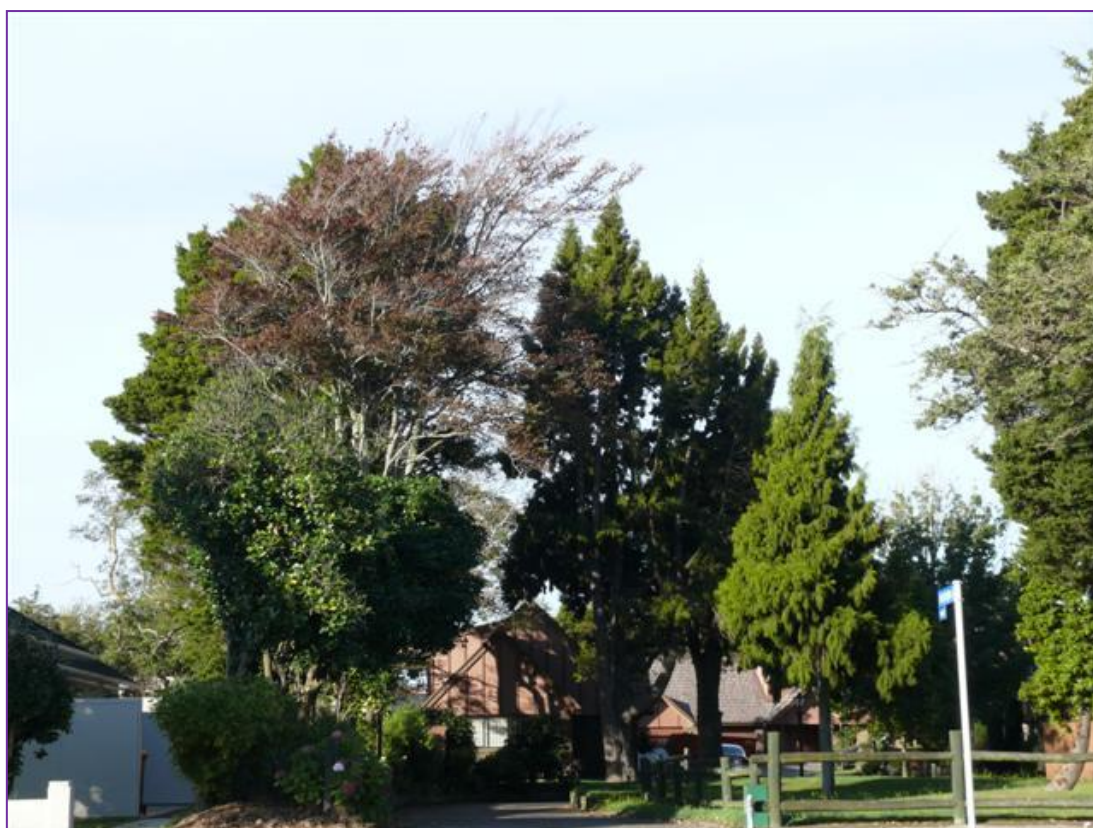
Figure 4, note the wind pruned beech canopy.

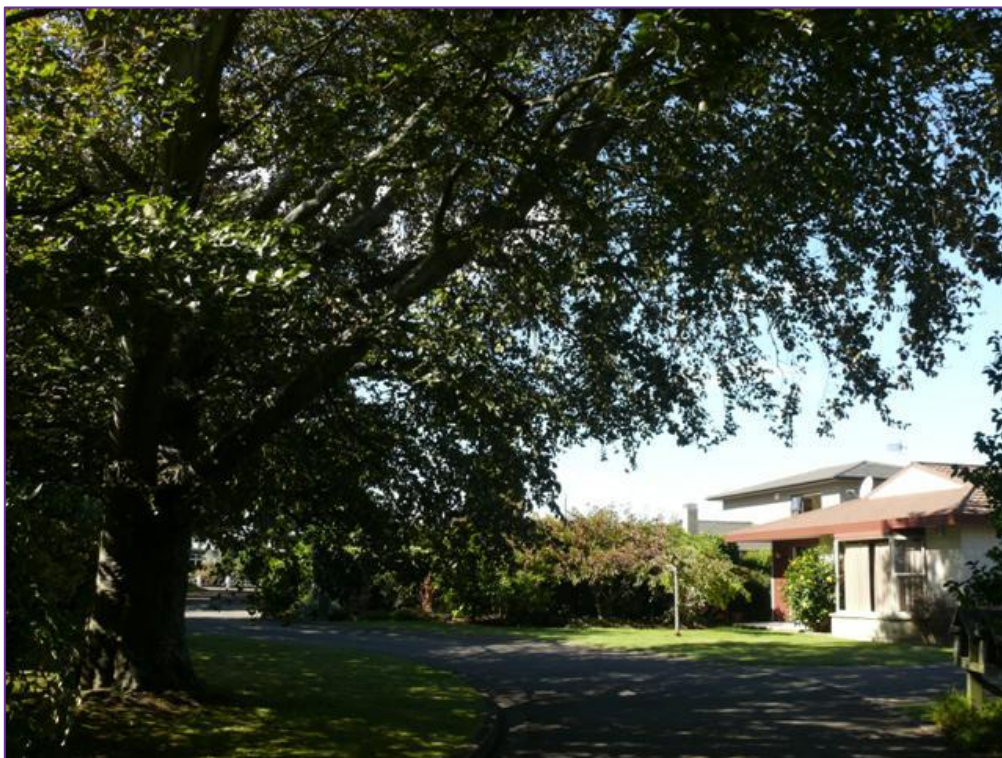
Figure 1 the low limb over the driveway will need some side branches removed before long

Category	Priority	Recommended Action	Timing (from April 2011)	Actioned	Completed
Amenity	routine	Deadwood. Shorten lower limbs to allow better driveway access.	In 2 to 3 years		
Health					
Safety					
Overhanging b'dry

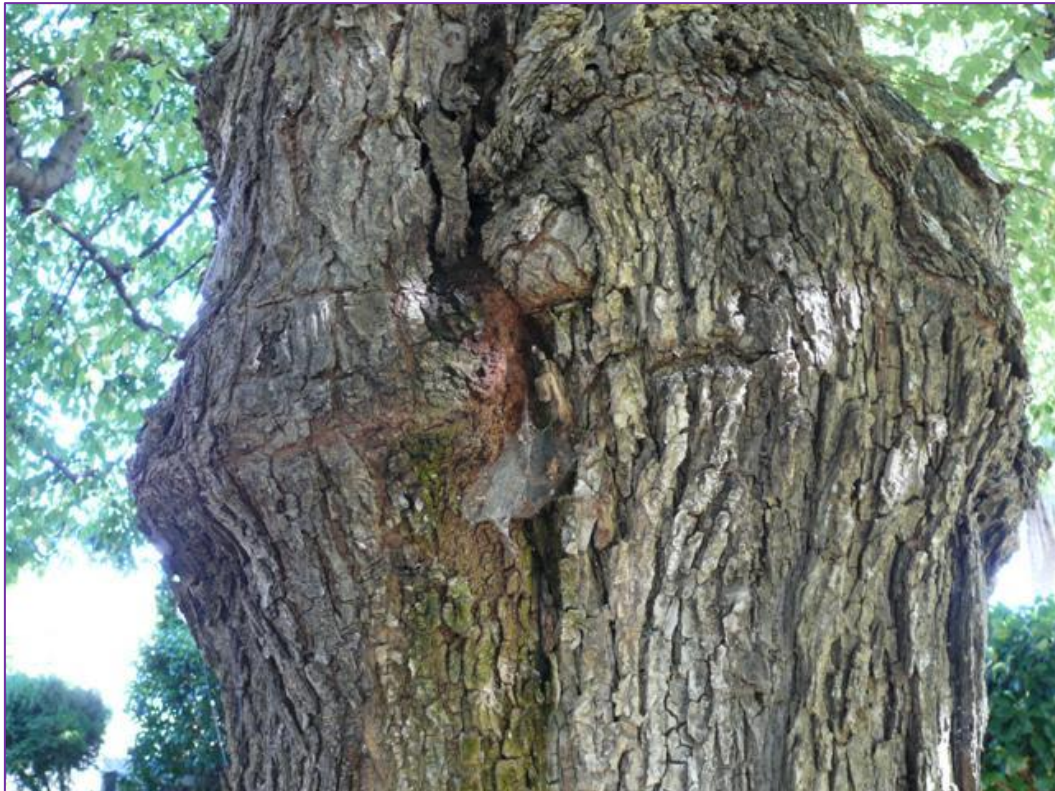
Figure 4. this is the area where the weeping section of the tree was grafted onto the straight, upright stock plant. This is a common source of infection

Category	Priority	Recommended Action	Timing (from April 2011)	Actioned	Completed
Amenity	routine	Reduce crown width, thin crown	Thin crown no more than 5 yearly		
Health	annual	Monitor the extent of the canker			
Safety	-				
Overhanging b'dry

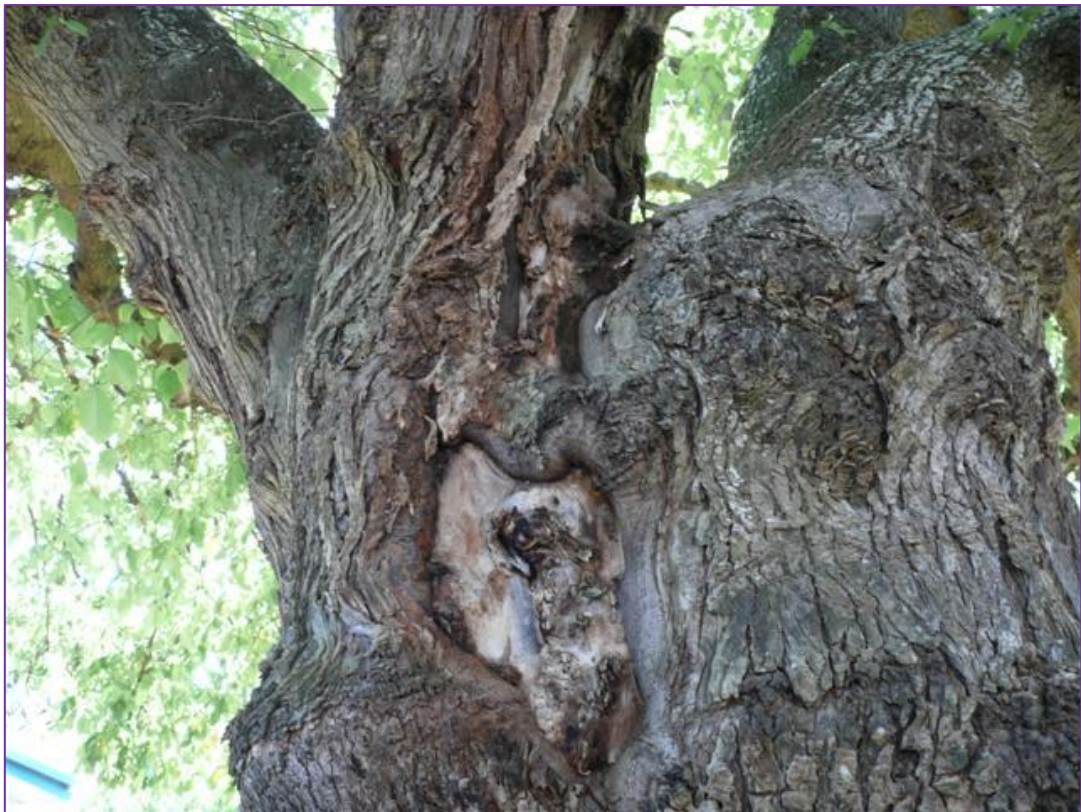
Figure 5. monitor this area for increased oozing and staining of the bark.
