Palmerston North City Council

Notable Tree Survey March and April 2011

Address	183 Grey Street	
Tree name	Phoenix palm (<i>Phoenix canariensis</i>)	
Location of the tree on the site	Front, near entrance gate	
Owner's name		
Date of Inspection	31 March 2011	Inspected by John Wakeling

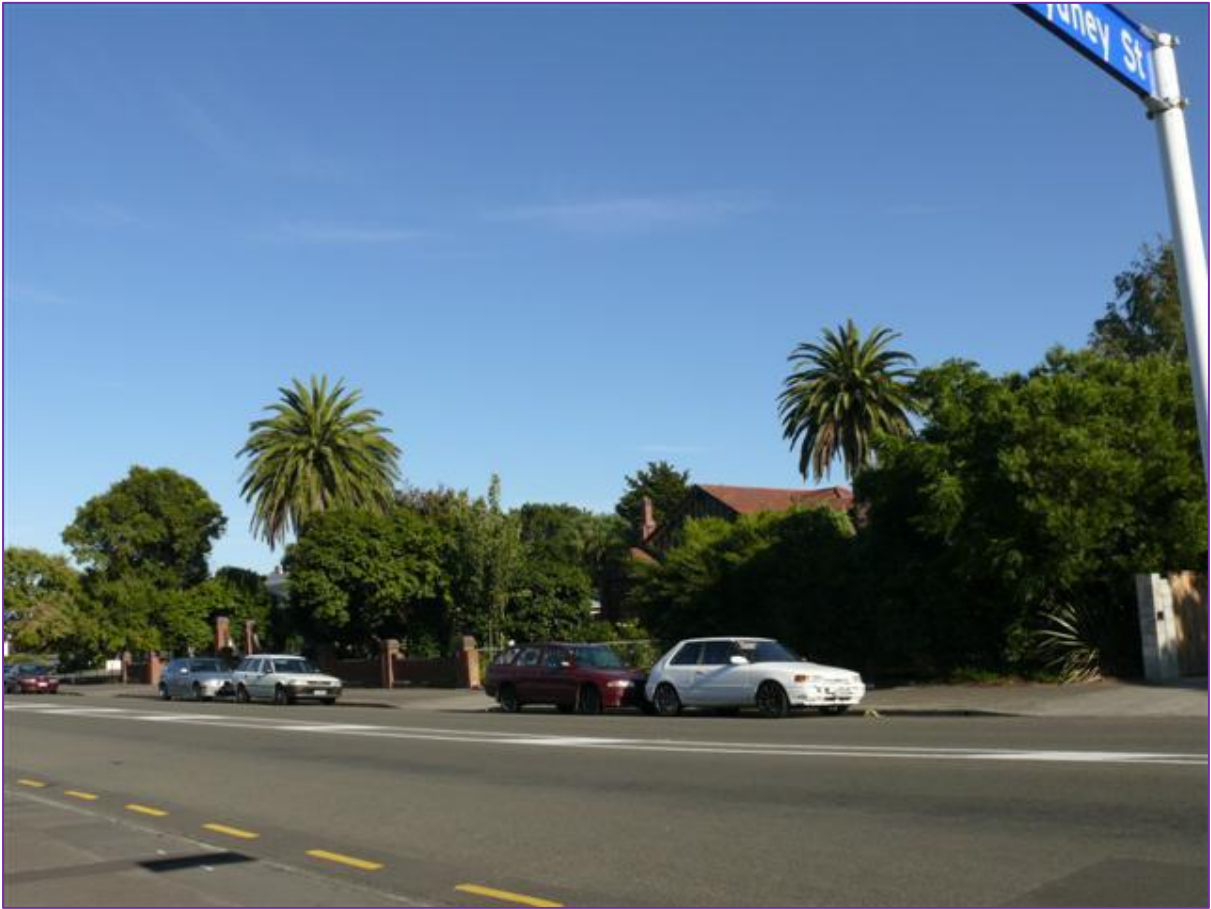
Comments	A healthy tree, in a commanding location alongside the imposing entrance

Figure 1. the protected palm is the tree to the left of the picture

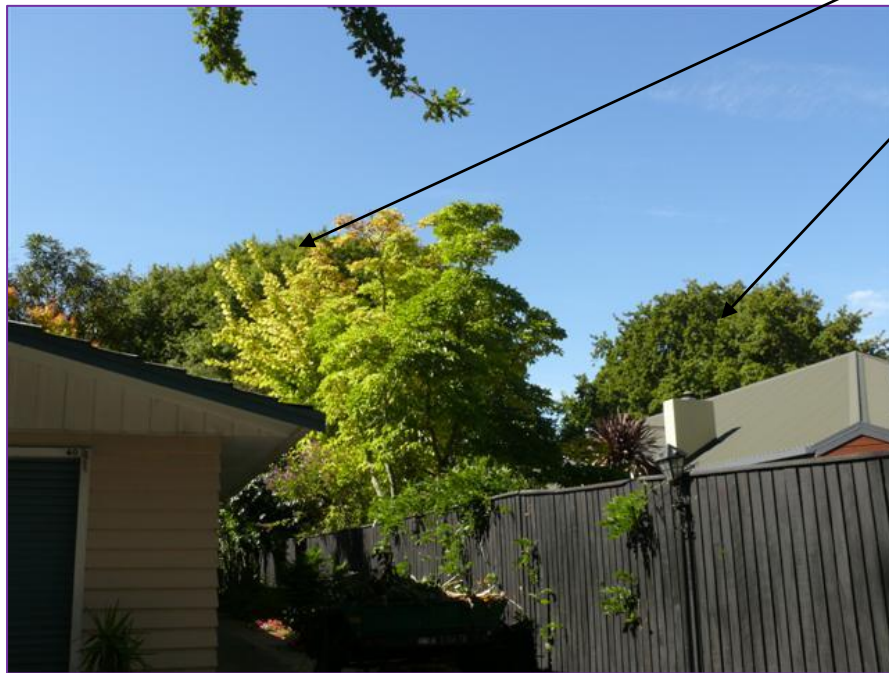
Figure 1. Crowns of two notable trees 38 Ihaka Street and 1 Pastoral Lane

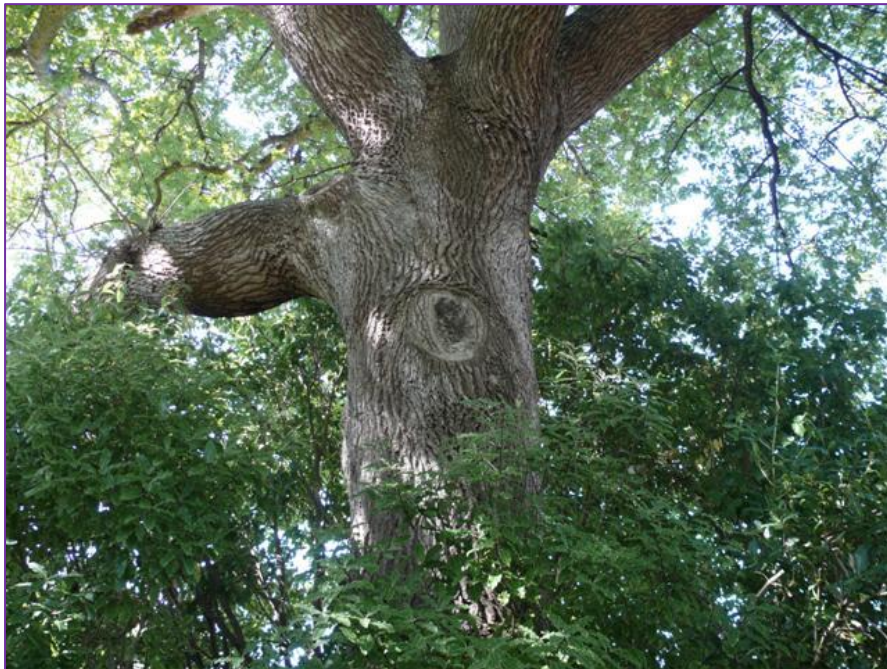
Figure 2. Looking into the crown

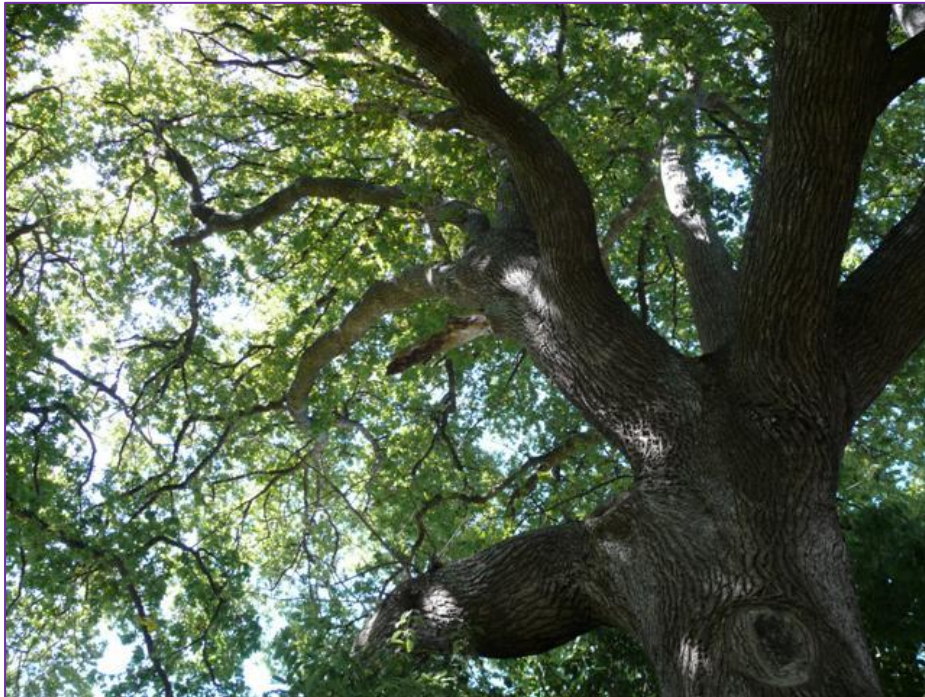
Figure 3. Healthy Crown

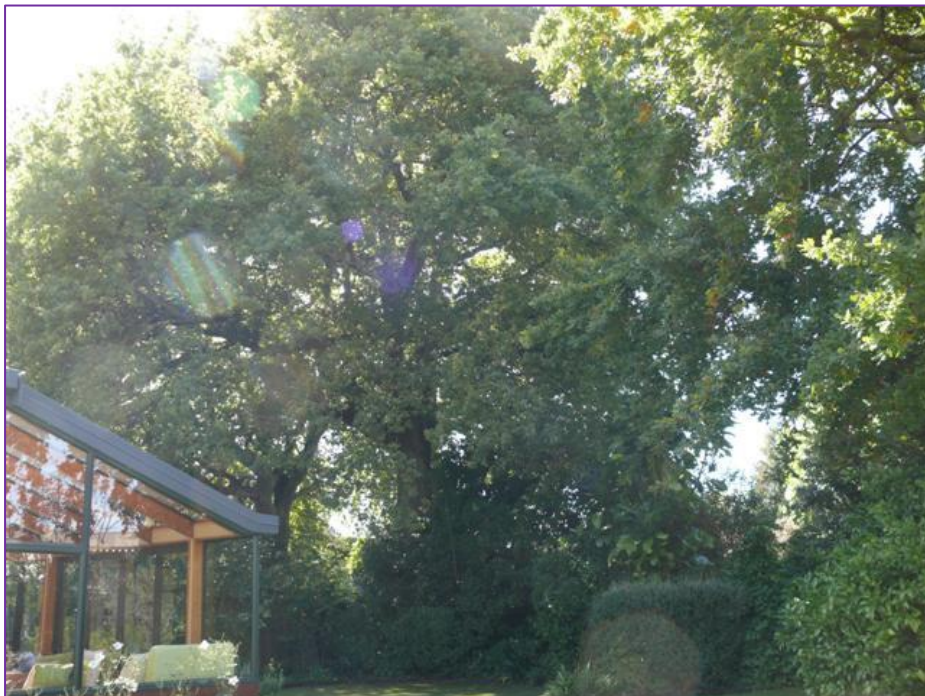
Comments	This tree grows better and better. It is very large on a small site, and will require some crown width reduction sometime soon

Figure 4. the crown dominates the garden

Category	Priority	Recommended Action	Timing (from April 2011)	Actioned	Completed
Amenity	As requested	Deadwood, reduce weight and width of the larger lower boughs	Within 5 years		
Health	-				
Safety	As for amenity section above				
Overhanging b'dry	As requested	The crown overhangs the boundary and will need some work in the future	As above

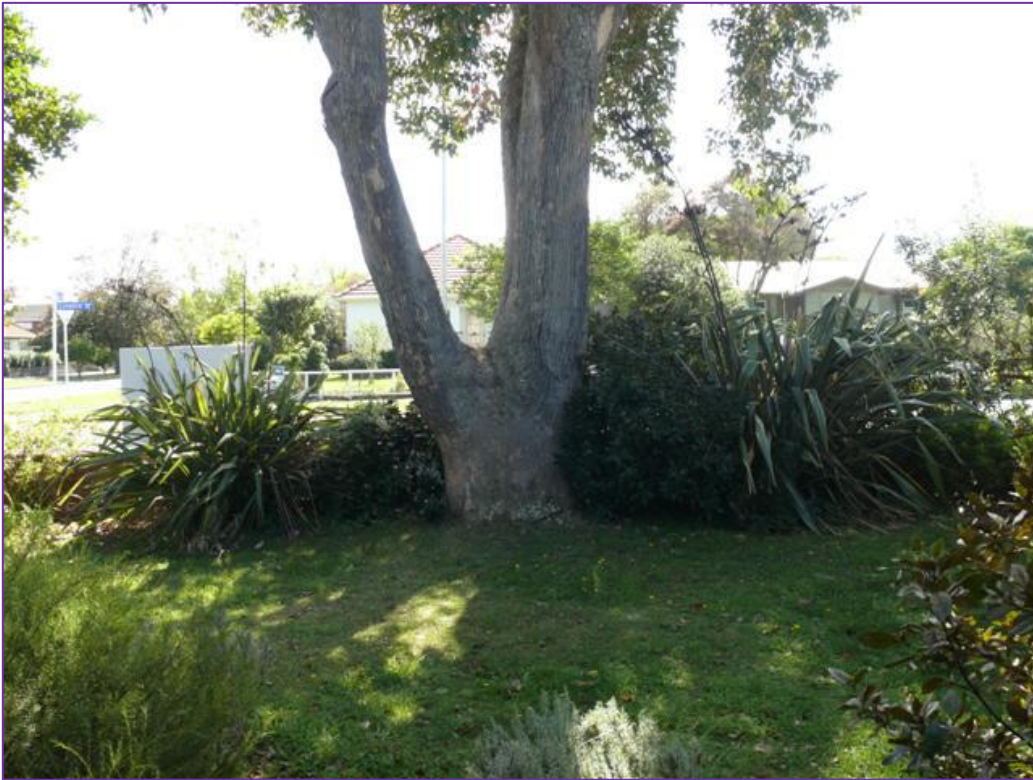
Figure 1 the tree in its setting

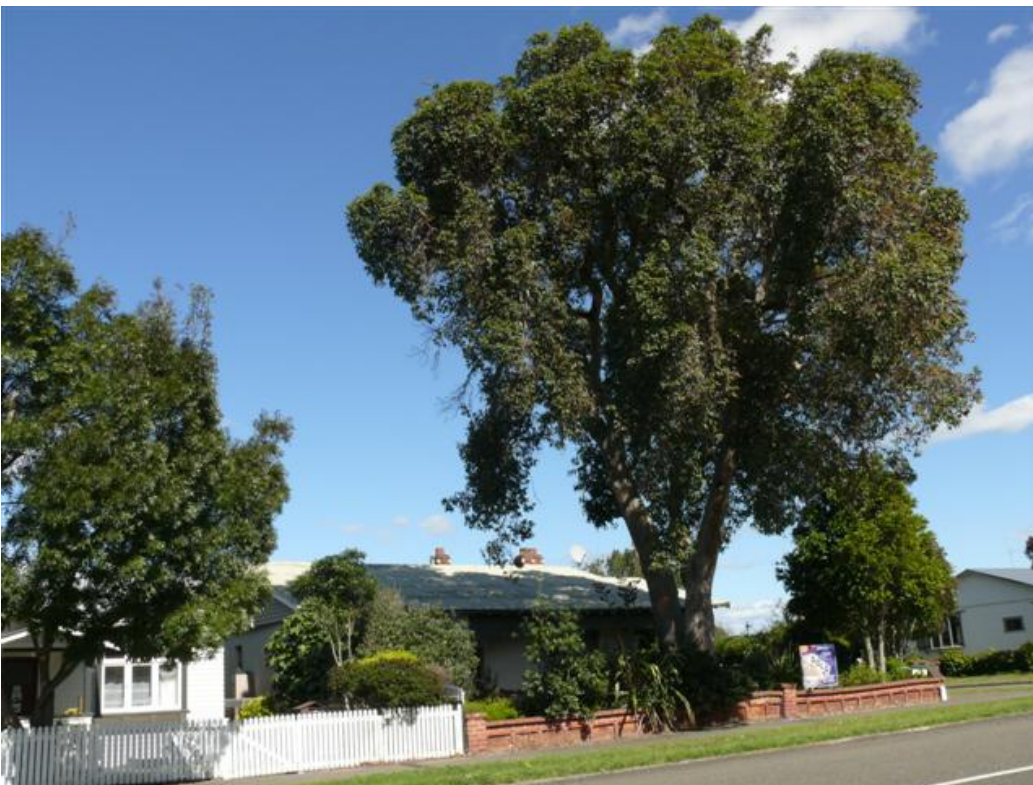
Figure 2, note the shade over the roof. The crown could be lifted to allow low winter sun into the windows, but still keep the house shaded from the high summer sun

Category	Priority	Recommended Action	Timing (from April 2011)	Actioned	Completed
Amenity	routine	Lift crown over roof;	six yearly from now		
Health					
Safety	-	Remove heavy crops of seed pods every few years			
Overhanging b'dry

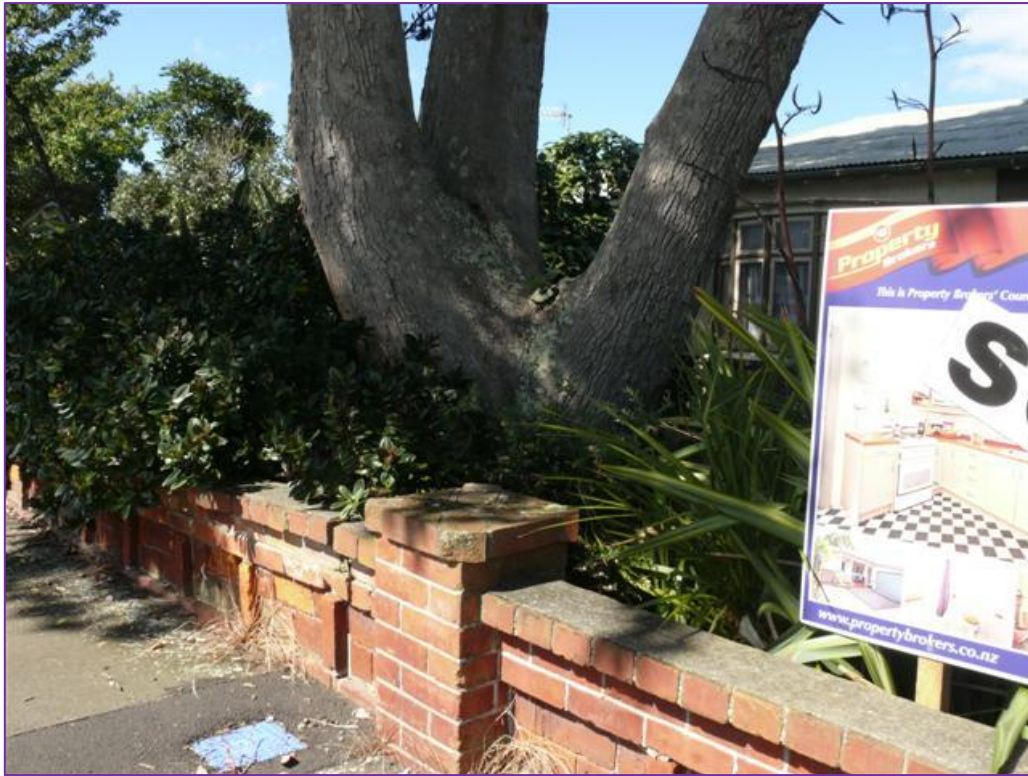
Requested for/by	Routine	Storm Damage	Owner	Developer	DP Review
Pruning History	No recent pruning				
Built Environment	Small tight dev'pment	Standard suburban	Large house and grounds	Other (describe)	
Garden environment	Solo tree	Few trees	Many trees	Mainly exotic/native	
Local Environment	Few trees	Some trees	Well treed neighbourhood		
Age Class	young	Semi mature	Mature	Post mature	
Special value	Horticultural	Landscape	Specimen	Historical	Botanical
Structural Character	Single leader	Double leader	Multi-stemmed	Included bark unions	Typical Atypical
Form	Refer to STEM scoresheet				
Crown Shape	Typical	Atypical	Wide spreading crown	Influenced by wind	Affected by other trees
Foliage Health	Good	Poor, if so, explain			
Limb Structure	Typical or sound	Atypical, if so, explain	The three leaders from about one meter above ground is unusual, but the unions of branch to trunk are sound and strong		
Trunk character	Not much wrong with the trunk – it is short and sound; pusing up against the small boundary wall.

Figure 3. the wall will have to be fixed,

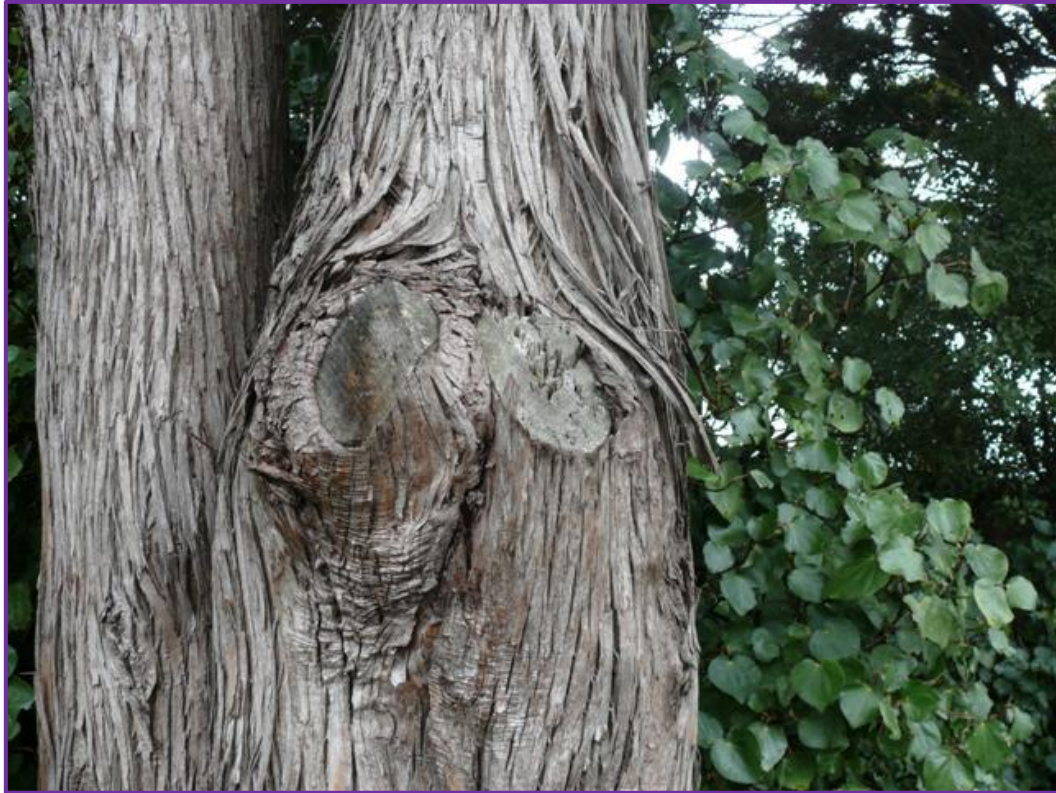
Figure 1 25 Lincoln Street. Old Pruning wounds

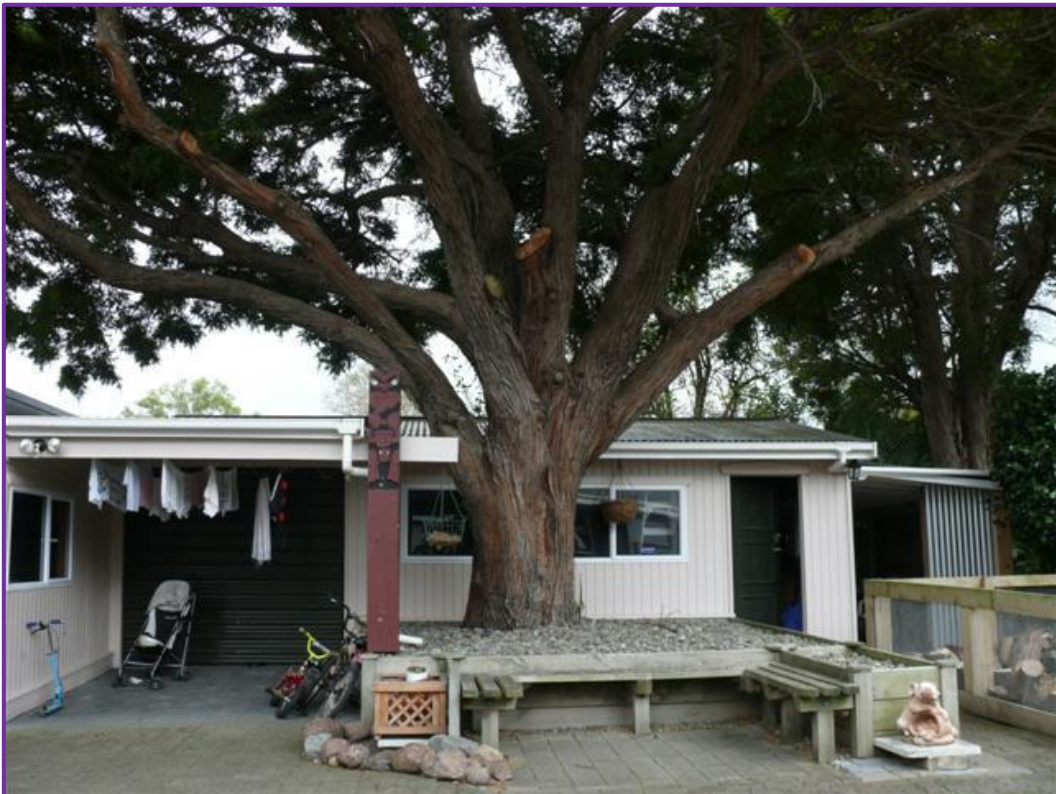
Figure 2. Storm damage repairs. Note: the tree has been backfilled in this fashion for at least ten years and it has not shown any decline – it is disturbing the floor of the wash house..

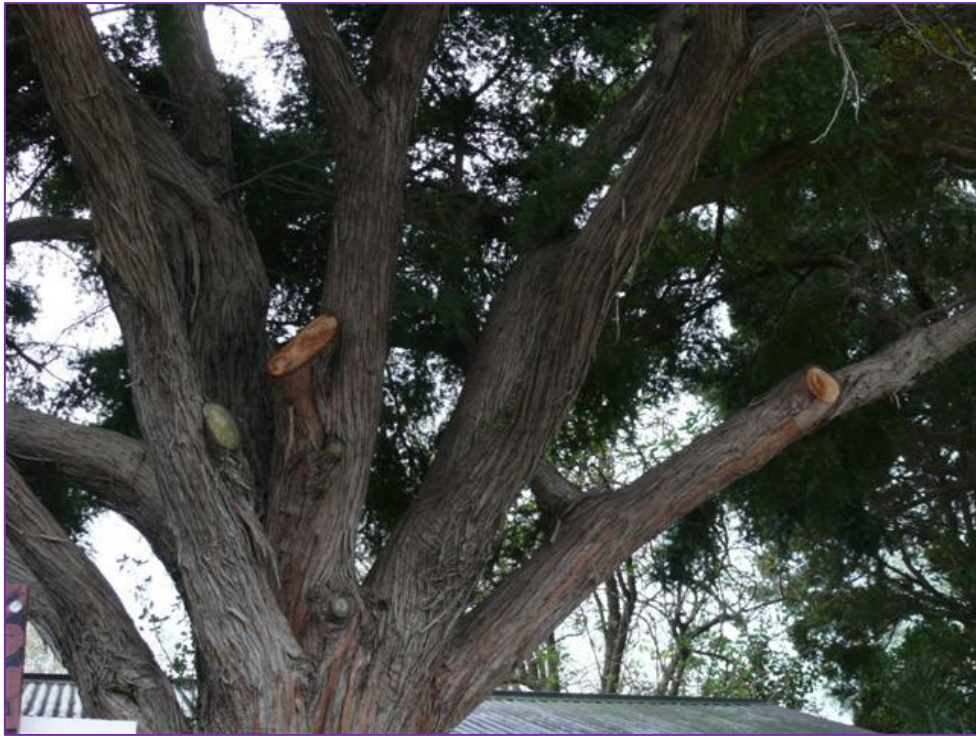
Figure 3. Storm damage pruning wounds.

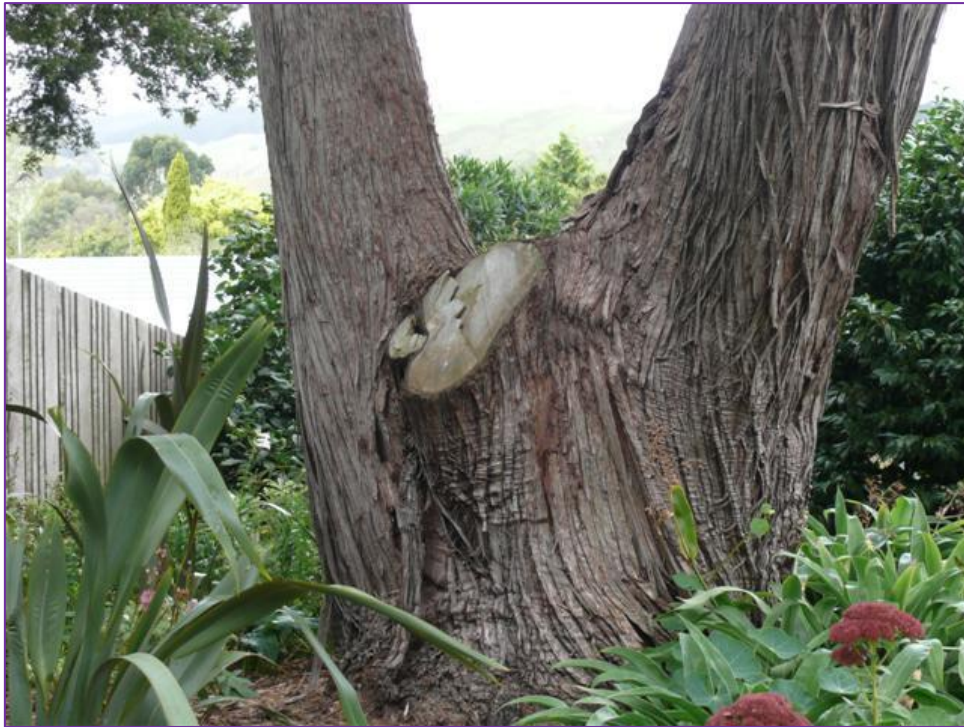
Figure 5. Old pruning wound

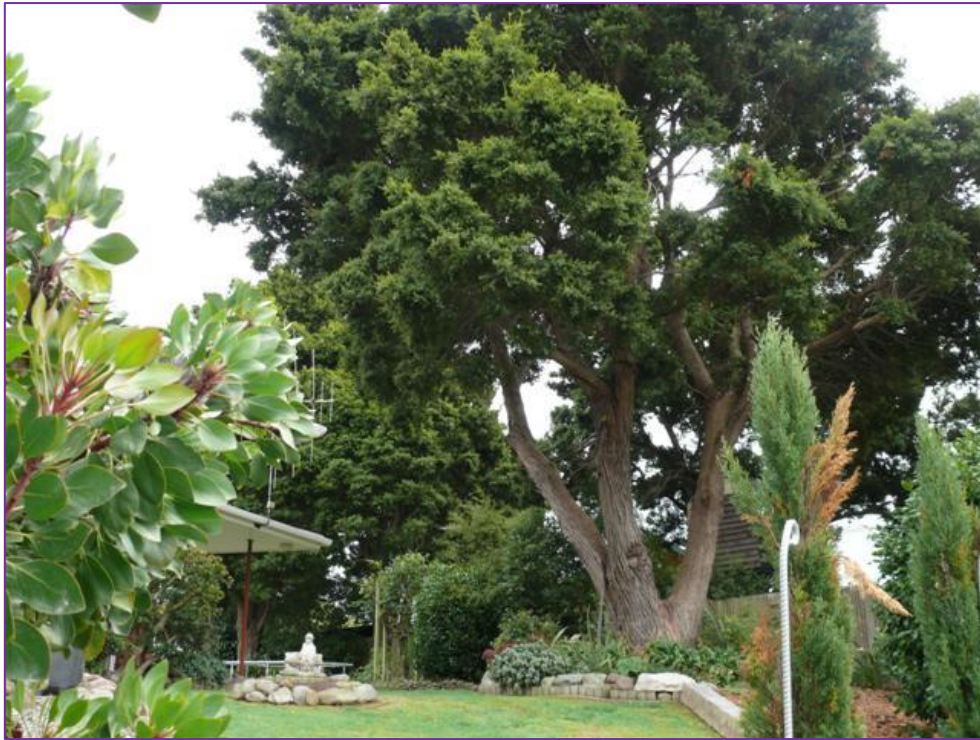
Figure 7. the gradients and level changes make this an interesting garden.

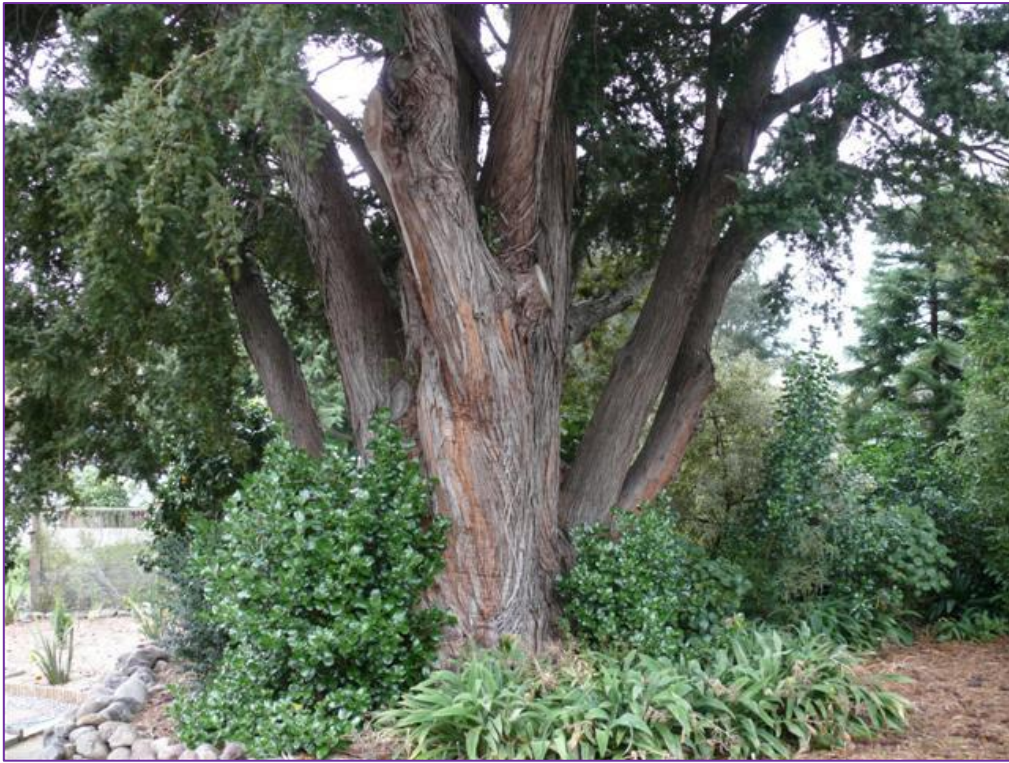
Figure 9. Good natural ground cover.

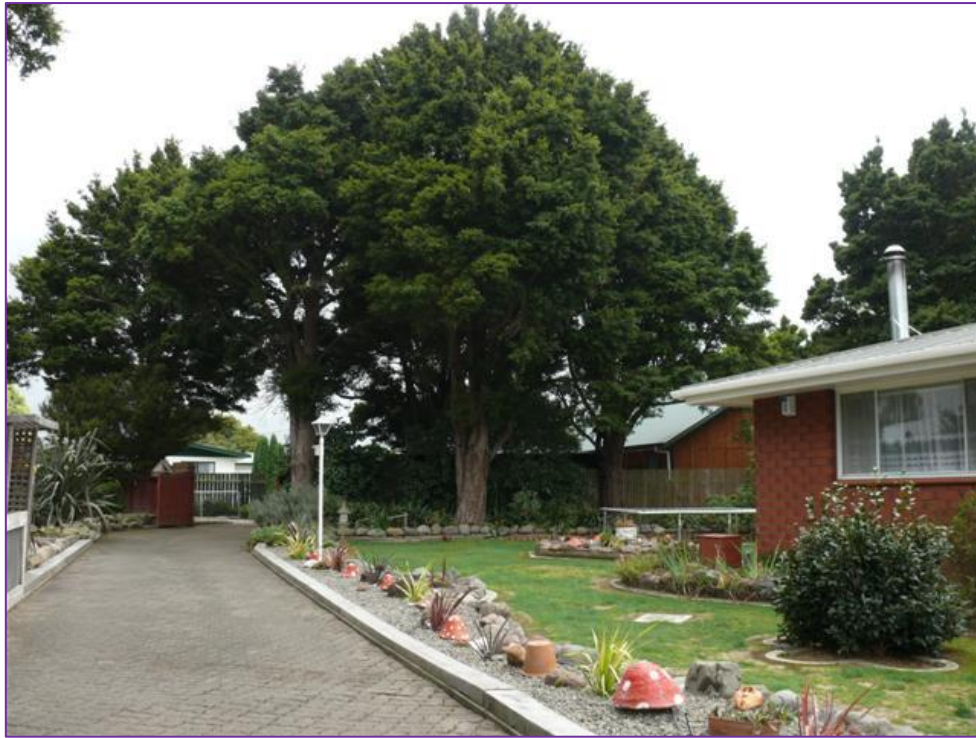
Figure 11. A fine entrance to the garden.

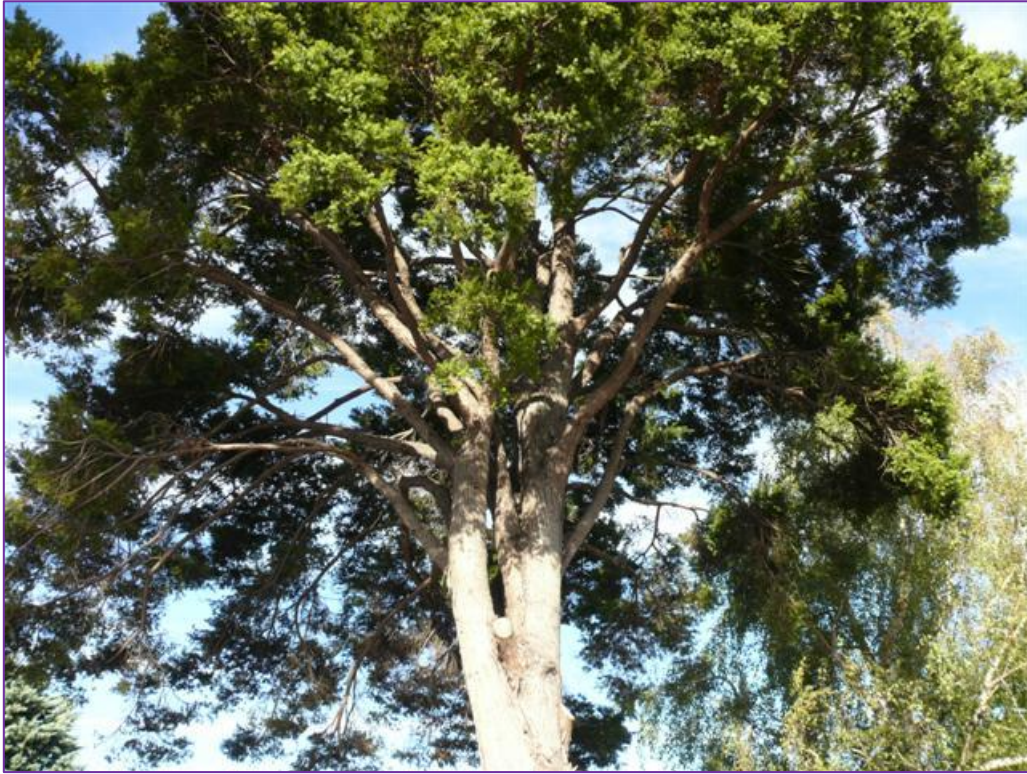
Figure 1 Detail of pruning and crown.

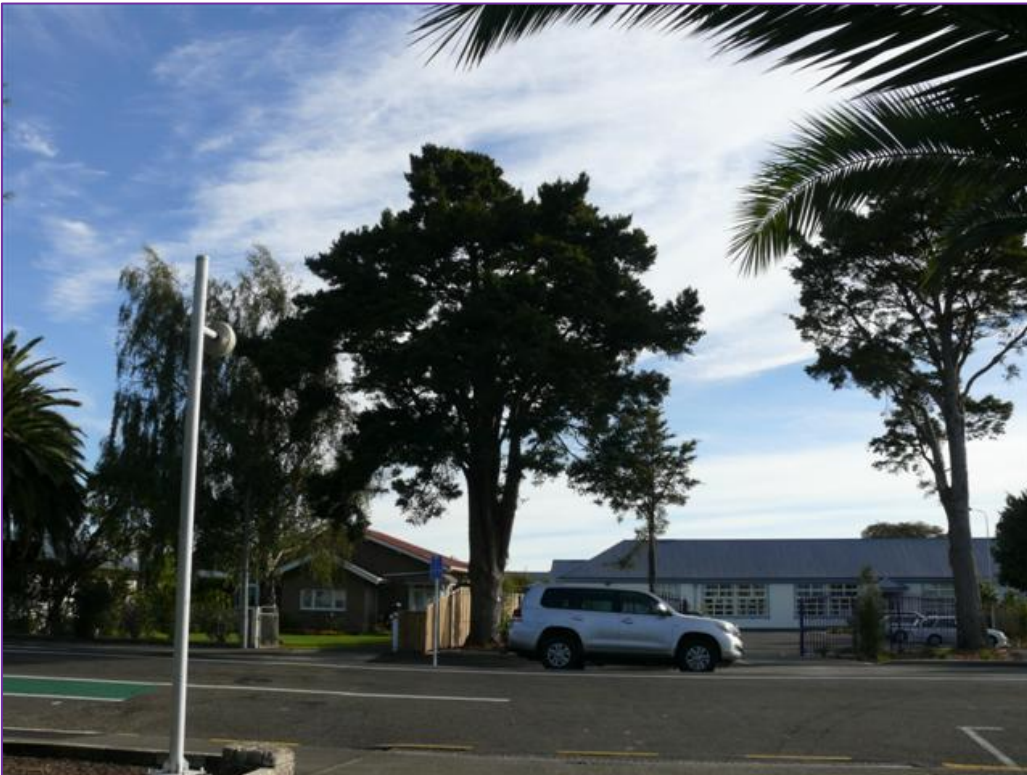
Figure 2 the new entrance

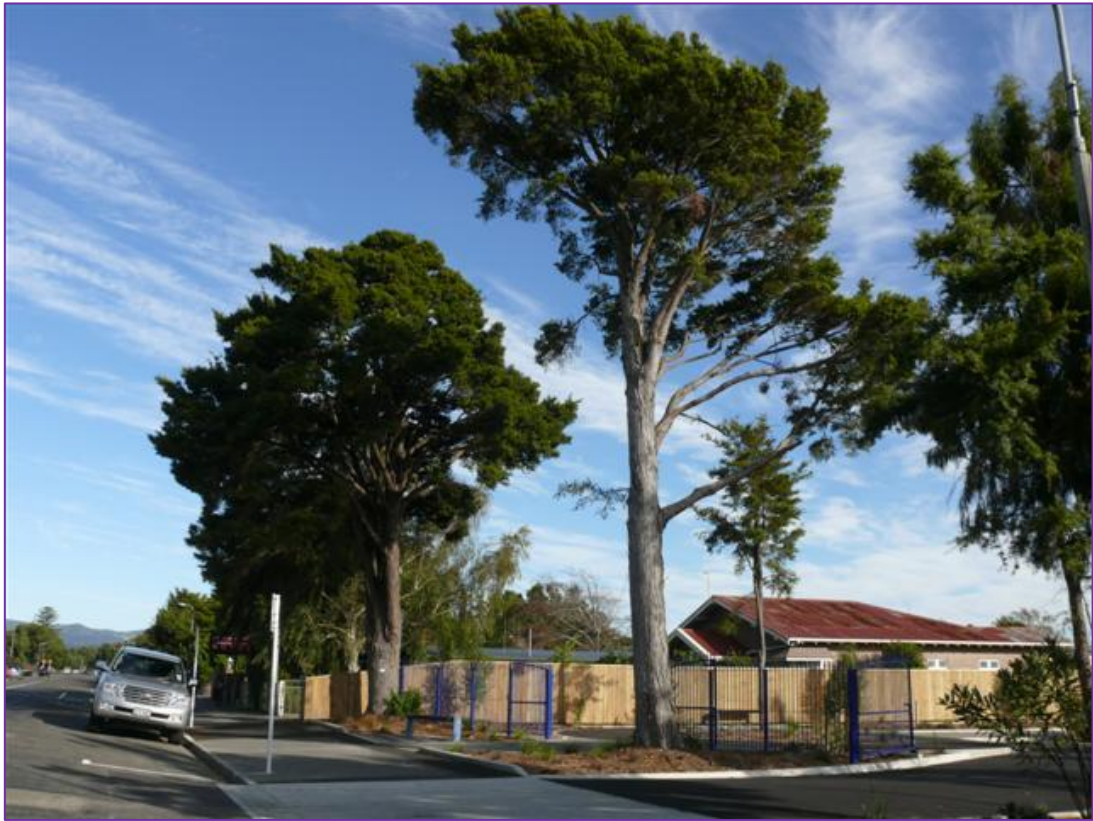
Figure 3. both trees

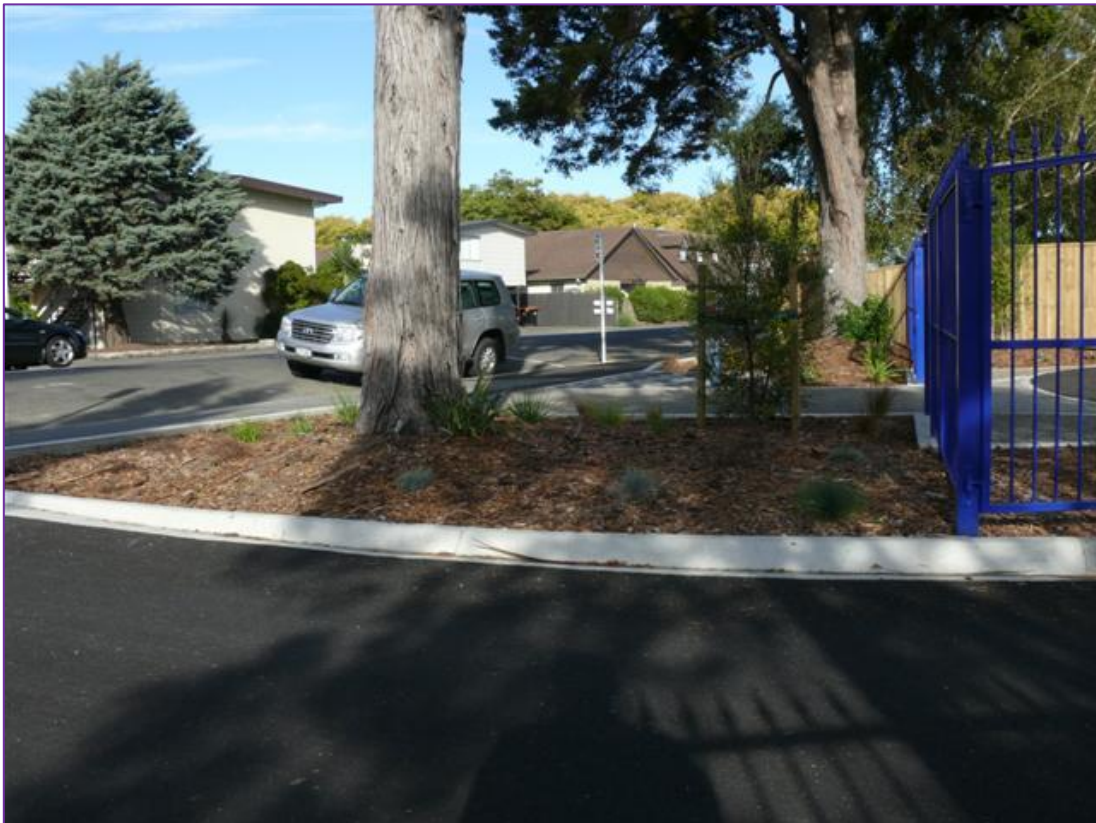
Figure 4. new tarmac and concrete kerbing. This will crack and the trees will be blamed.

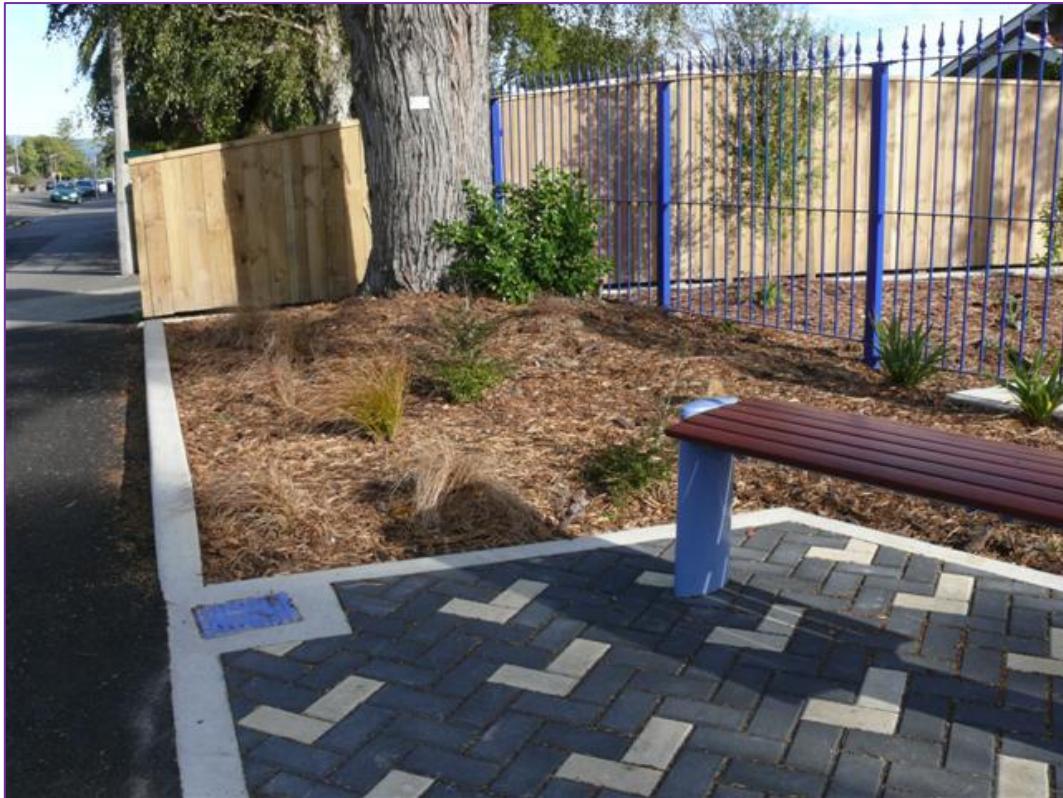
Figure 5. New hard and soft landscaping

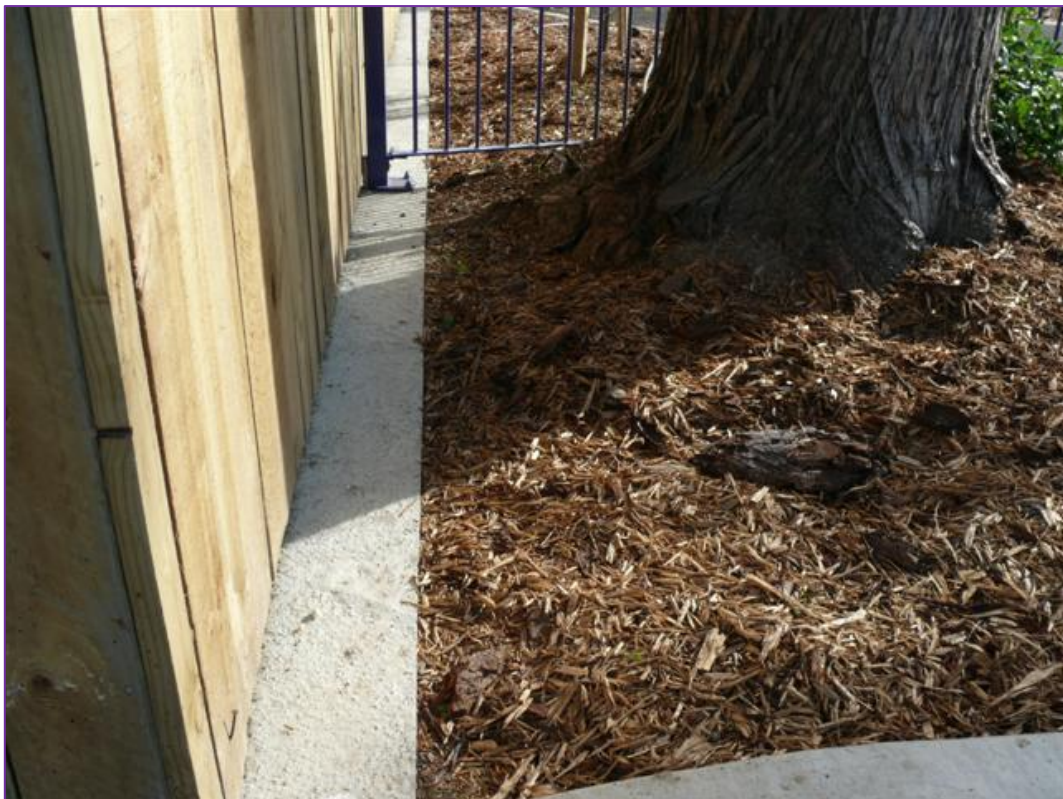
Figure 6. A mowing strip is completely out of place here.

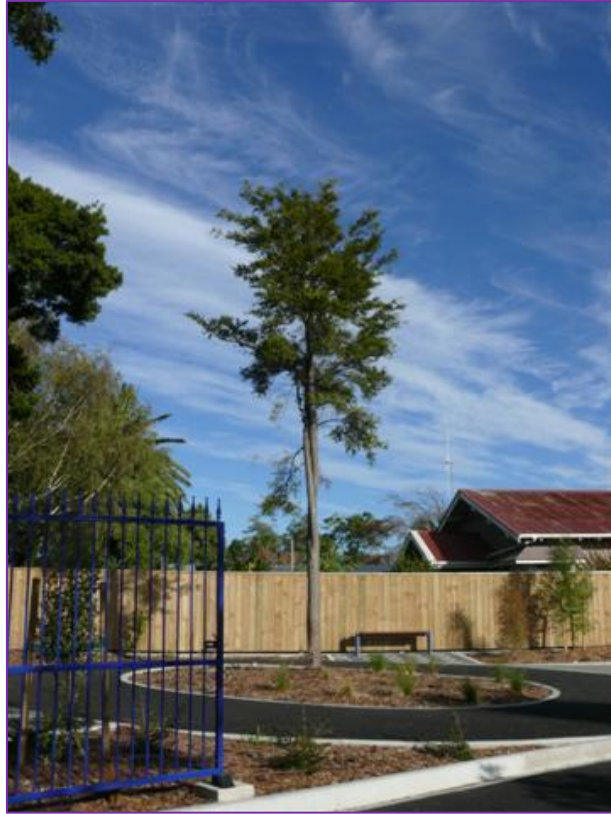
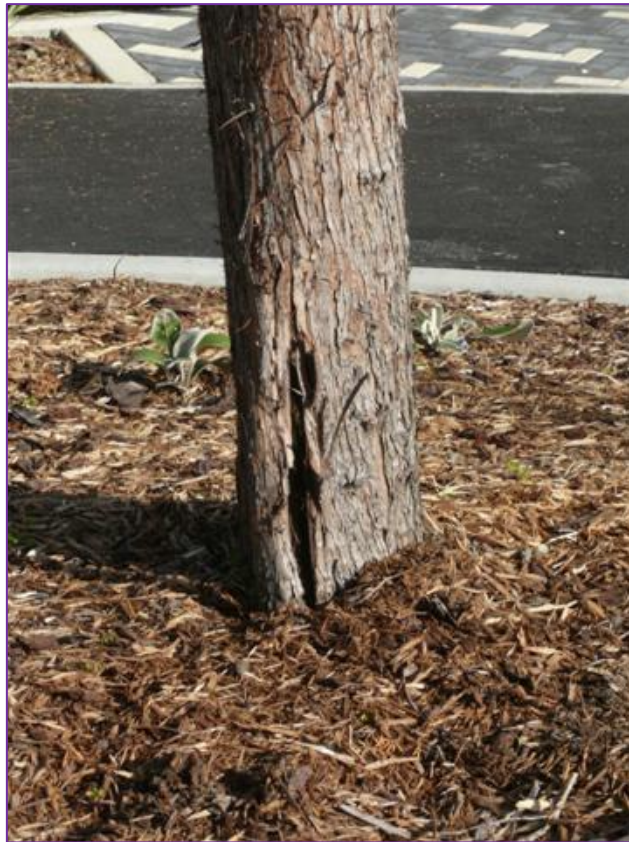
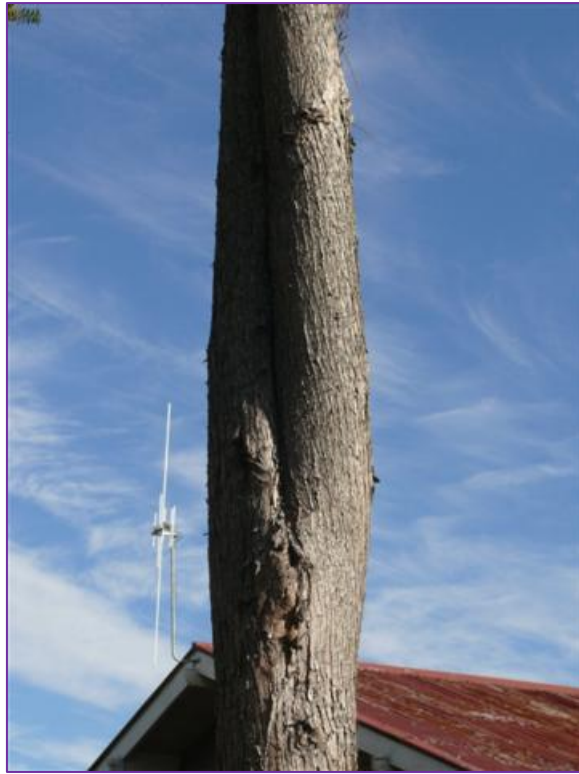
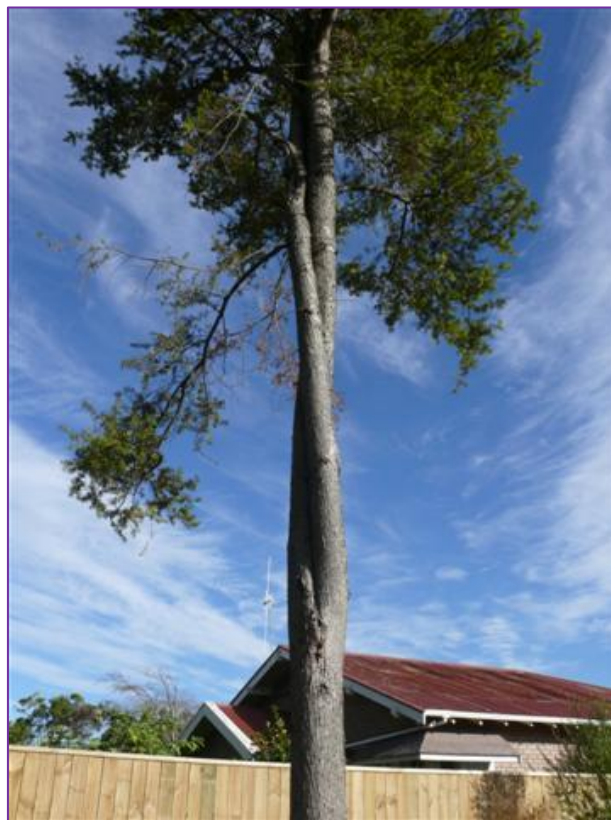
Figures 7 to 10 show a very poor specimen of a totara, just inside the school, in a prized spot. The tree is very badly formed and has been

damaged at the root plate. If it lives, it will never develop into a good specimen, unless the double leaders are sorted out. If the root damage is as bad as is indicated in figure 8, it may not survive more than a few years.

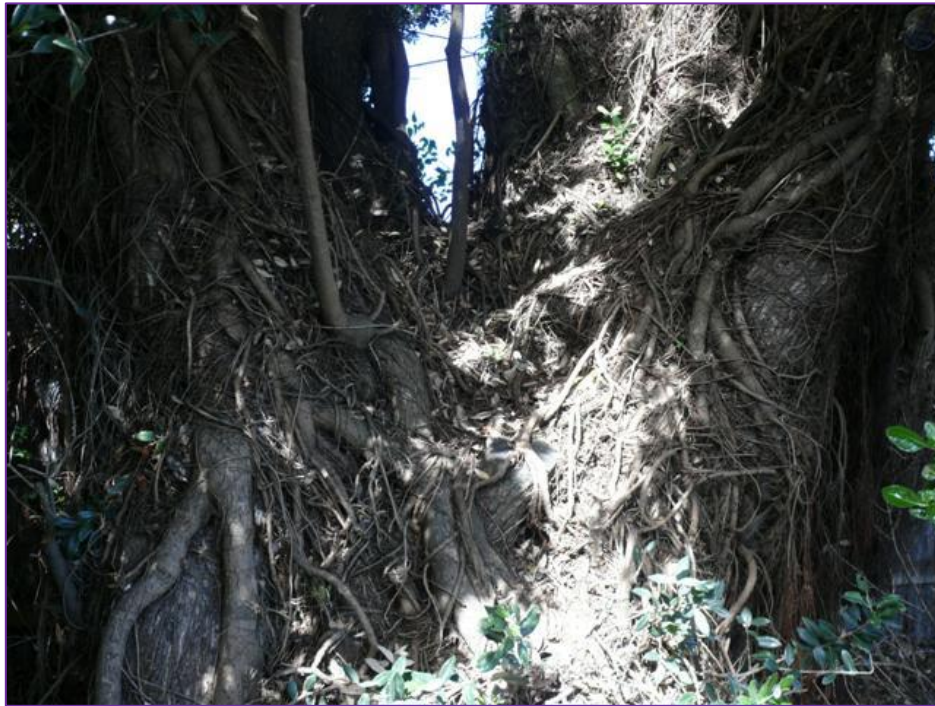
Figure 1. the dense mat of intertwined aerial roots covering the main stems.

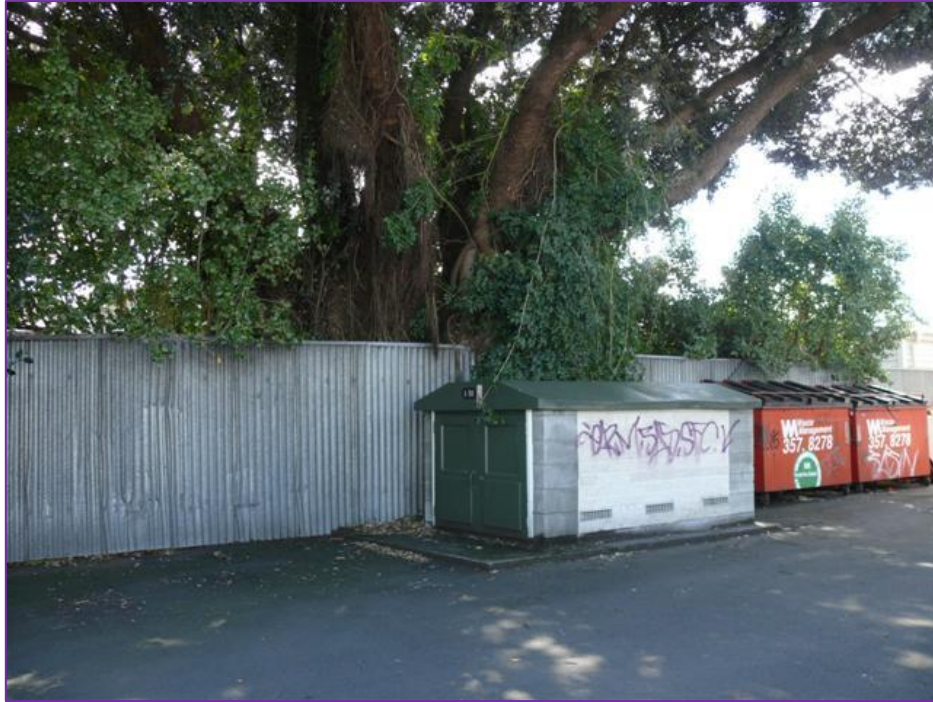
Figure 2. the electrical substation, and the dumpsters. Note: the fence has been damaged by cars, but is otherwise upright and stable

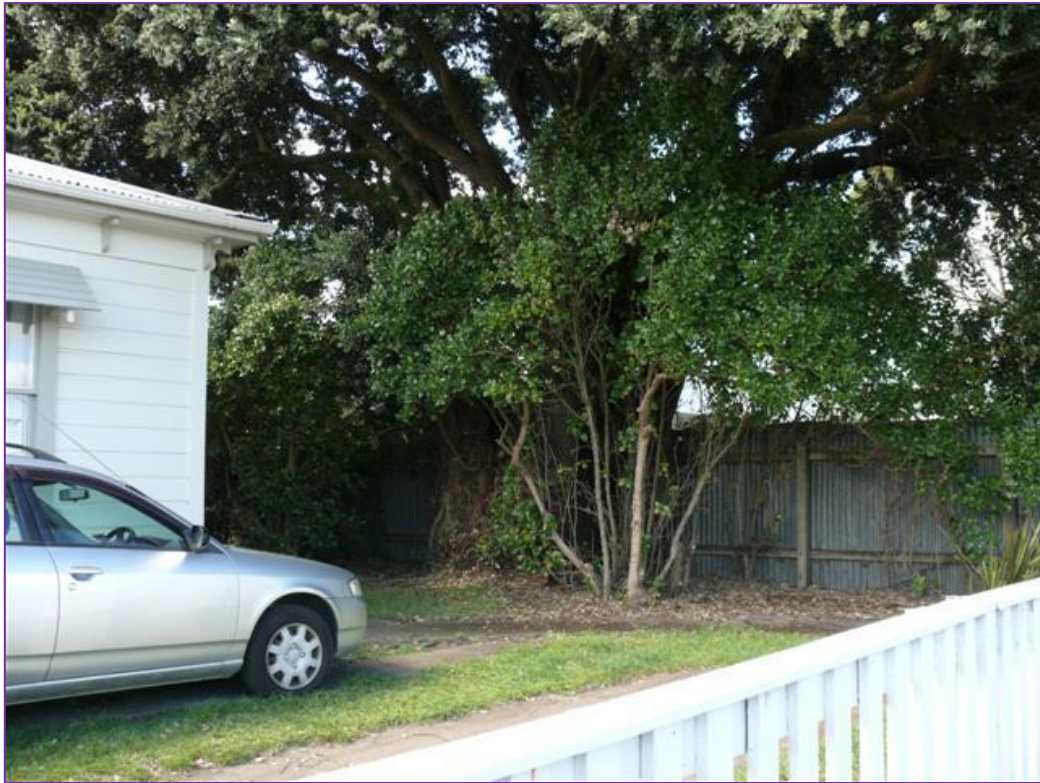
Root Zone	Garden	Natural	Lawn/paddock	U/g services apparent?	Hard surface, if so, explain - carparking on the neighbouring site.	
Comments	The tree is very vigorous; it is challenging to administer, but a magnificent specimen that adds charm and character to part of town with few outstanding natural features.

Figure 4. the tree in its setting
