Palmerston North City Council

Notable Tree Survey March and April 2011

Address	863 Main Street				
Tree name	Oak (<i>Quercus robur</i>)				
Location of the tree on the site	Rear garden				
Owner's name					
Date of Inspection	30 March 2011	Inspected by John Wakeling

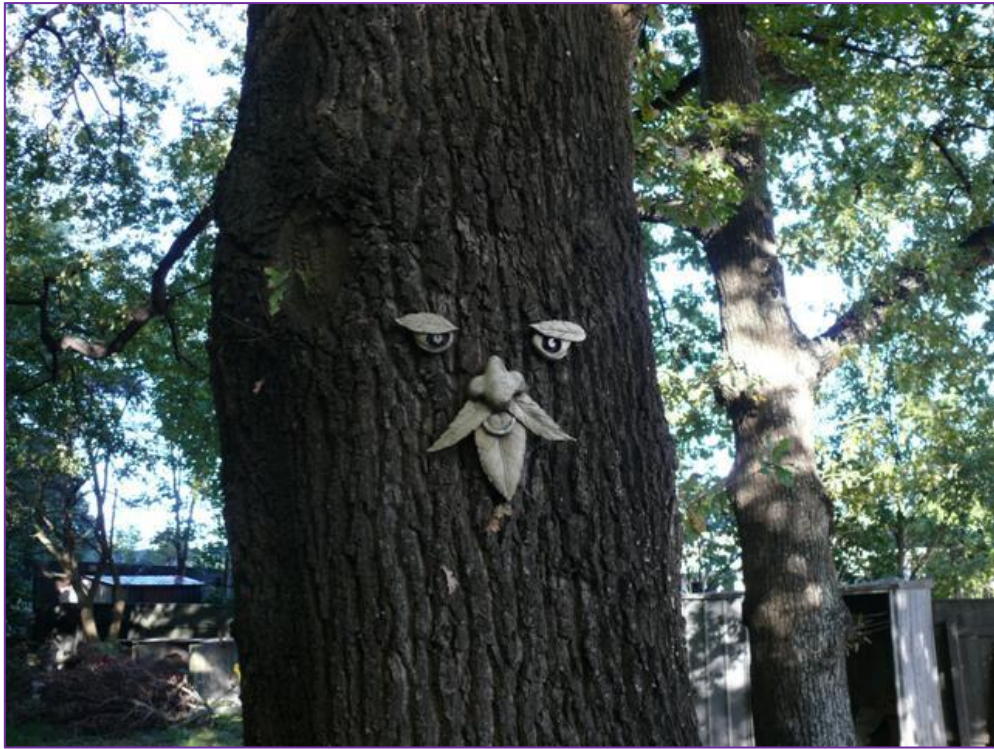
Figure 5. Reversion to Ent-like State

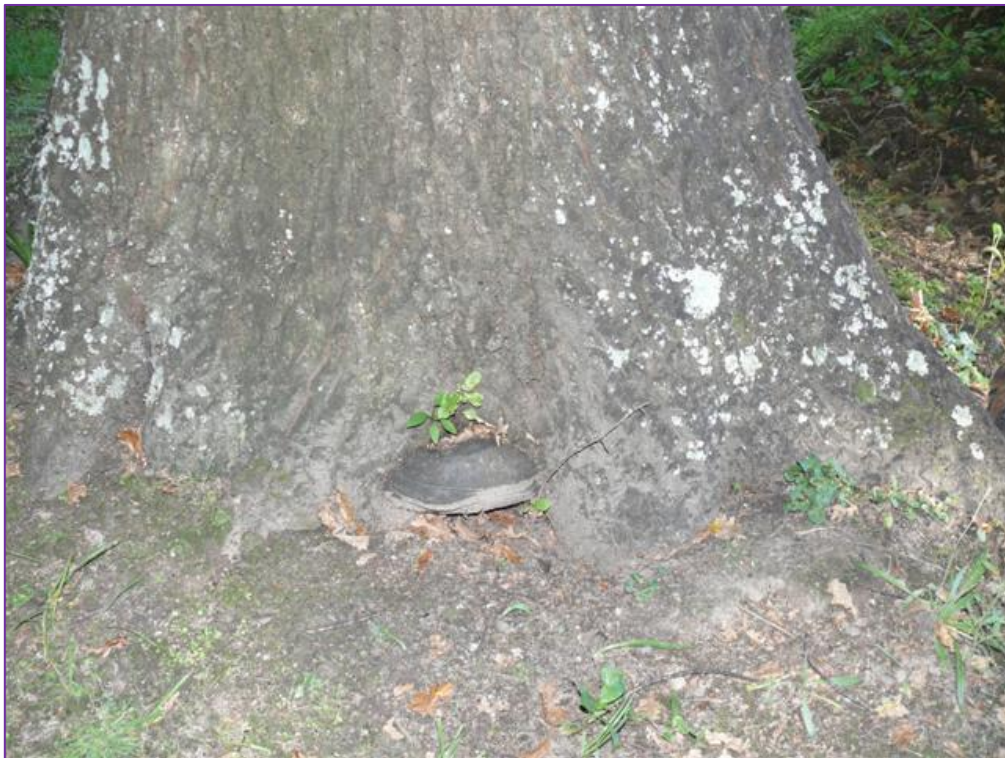
Root Zone	Garden	Natural	Lawn/paddock	U/g services apparent?	New earthworks just within the drip line. Topsoil stored within the drip line one small section only.
Comments	Alert! There is a hard, dark fungus bracket at the base of the tree. This bracket was present at my last inspection, and has not grown much larger in five years. Nonetheless, it is a symptom of basal infection and possibly decay of the wood nearby. Invasive core sampling could identify whether wood decay is far advance but this is not a conclusive or very accurate technique. I am not sure how long the tree will continue to thrive as it is at present. Eventually its 'Vigour and Vitality' will have to be down-grade.

Figure 6. The fungus bracket. (*Ganoderma* sp?)

Category	Priority	Recommended Action	Timing (from April 2011)	Actioned	Completed
Amenity	routine	Deadwood removal	Now, then 5 yearly		
Health		Monitor health of the foliage and size of the fungal bracket annually			
Safety		Safety is largely dependent on health in this case.			
Overhanging b'dry

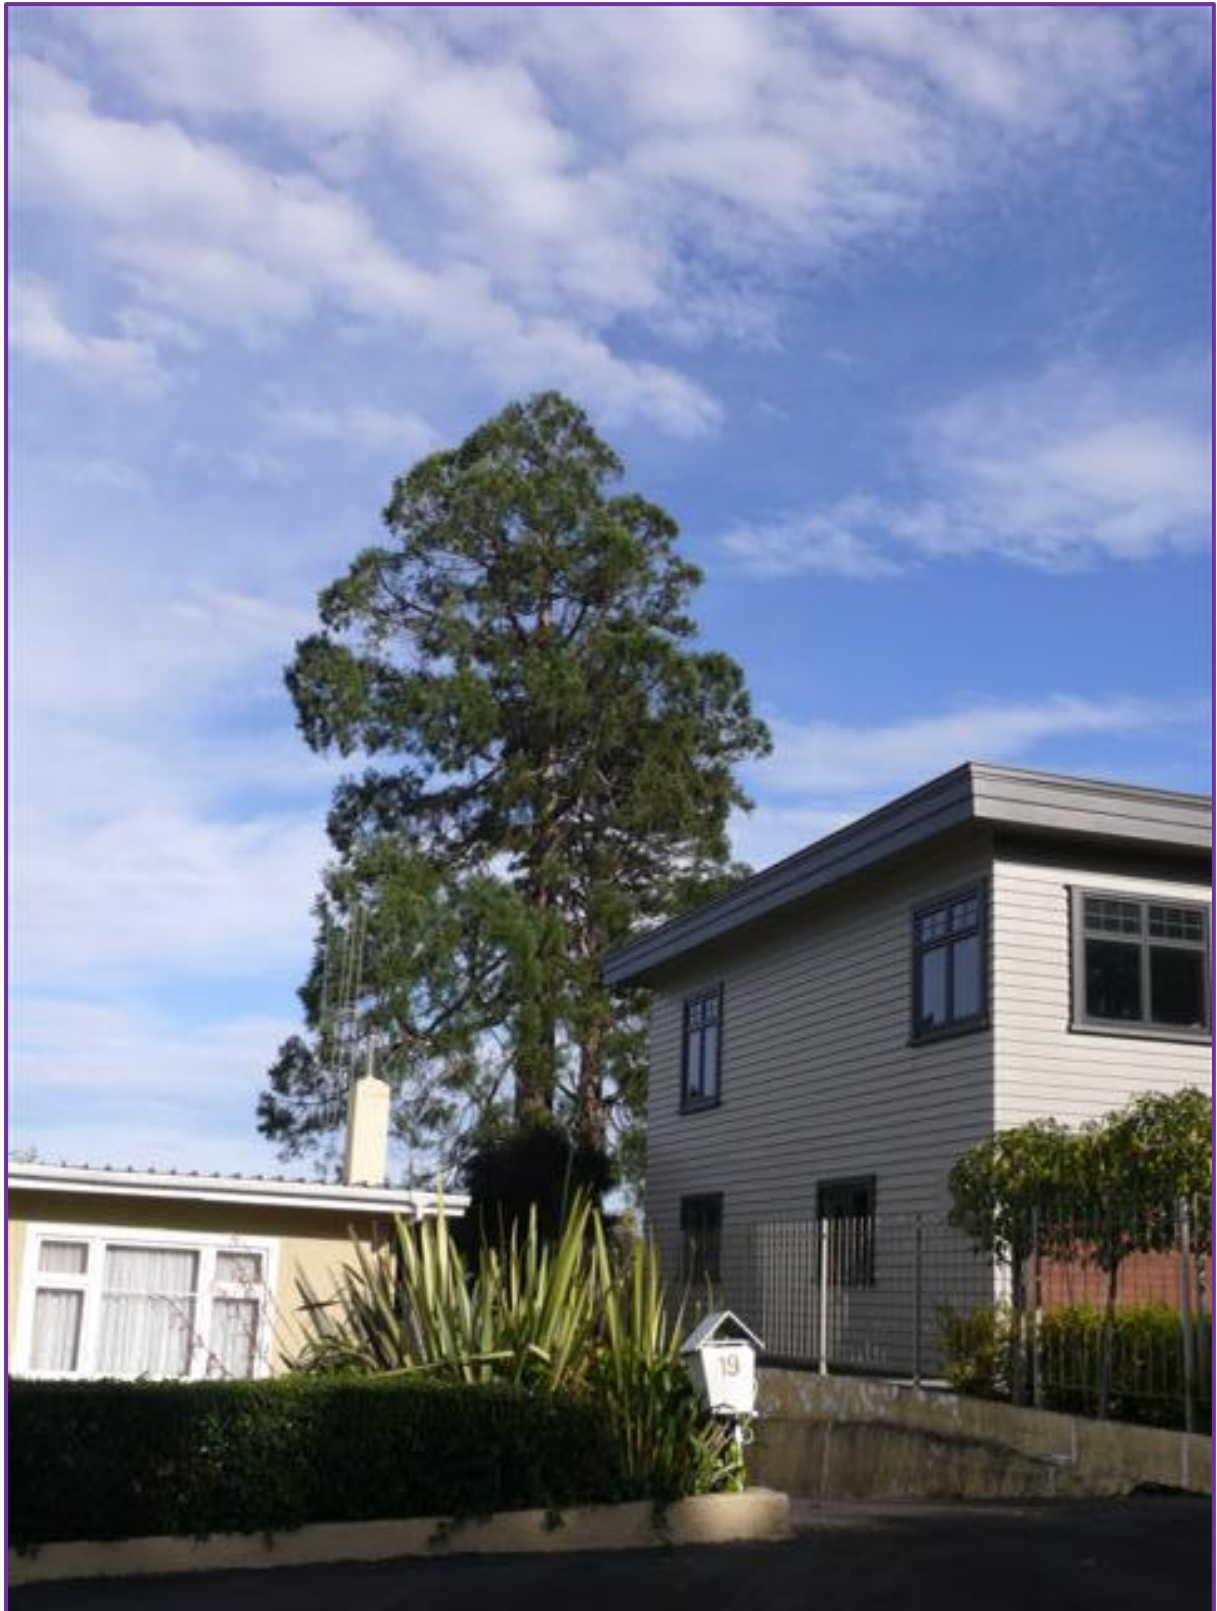
Trunk character	Sound, with good taper. Ground around the base of the trees shows no signs of heaving nor depressions. The new garden was built to keep the new topsoil away from the base of the trees.					
Root Zone	Garden Native species Lawn/paddock U/g services apparent? Hard surface, if so, explain					
Comments	<p>I met Mr. and Mrs Staddon on site and had a discussion with them about the health and stability of the trees. I explained that I considered the lean on the one tree is not a slowly increasing phenomenon, but is the result of the competition from the third tree (that was felled) The Staddons explained their concerns, especially about the noise of the wind in the crowns during stormy weather.</p> <p>Both trees appear to be in good health, with no indications of soil weakness, or fungal disease.</p>

Figure 1 the two trees

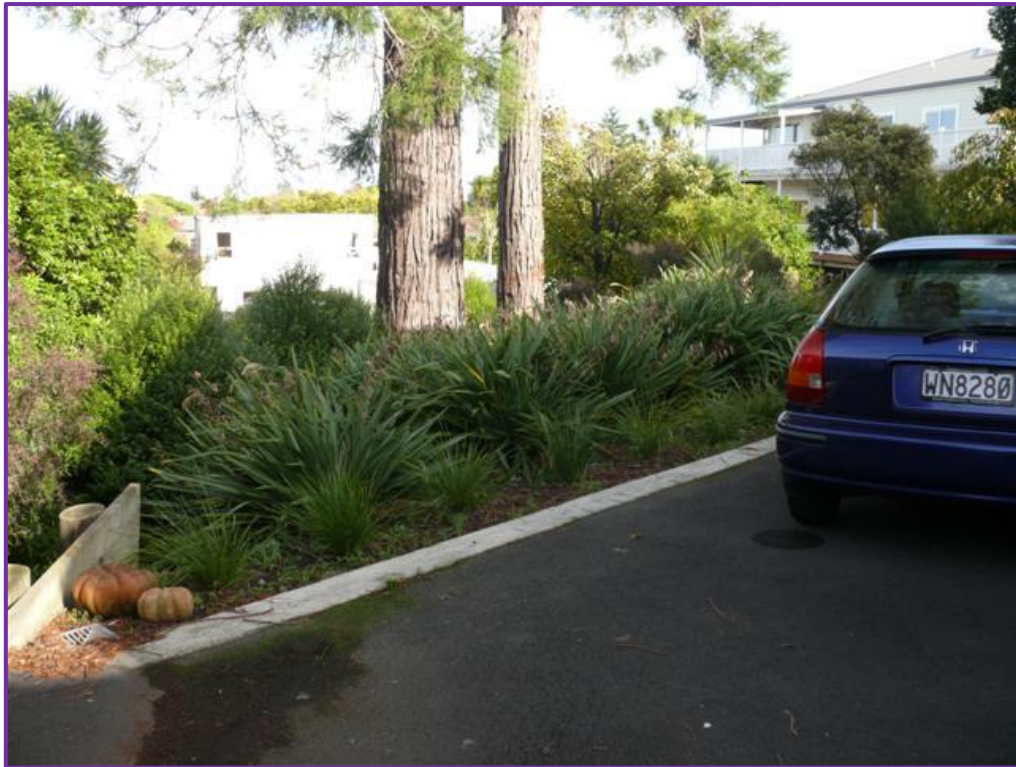
Figure 2, the new garden

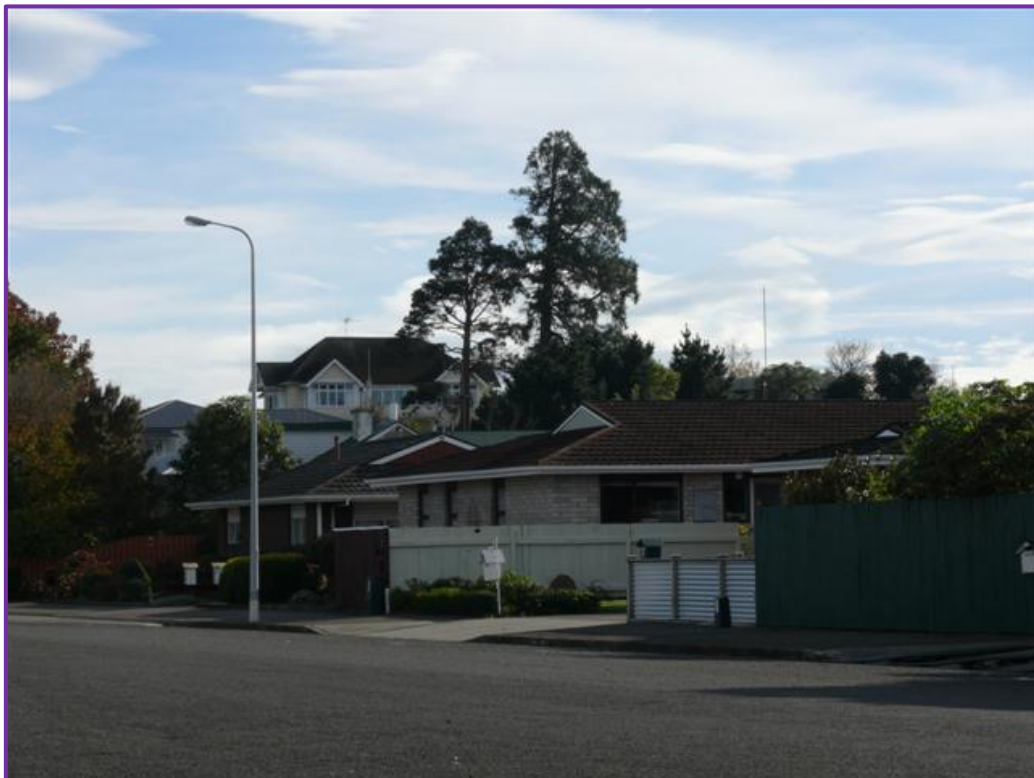
Figure 3 From the Napier Highway

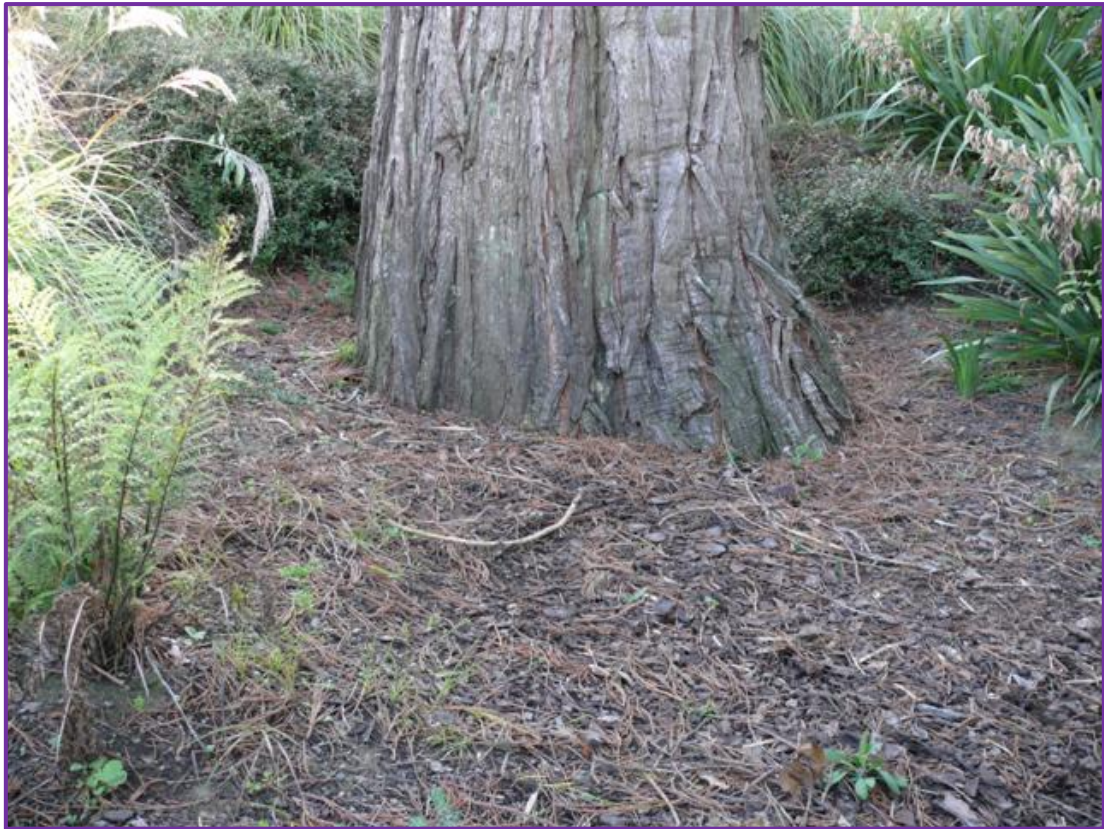
Figure 4, Ground conditions are good

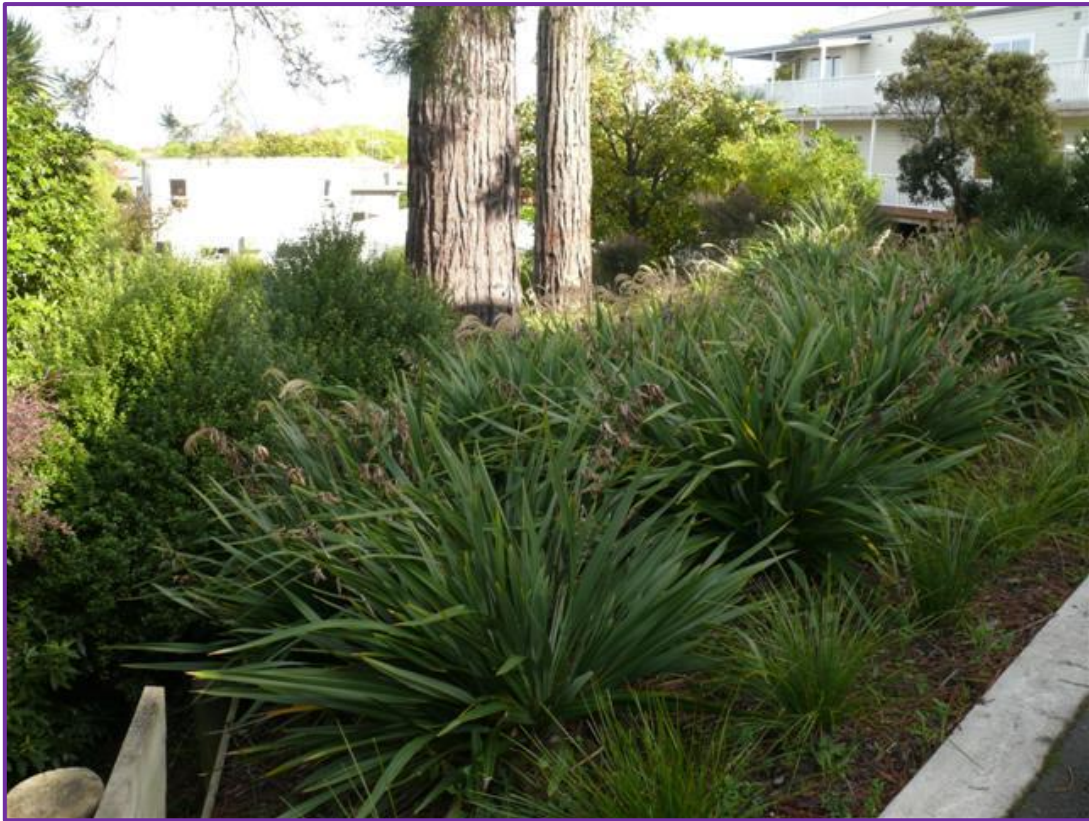
Figure 6, the different sizes of the trunks

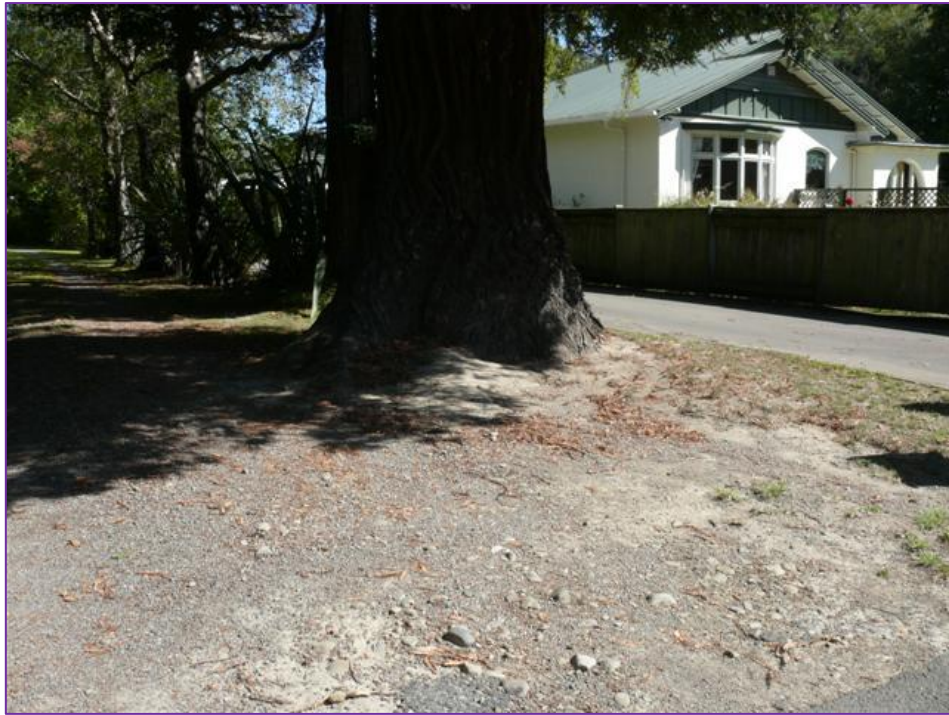
Comments	The driveway and tree have been living in some sort of harmony for about 80 years, so unless there is some major redevelopment, I think the tree has adapted well to the situation.

Figure 2. Base of tree, showing the limited grow space available for the root system.
