Palmerston North City Council

Notable Tree Survey March and April 2011

Address	47 Te Awe Awe Street				
Tree name	Oak (<i>Quercus robur</i>)				
Location of the tree on the site	At the end of a RoW, close to the boundary				
Owner's name					
Date of STEM Assessment	28 March 2011		Inspected by John Wakeling

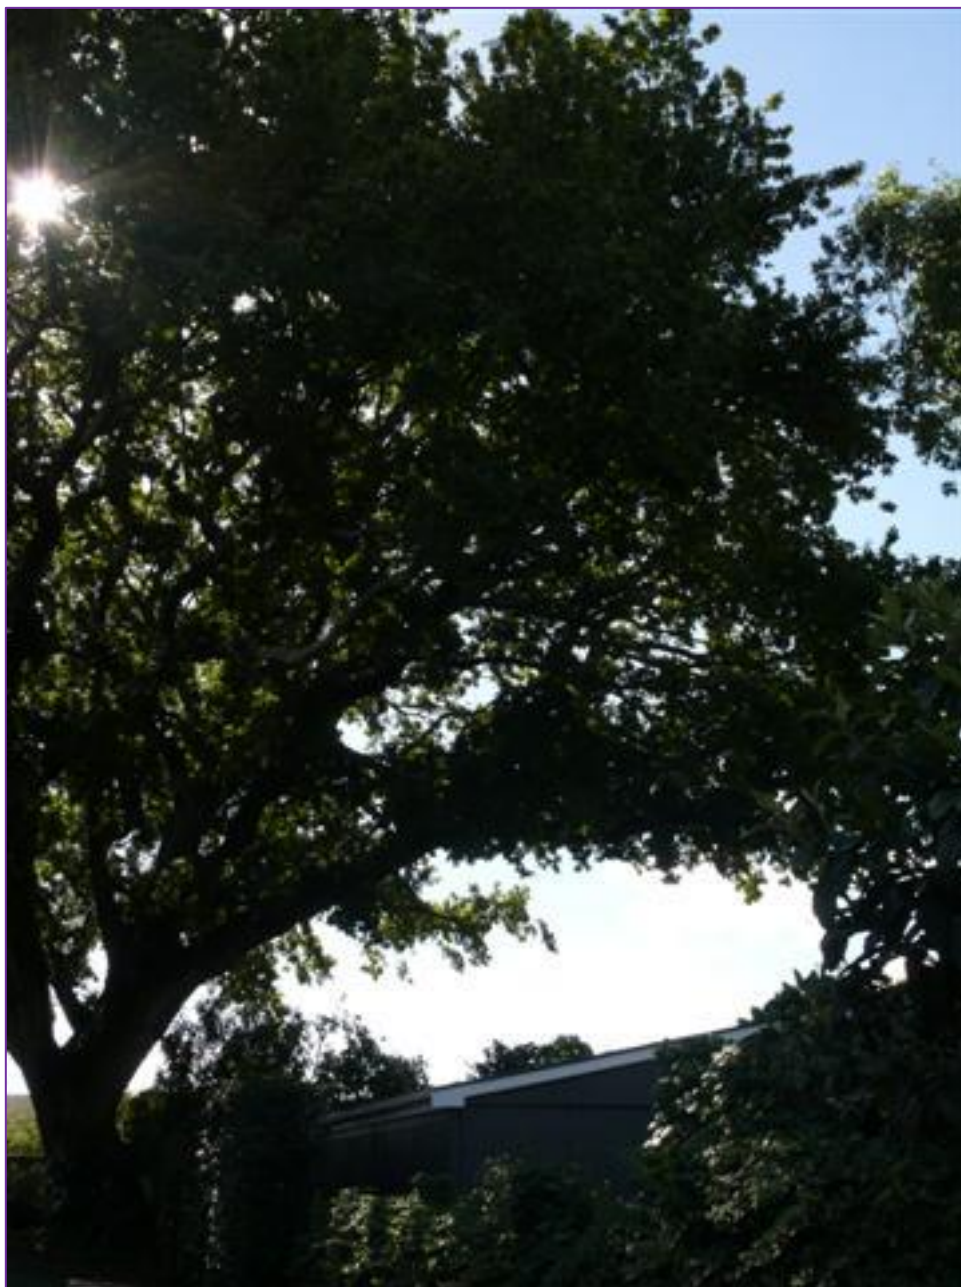
Figure 1, the crown overhangs the neighbour's shed

Category	Priority	Recommended Action	Timing (from April 2011)	Actioned	Completed
Amenity	routine	The owners will be applying to reduce the crown over the house the next time they prune the tree. Deadwood	Within the next 2 years thereafter 5 yearly		
Health	-				
Safety	-				
Overhanging b'dry	routine	This is undertaken every few years

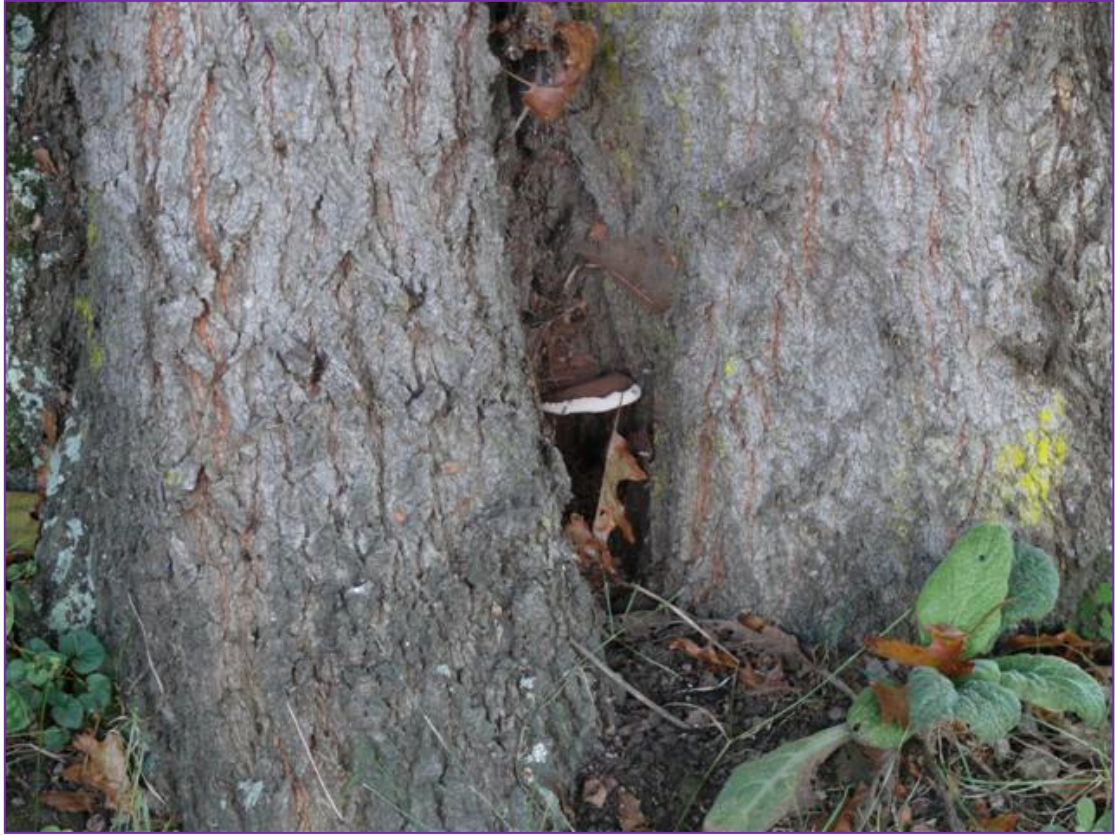
Foliage Health	Good	Poor, if so, explain	Foliage health is variable poor at the top, good in some of the periphery			
Limb Structure	Typical or sound	Atypical, if so, explain	Poor, much rot,			
Trunk character	The trunk is infested with wood rotting fungi (see photos), the tree has started to fall over – there is a distinct mound of raised soil at the base of the tree.					
Root Zone	Garden	Natural	Lawn/paddock	U/g services apparent?	Hard surface, if so, explain	
Comments	I doubt the tree will stay upright much longer. Darryl Judd of Guardian Tree services, is looking after the tree very well. He advocates some quite hard pruning to reduce the strain on the dodgy root plate and to encourage more upright growth. This will help keep the tree, but it will also reduce the undoubted character of the tree. On a personal note, I undertook some work on the tree back in 1979 – it was already a tree of great character back then.

Figure 1, a Ganoderma fungus bracket in one of the interstices between buttresses

Category	Priority	Recommended Action	Timing (from April 2011)	Actioned	Completed
Amenity					
Health	One off	Re-balance the crown as prescribed by DJ of Guardian Tree Services	Within the next few years		
Safety					
Overhanging b'dry

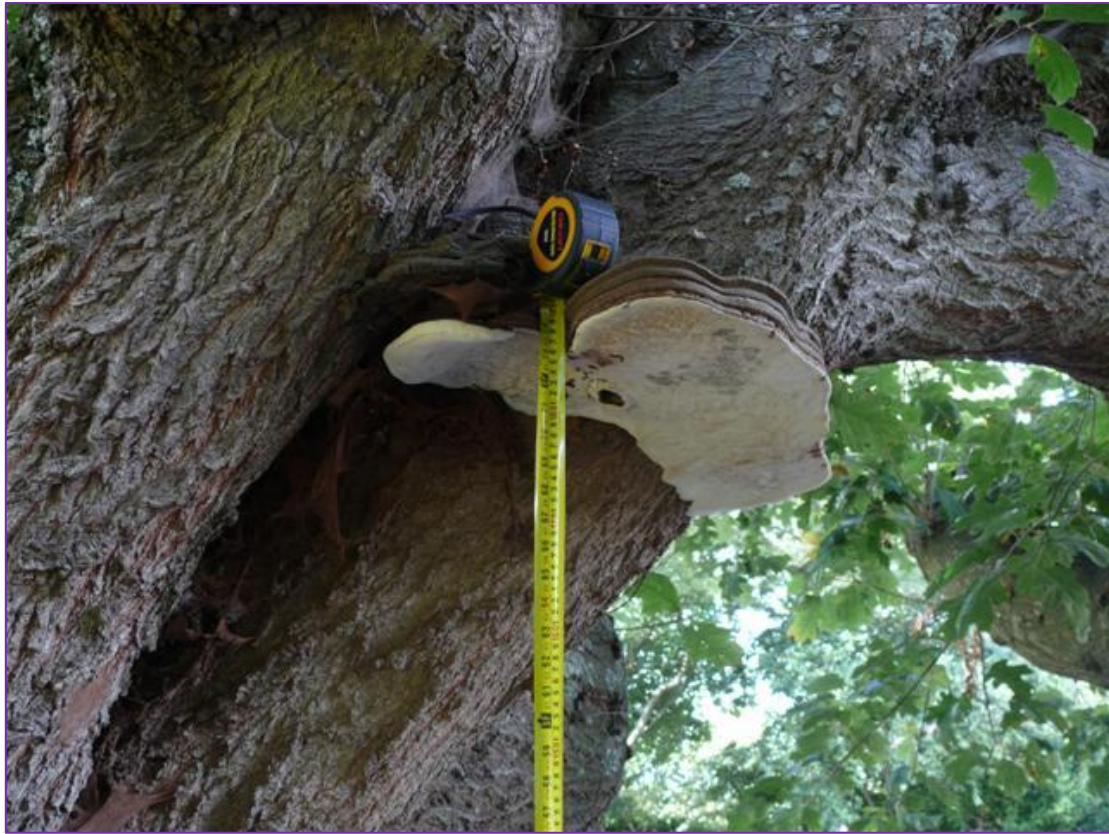
Figure 2, as for fig one, at about 2m above ground

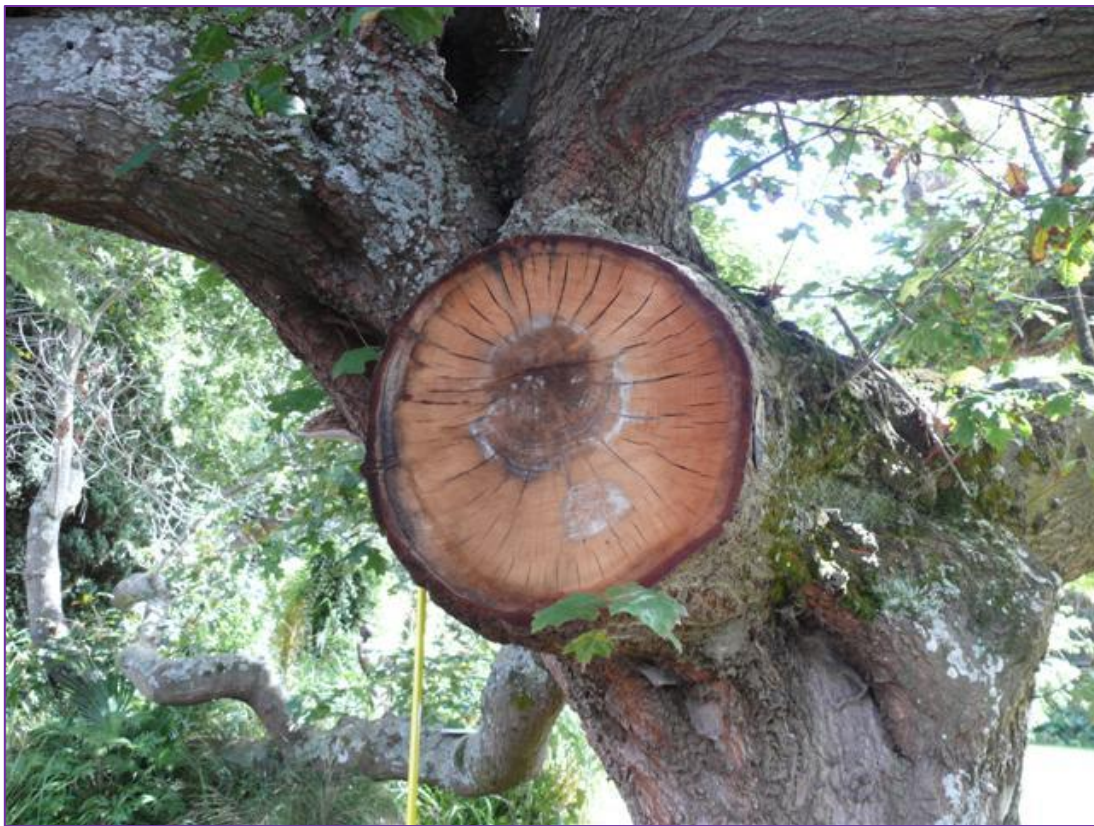
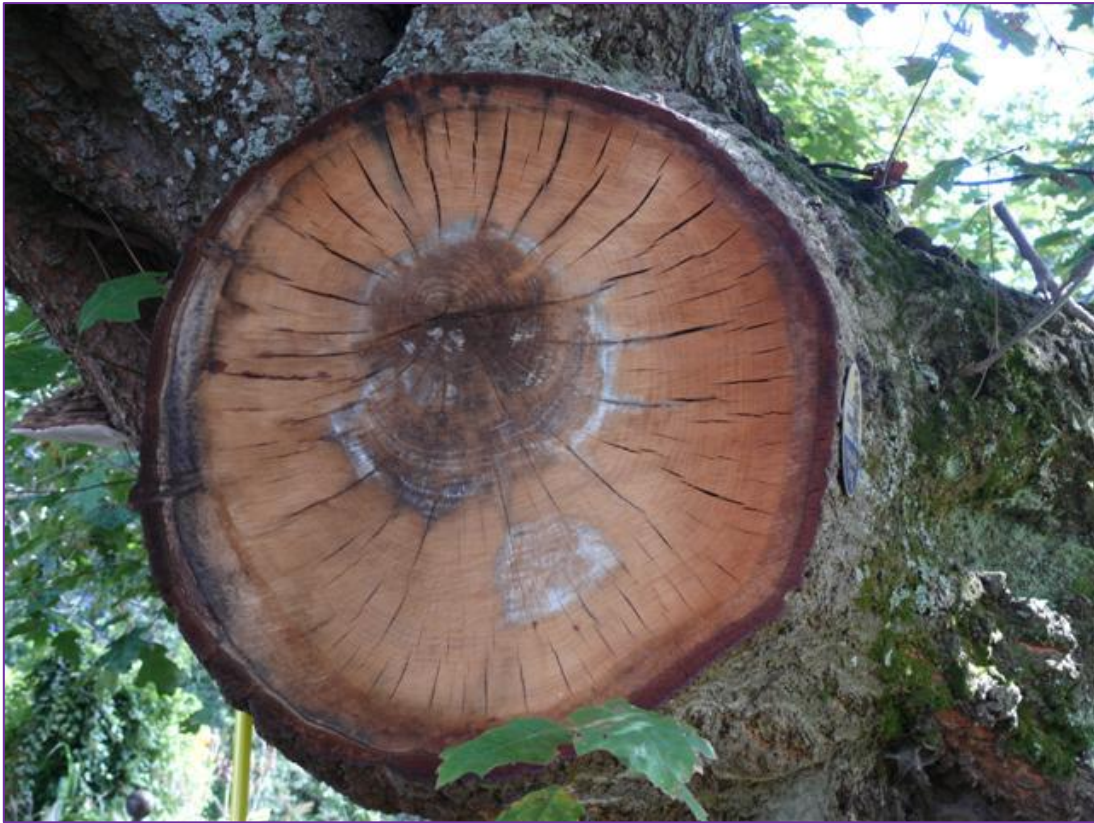
Figure 3

Figure 4, and fig. 3 - one of the large recent pruning cuts. Note discoloured heartwood.

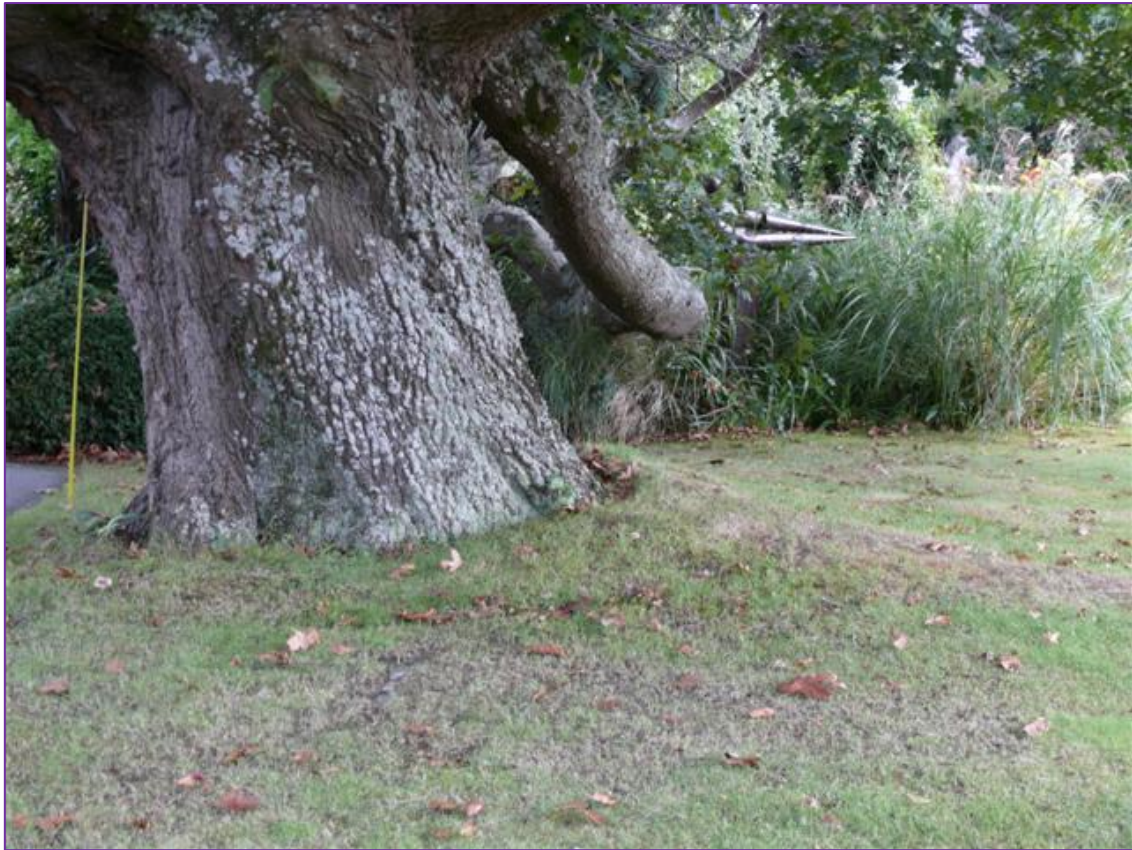
Figure 10, soil heave around the base.

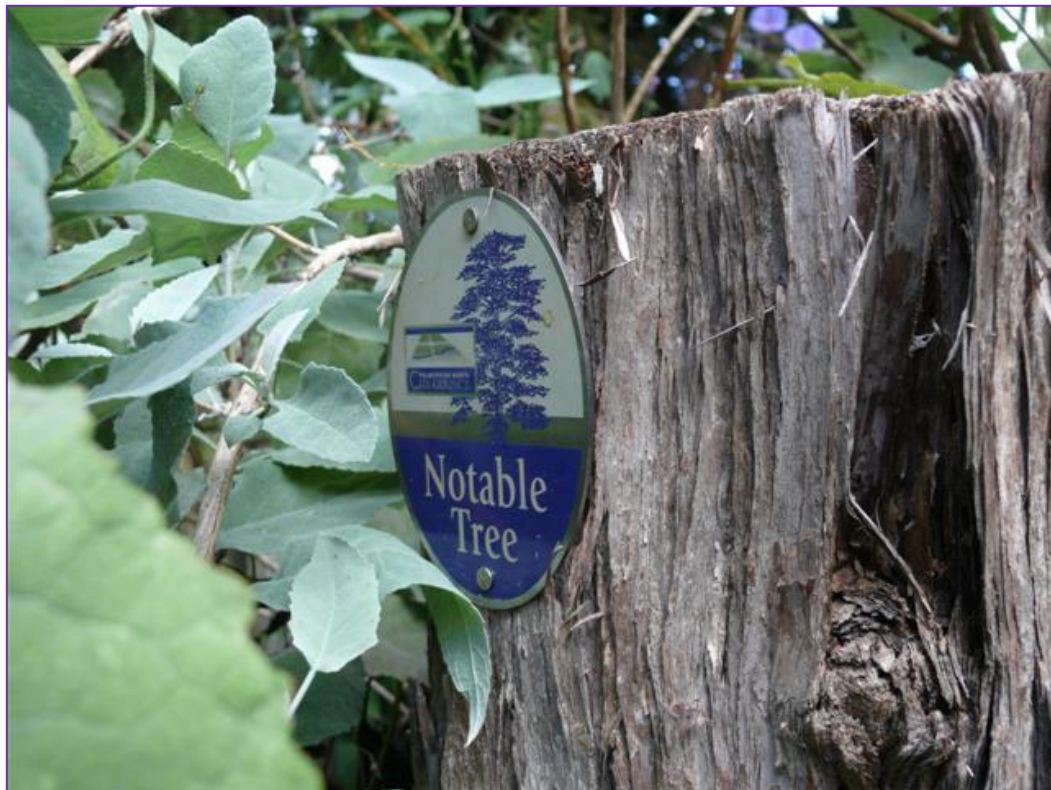
Trunk character	The trunk is infected with heart rotting fungus, and the vitality of the tree is slipping away				
Root Zone	Garden	Natural	Lawn/paddock	U/g services apparent?	Hard surface, if so, explain
Comments	Only carry out necessary safety work.

Figure 2, not much left of the main trunk

Category	Priority	Recommended Action	Timing (from April 2011)	Actioned	Completed
Amenity					
Health					
Safety	As needed	Remove dead and weak limbs, monitor strength of root system			
Overhanging b'dry

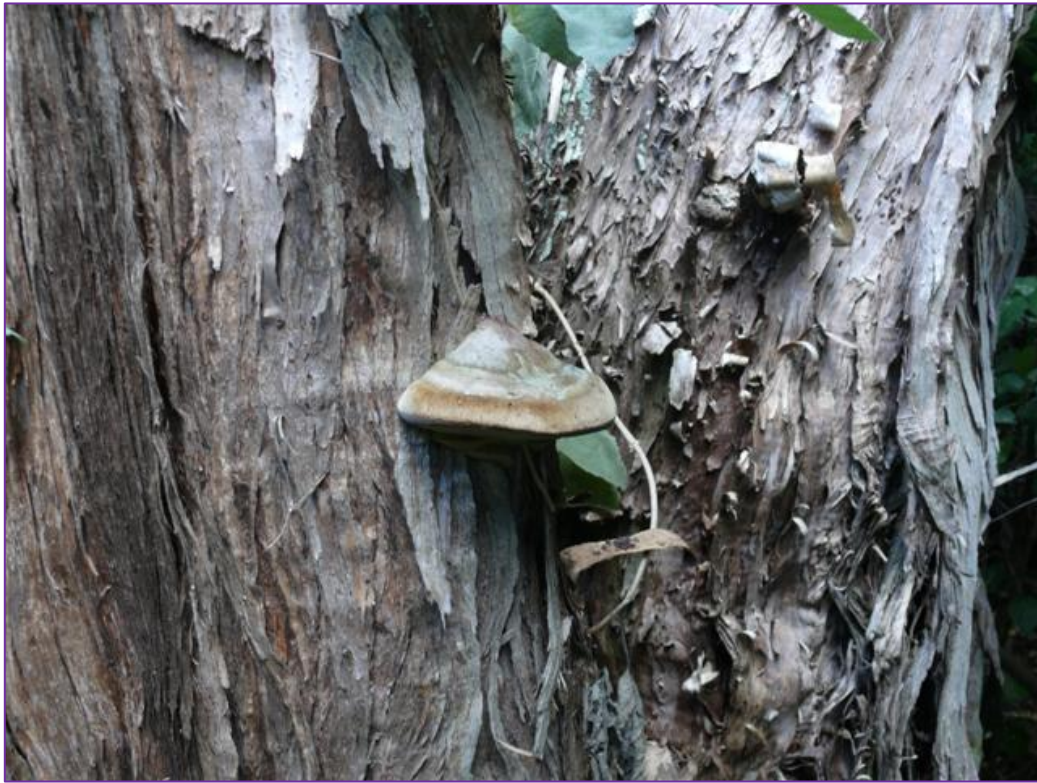
Figure 3, fungus brackets in the main trunk

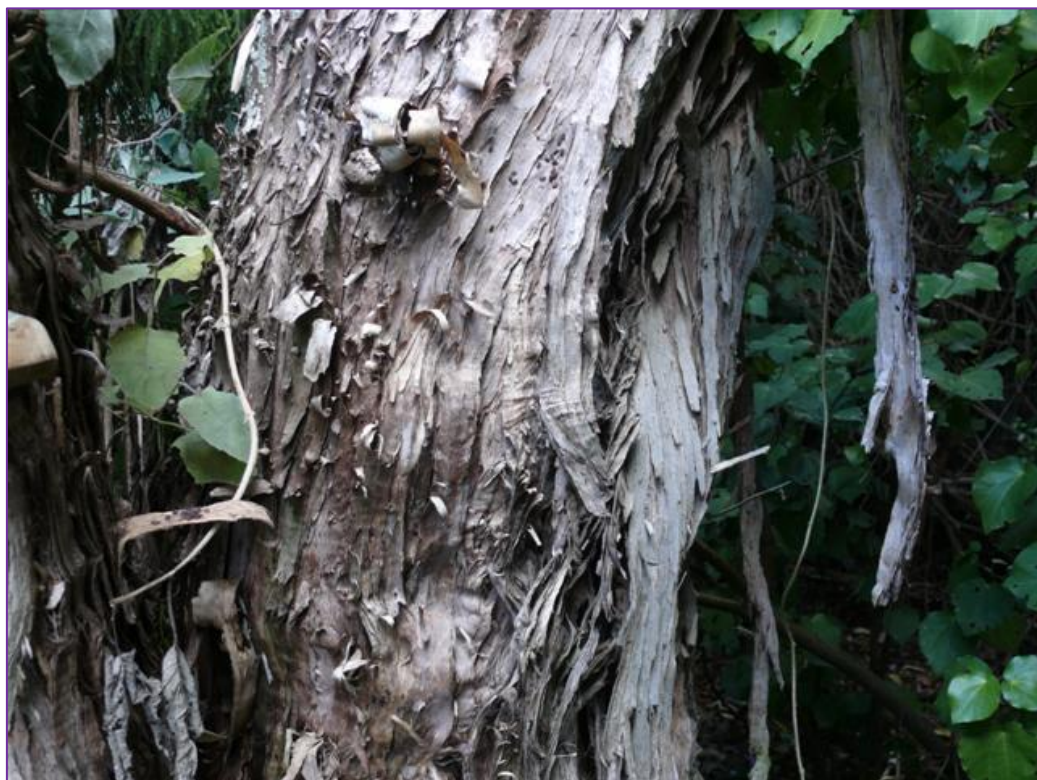
Figure 4, bark separating on the compression side

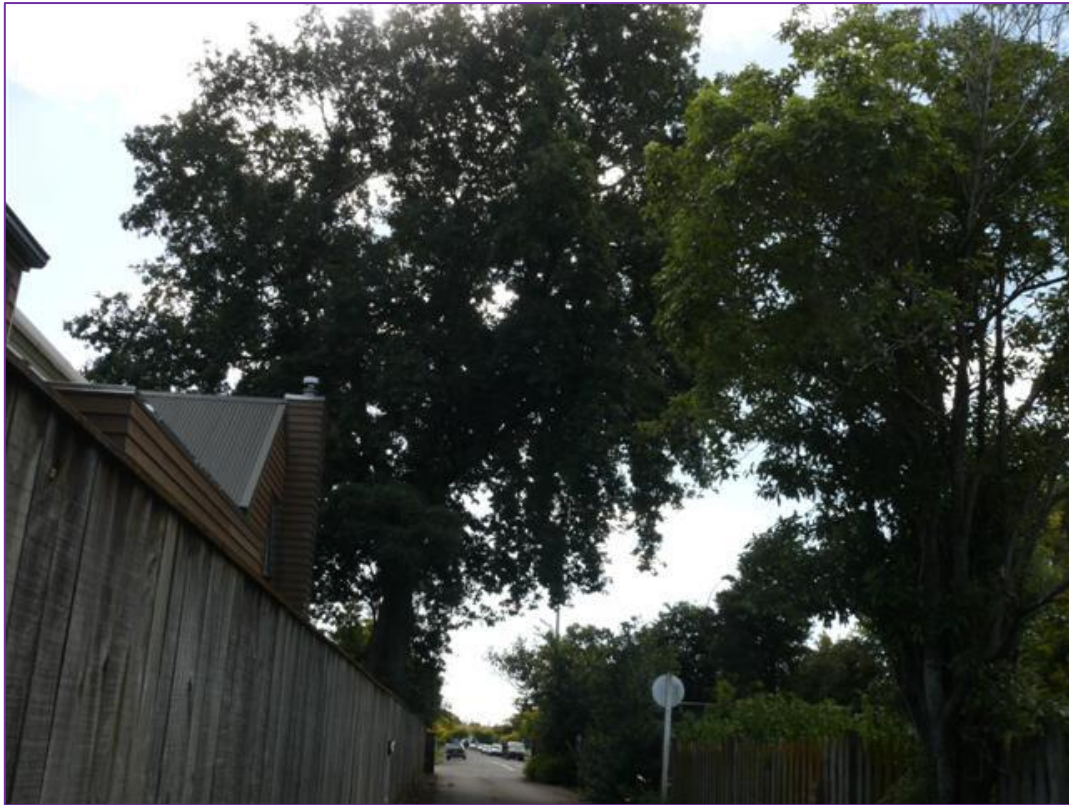
Figure 2m the crown overhangs the ROW

Category	Priority	Recommended Action	Timing (from April 2011)	Actioned	Completed
Amenity	routine	Prune away from house	Within five years, thereafter check quinquennially		
Health	-				
Safety	-				
Overhanging b'dry	-

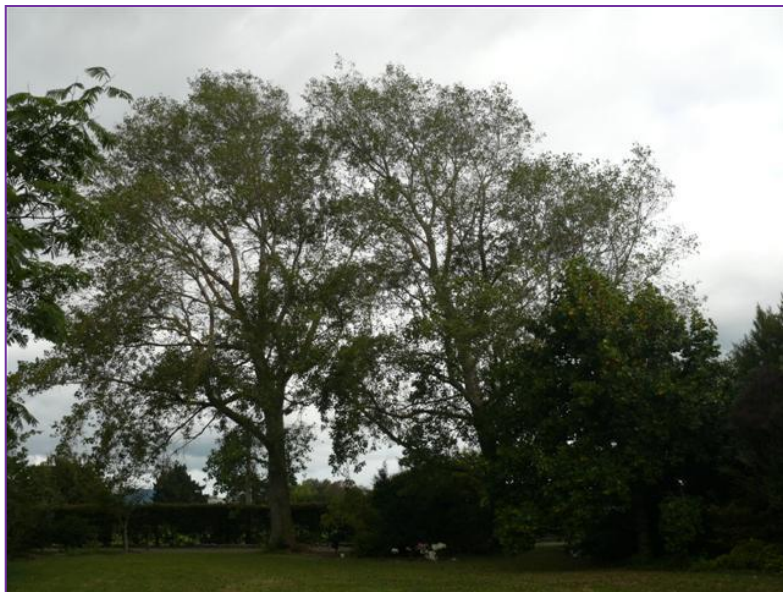
Both sets of trees score very high on the STEM assessment, above the threshold for inclusion in the register of notable trees. However, in the case of the poplar trees, I do not consider that they are suitable candidates – although the trees are large and have a high profile, as a species they are a) not very long-lived and b) prone to shedding large limbs at maturity. Therefore, I suggest that these two trees are not put on the list of notable trees.

Poplars not recommended for inclusion on the notable tree list.

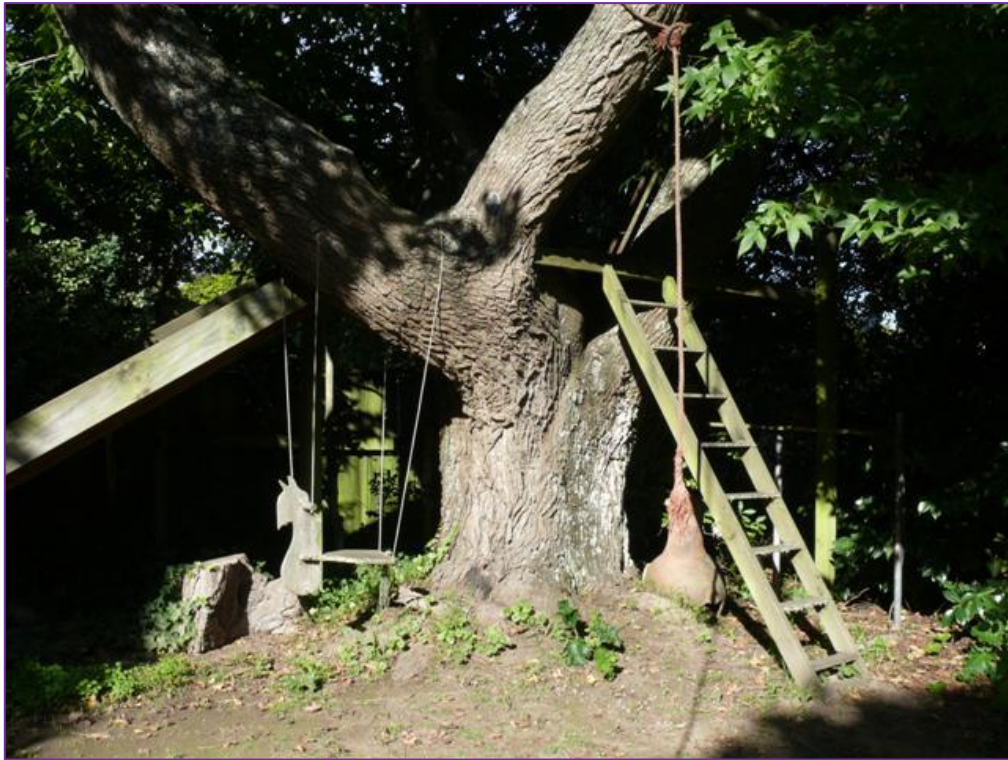
Requested for/by	Routine	Storm Damage	Owner	Developer	DP Review
Pruning History					
Built Environment	Small tight dev'pment	Standard suburban	Large house and grounds	Other (describe)	
Garden environment	Solo tree	Few trees	Many trees	Mainly exotic/native	
Local Environment	Few trees	Some trees	Well treed neighbourhood		
Age Class	young	Semi mature	Mature	Post mature	
Special value	Horticultural	Landscape	Specimen	Historical	Botanical
Structural Character	Single leader	Double leader	Multi-stemmed	Included bark unions	Typical Atypical
Form	Refer to STEM scoresheet				
Crown Shape	Typical	Atypical	Wide spreading crown	Influenced by wind	Affected by other trees
Foliage Health	Good	Poor, if so, explain			
Limb Structure	Typical or sound	Atypical, if so, explain	As so frequently happens with liquidambar, there is a serious flaw in the branch structure – the trunk has a significant included bark branch union that needs attention.

Figure 2. Short stem, with irregular branch habit, elegant tree house

Category	Priority	Recommended Action	Timing (from April 2011)	Actioned	Completed
Amenity					
Health					
Safety	Quite urgent	Reduce the crown particularly on the stem with the included bark	Try to get this done soon		
Overhanging b'dry
