Palmerston North City Council

Notable Tree Survey March and April 2011

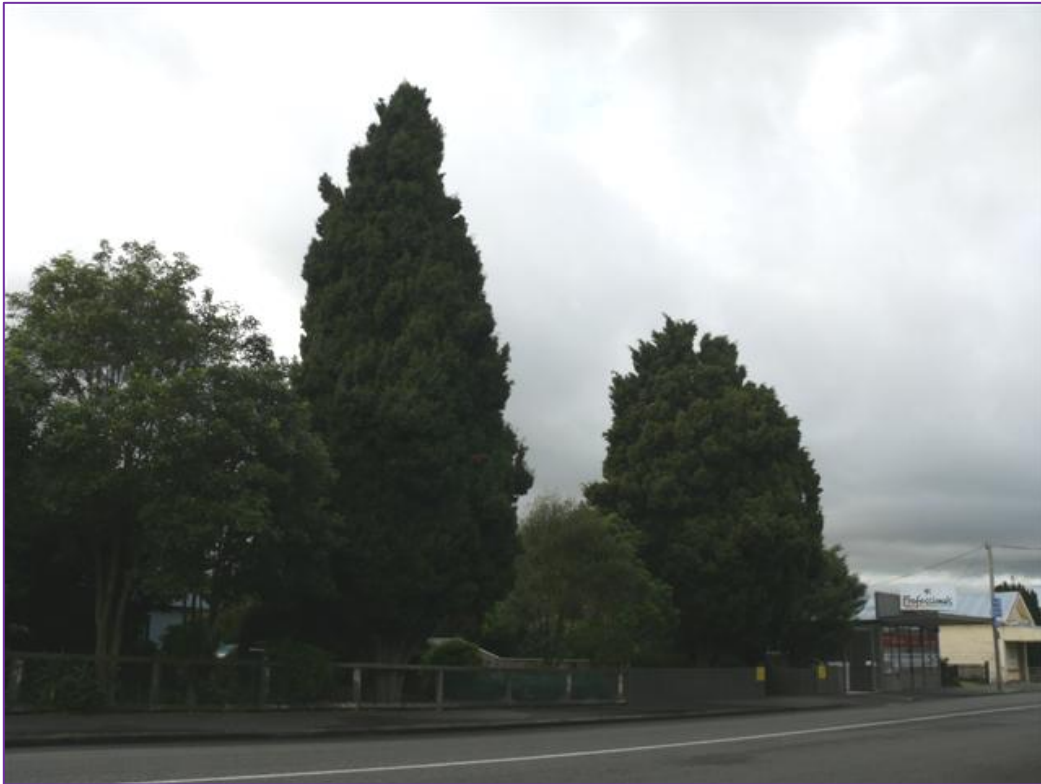
Comments	I consider that only the best tree be included in the register this time. The larger and better specimen is suitable to be retained on the register, but not the smaller tree. It is unusual to see the variations between the two trees becoming more exaggerated as the years go by. They were fairly similar when I first inspected them.

Figure 1. the two trees

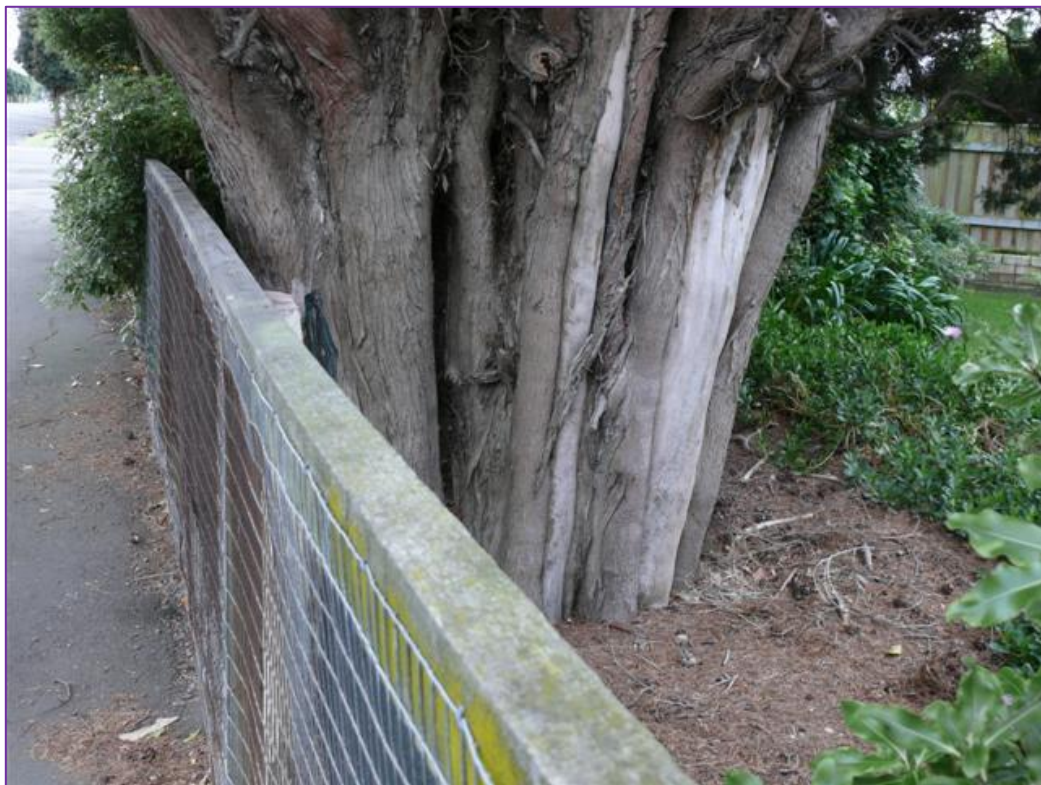
Figure 2. the wounds in the trunk have not changed in 8 years.; healing well.

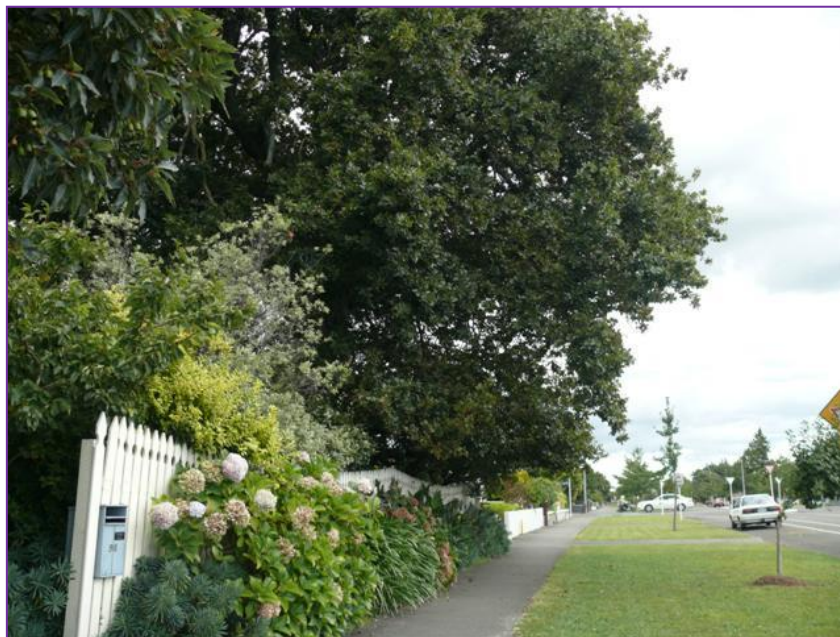
Figure 4 Overhanging canopy

Routine: deadwood removal is recommended every five years or so, this tree is inclined to have a low crown, so some crown lifting may be required over the footpath. The wide spreading crown will need to be reduced some time in the next 15 years this is not necessary at present – Mr. Reilly stated he liked the privacy. reduce crown width.

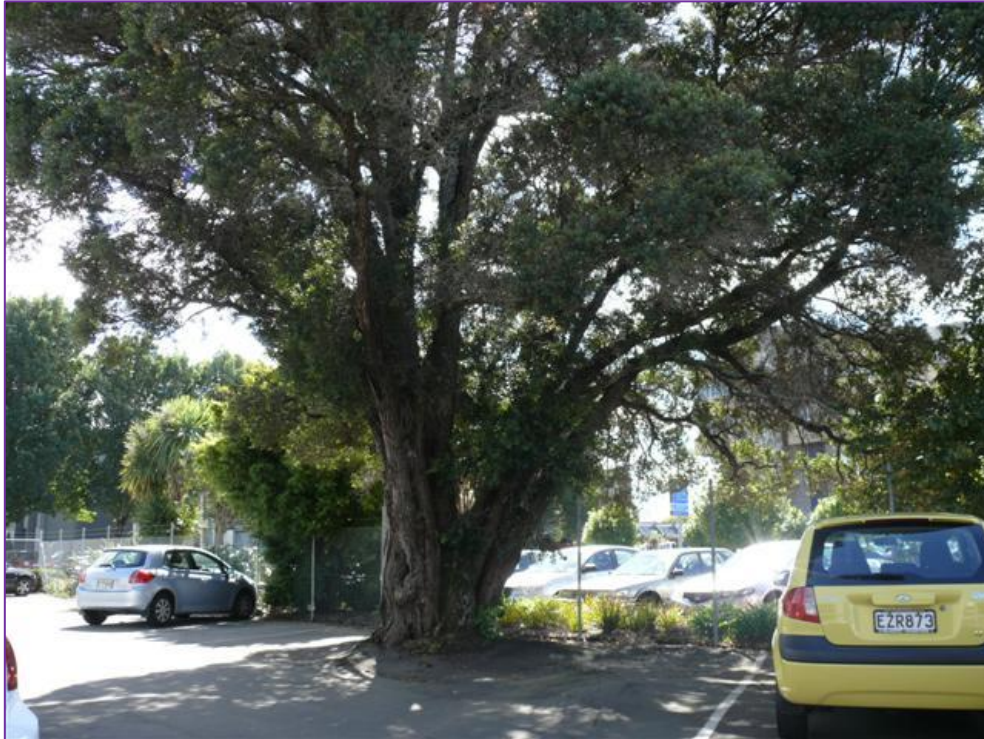
Root Zone	Garden	Natural	Lawn/paddock	U/g services apparent?	Hard surface, if so, explain – carparking right up to the base. The roots have subverted the integrity of the tarseal
Comments	<p>The tree is accompanied by trees on the other side of the fence, making a little group divided by th fence. This group could become an interesting feature as the trees mature and their shapes develop. It will require cross boundary cooperation.</p> <p>It would be good to see a better treatment of the root growth zone, with a shrub bed and mulch.</p>

Figure 1. the car parks either side of the will eventually have a n adverse effect on the health of the tree

Category	Priority	Recommended Action	Timing (from April 2011)	Actioned	Completed
Amenity	routine	Lift lower parts of the crown as required	No more than 5 yearly		
Health	Recom mended	Remove carparks to the left and right of the base of the tree and install a slightly raised, mulched bed with native shrubs under.	asap		
Safety					
Overhanging b'dry	Work towards integrating the management of group of trees, so that overhanging is not an issue.

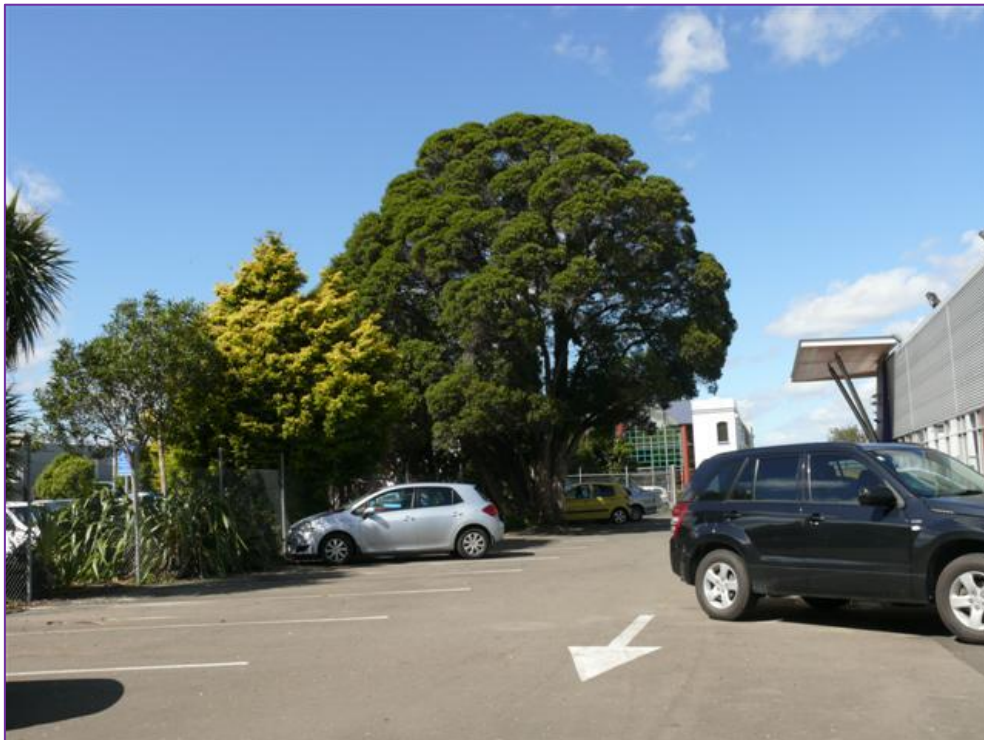
Figure 2. the Rata and golden totara are growing well together at present – time and comparative growth rates will determine the success or otherwise of their juxtaposition.

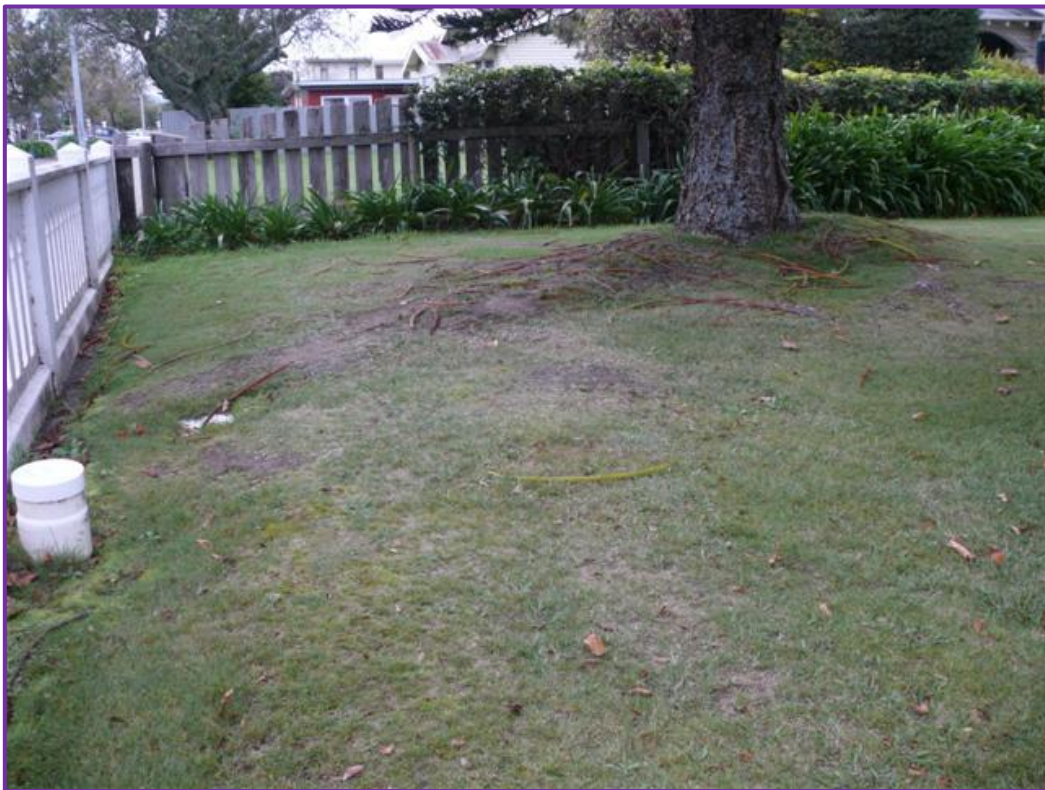
Figure 2, raised ground levels over the roots

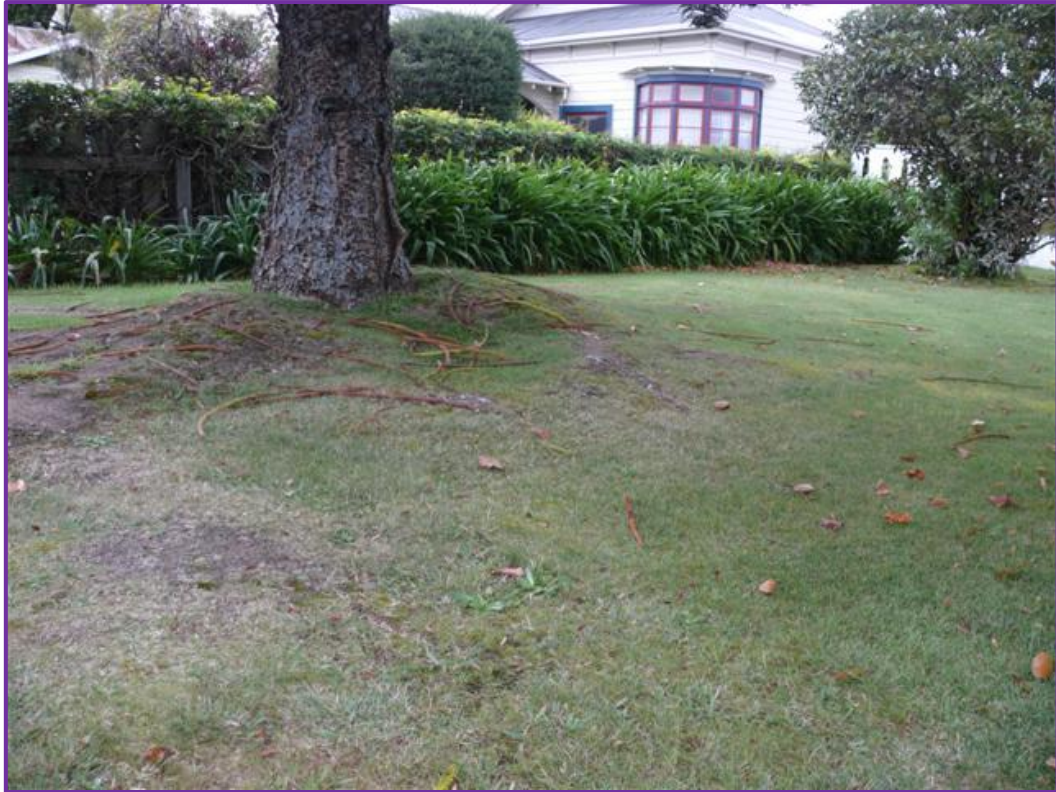
Figure 3, Raised soil levels

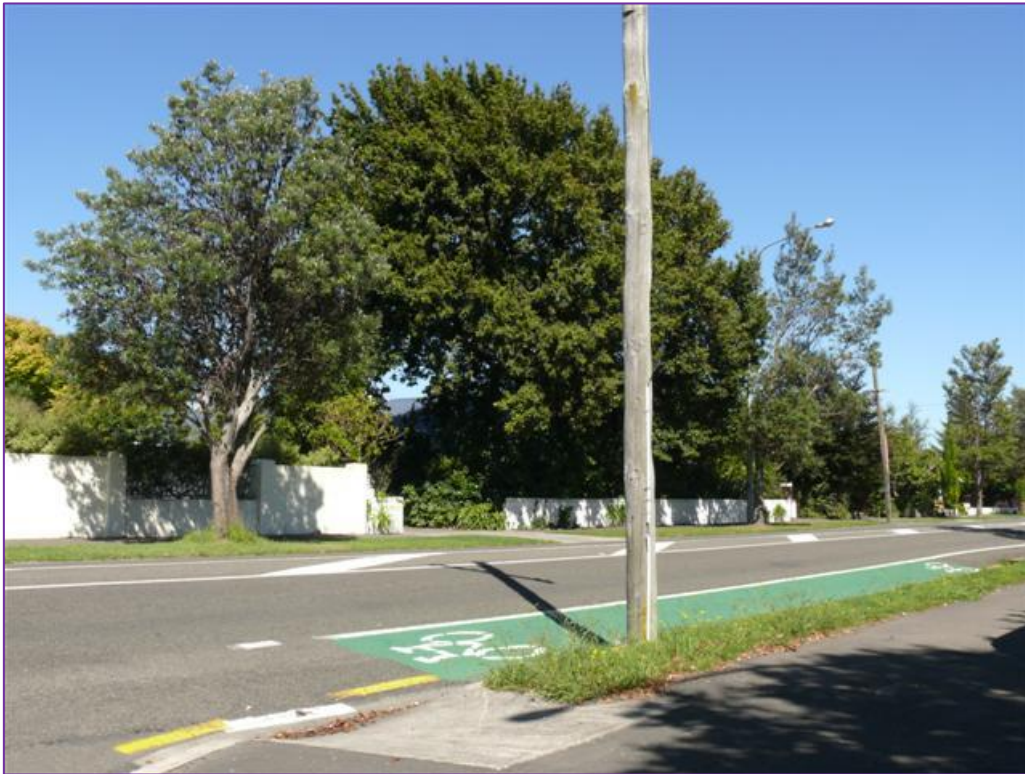
Comments	A huge specimen, in good health. The leeward side is somewhat over-weighted

Figure 1. note wind-pruned shape

Category	Priority	Recommended Action	Timing (from April 2011)	Actioned	Completed
Amenity	Routine,	Crown lifting	As required		
Health	-				
Safety	occasional	Reduce the canopy on the leeward	Every 10 years or so		
Overhanging b'dry	-
