Palmerston North City Council

Notable Tree Survey March and April 2011

Address	40 Pahiatua Street				
Tree name	Group of two <i>Ginkgo biloba</i>				
Location of the tree on the site	Rear garden				
Owner's name					
Date of STEM Assessment	10 May 2011		Inspected by John Wakeling

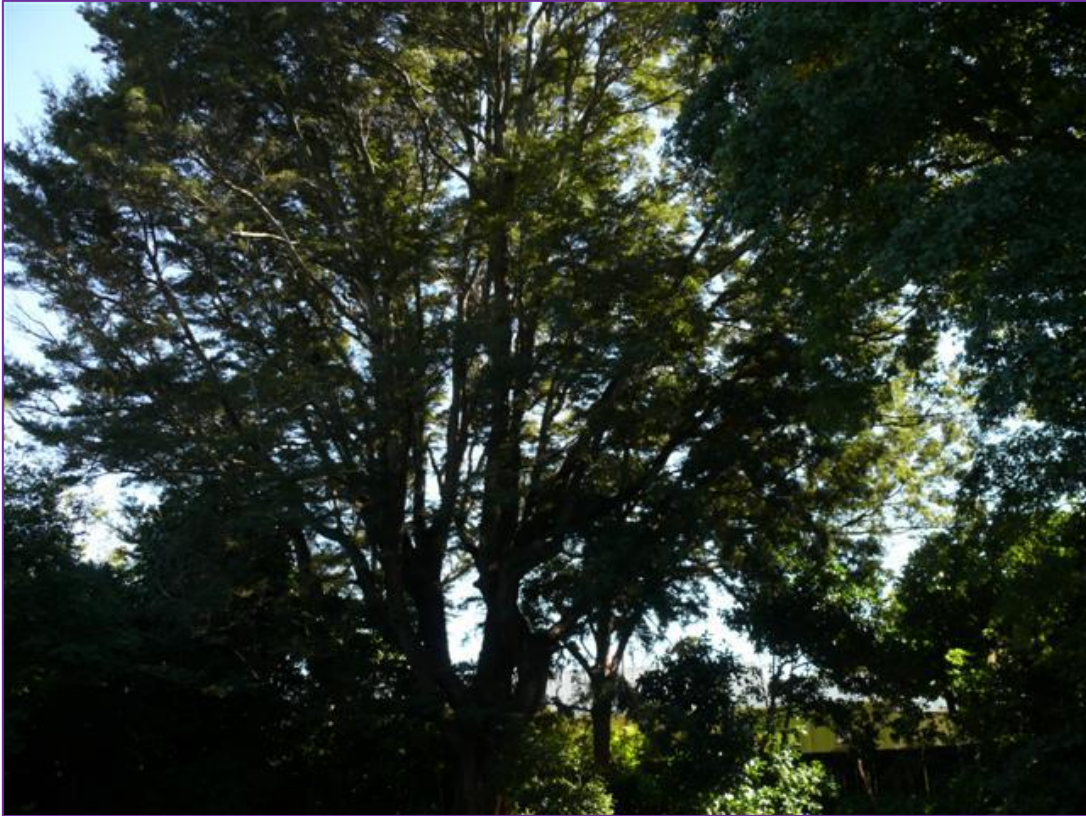
Root Zone	Garden	Natural	Lawn/paddock	U/g services apparent?	Hard surface, if so, explain	
Comments	An amazingly beautiful tree, set in a lovely garden. The large crown makes it vulnerable to storm damage – some crown reduction is recommended

Figure 1, the crown – vigorous growth

Category	Priority	Recommended Action	Timing (from April 2011)	Actioned	Completed
Amenity	routine	deadwood			
Health	-				
Safety	One off	Some very careful width reduction. This will be a very difficult job and should be undertaken by contractors who understand natural form and habit.	Any time from now, ten year or so repeat		
Overhanging b'dry		As required

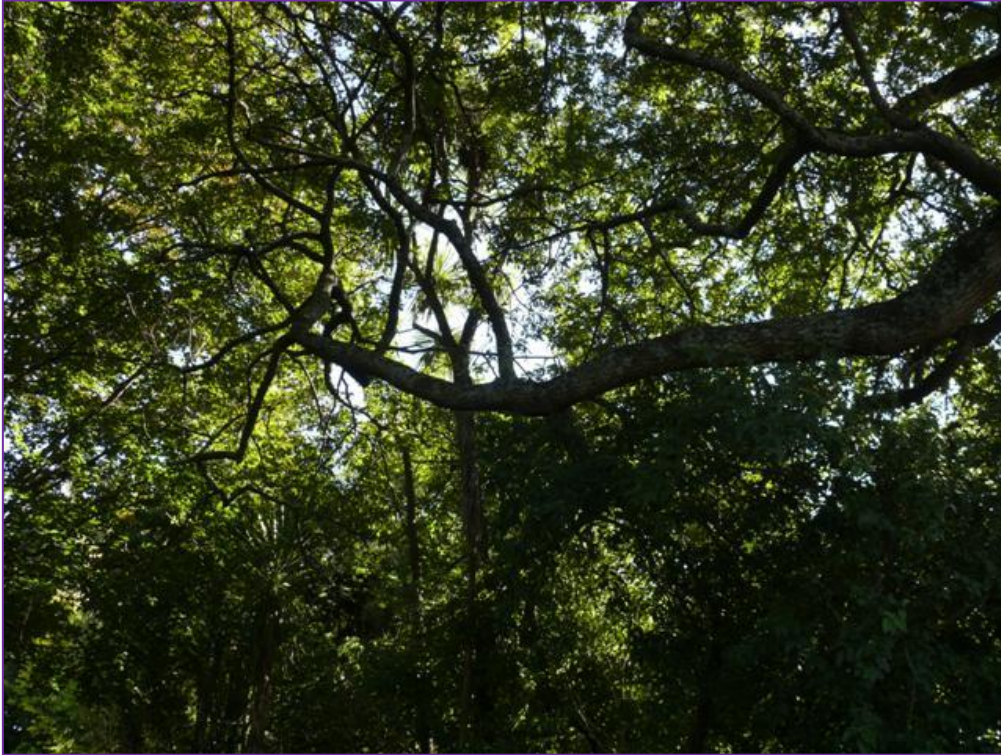
Figure 1, this branch to be shortened to allow more light to the garden nearby.

Category	Priority	Recommended Action	Timing (from April 2011)	Actioned	Completed
Amenity	One off	One long limb growing to the north could be shortened to allow more light into 121	soon		
Health					
Safety		Part of Amenity – dead wood removal	Now and thereafter 5 -6 yearly		
Overhanging b'dry

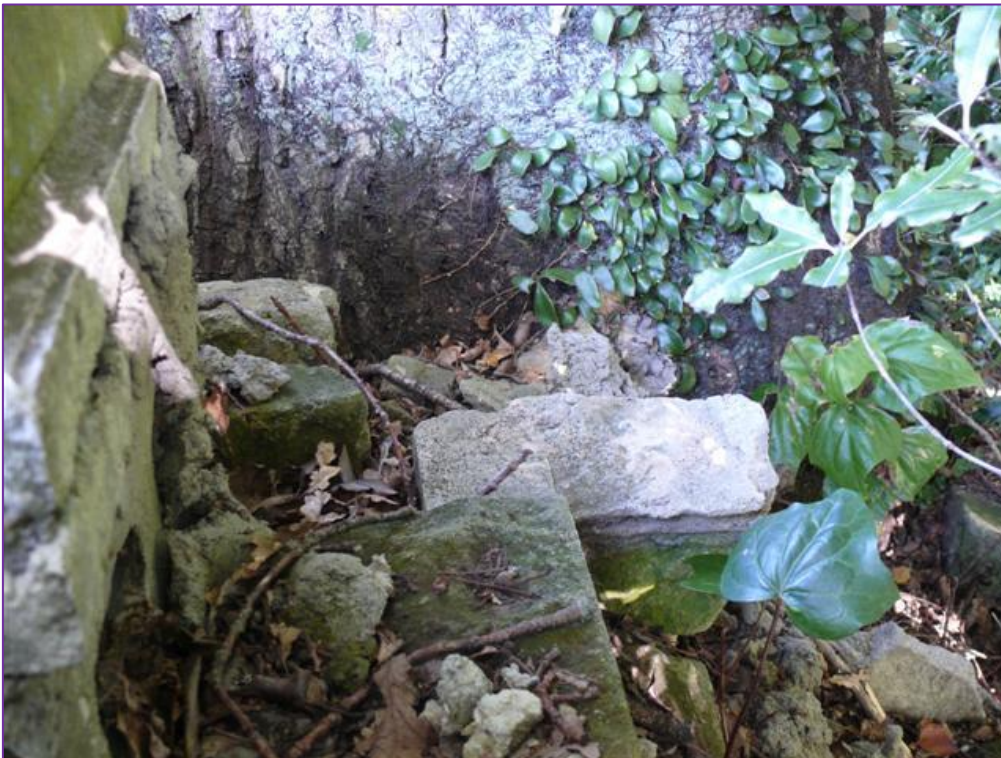
Figure 2, collapsing wall

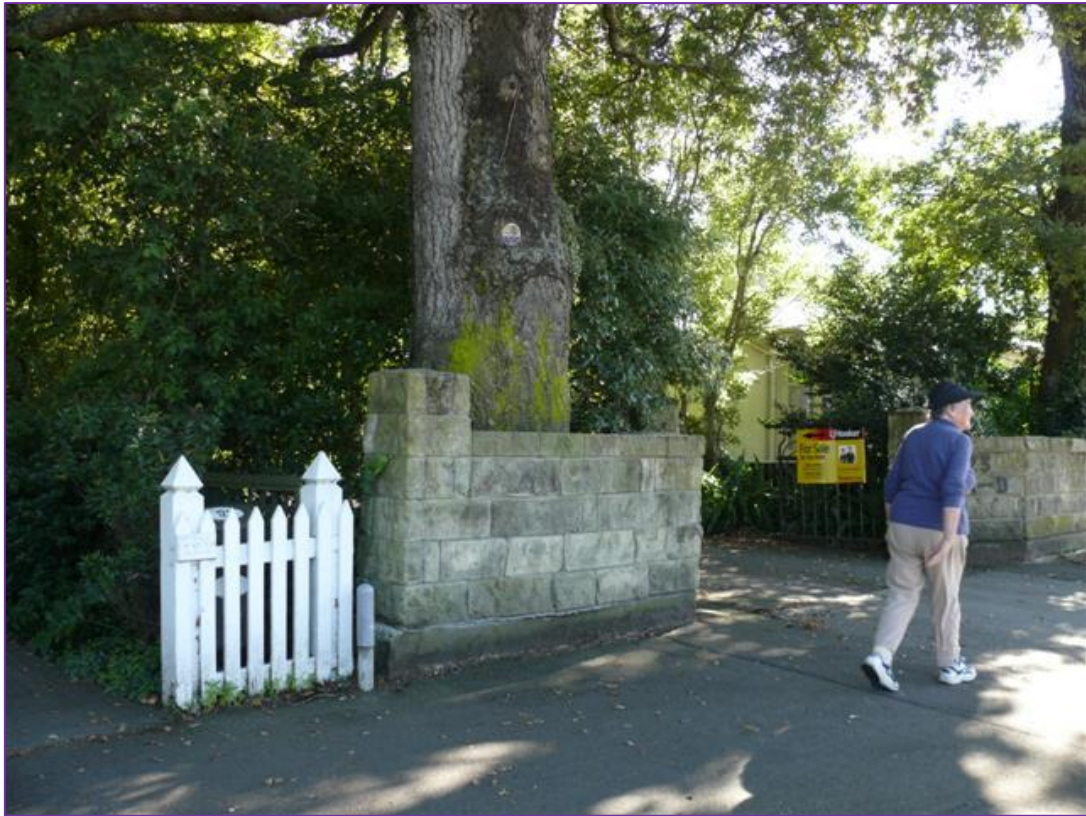
Figure 3, the tree in its setting – note the newly patched asphalt where a trench had been dug.

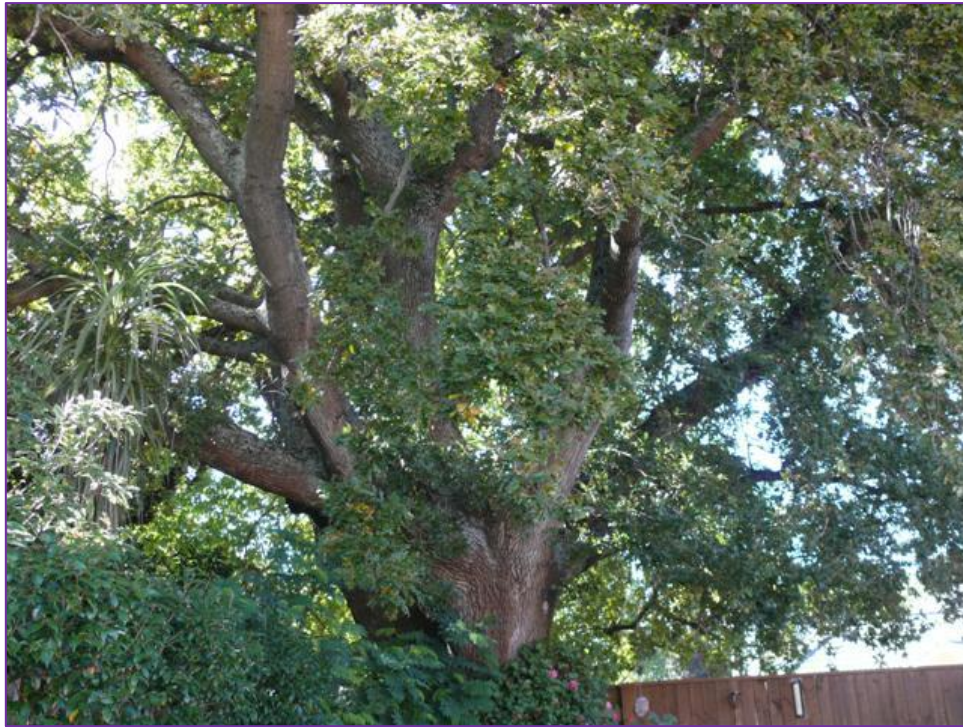
Comments	The tree is in very good health. It suffered a great deal of damage during redevelopment 12 or so years ago. Very small garden, v. large tree.

Figure 3 the crown.

Category	Priority	Recommended Action	Timing (from April 2011)	Actioned	Completed
Amenity	routine	Reduce width of crown, deadwood	As requested, then 5 yearly		
Health					
Safety		End weight reduction			
Overhanging b'dry	As requested	The tree overhangs neighbours – prepare to consent to width reduction	As above

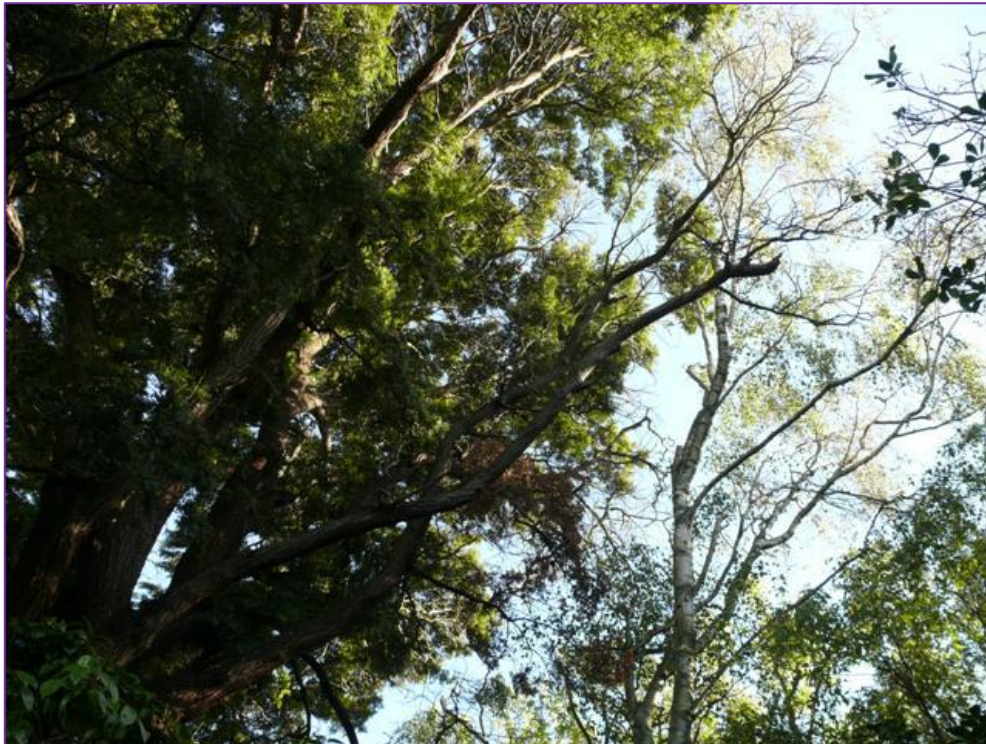
Figure 1 dead limbs in upper canopy

Category	Priority	Recommended Action	Timing (from April 2011)	Actioned	Completed
Amenity	urgent	Remove dead wood in the crown.	This year. Then 5 yearly		
Health	-	Apply a layer of mulch	On an annual basis		
Safety	See Amenity section above		ditto		
Overhanging b'dry

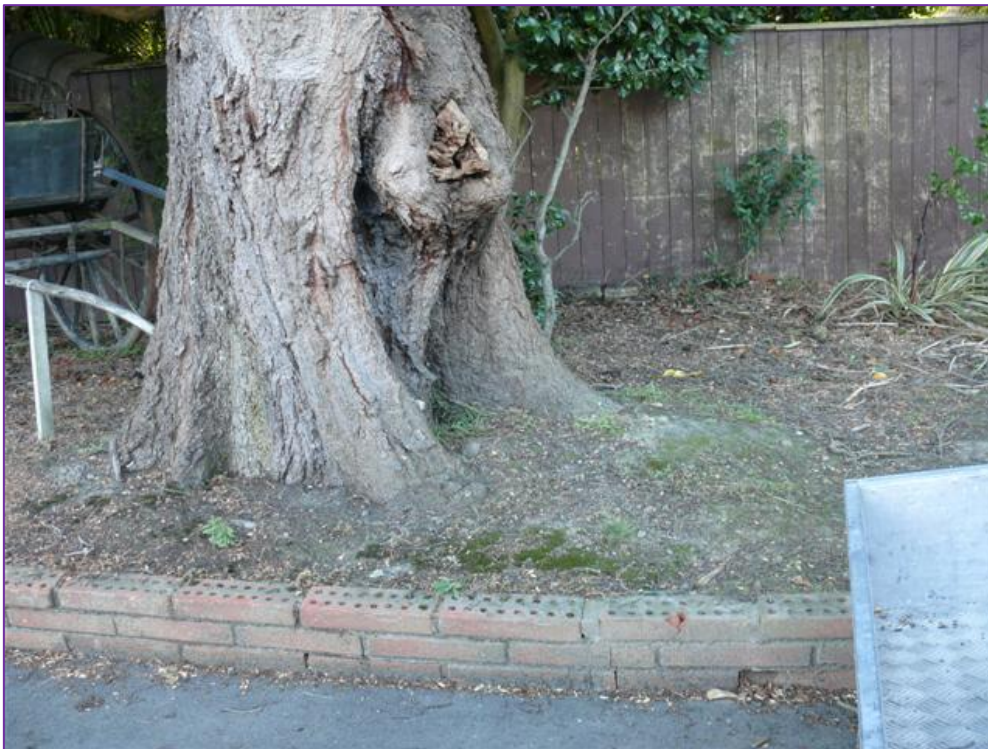
Figure 2. trunk appears sound and growing well. Needs mulch

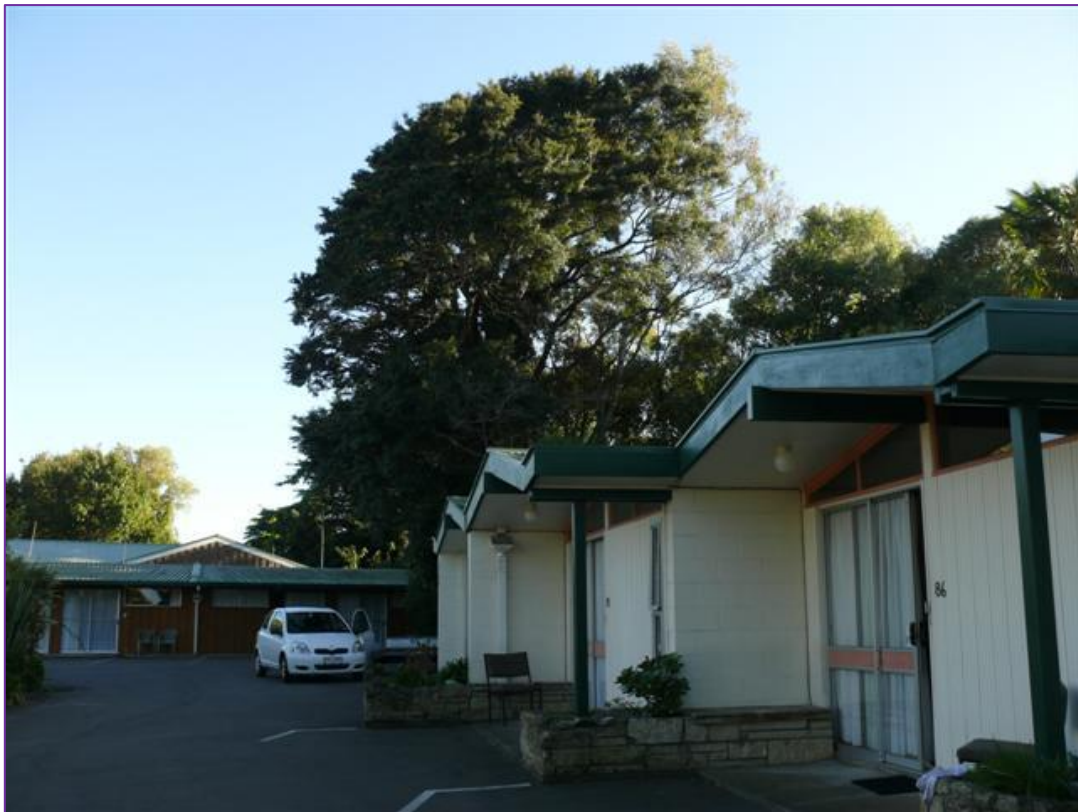
Figure 3. sparser foliage on eastern side. Can be examined during deadwooding programme

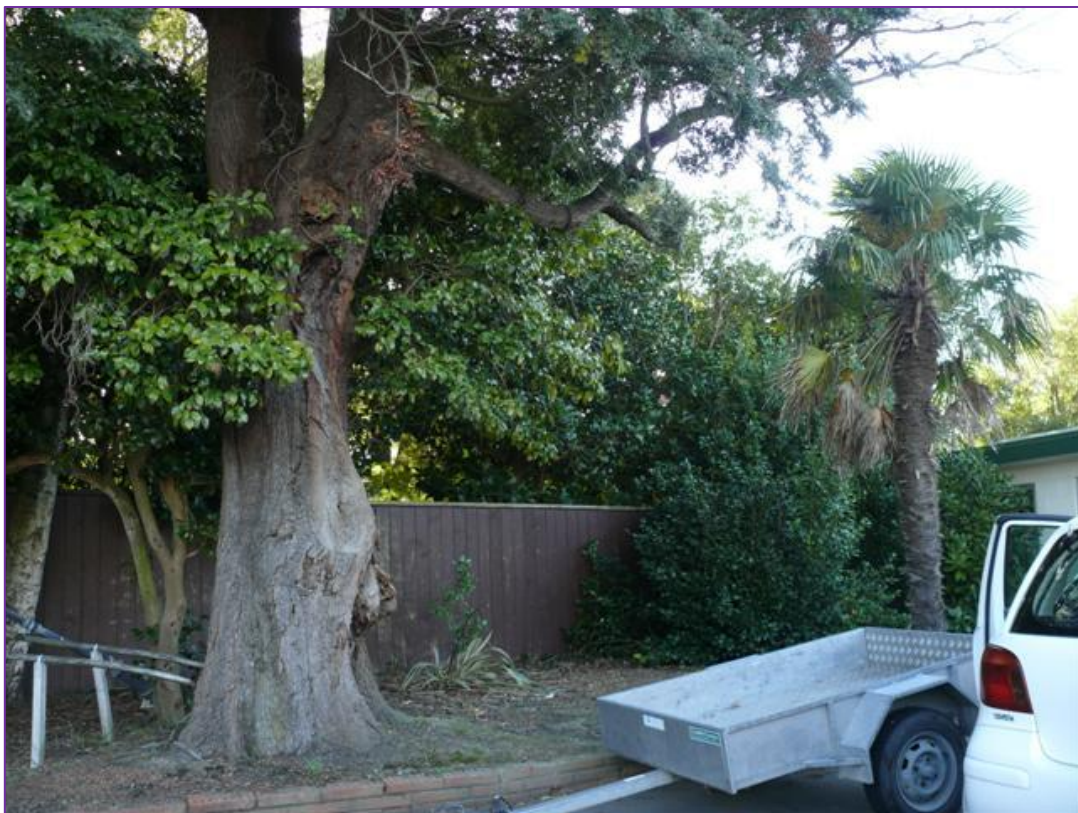
Figure 4. the dead lower limb should be removed

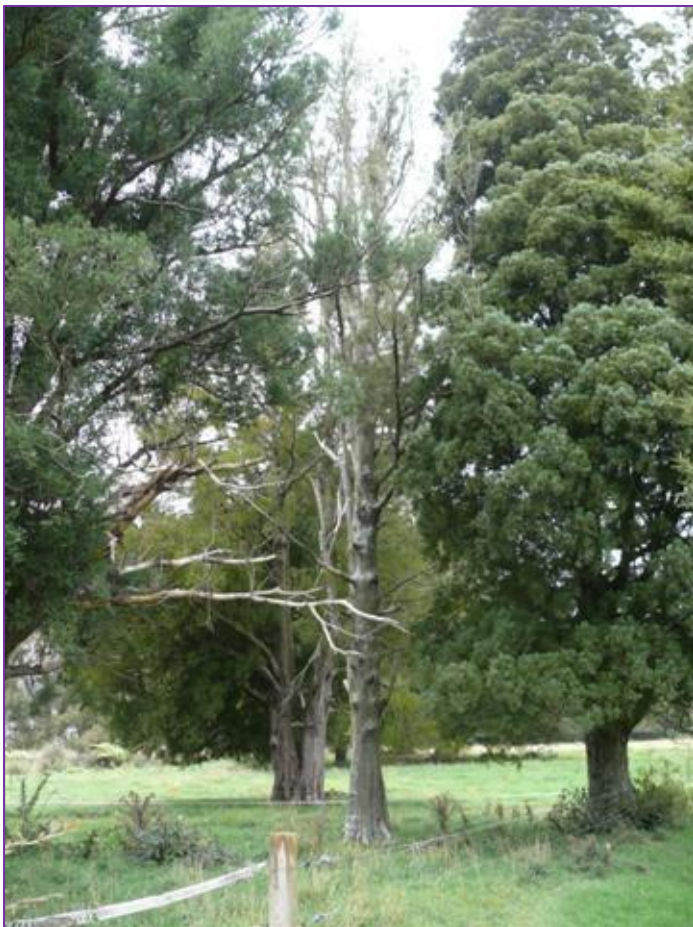
Figure 4 two poorly trees

Category	Priority	Recommended Action	Timing (from April 2011)	Actioned	Completed
Amenity	-				
Health		Remove the nails and fence batten from the trunk of trees	Would like to see this done soon –		
Safety		The dying trees will need to be removed	Not urgent		
Overhanging b'dry	-

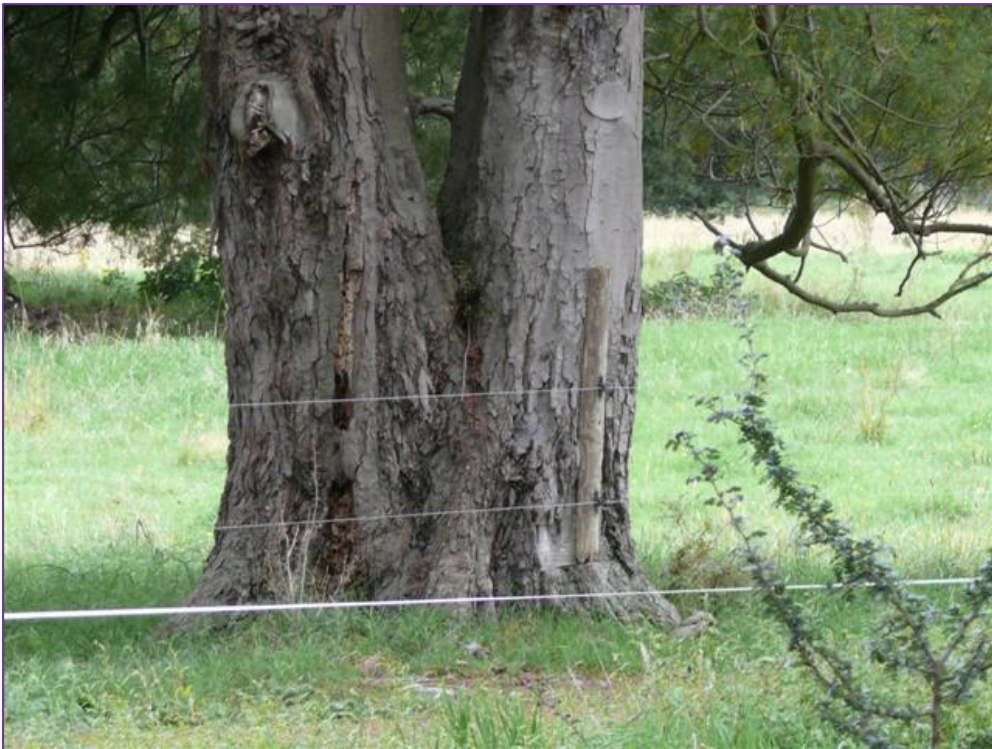
Figure 6. batten nailed to tree trunk

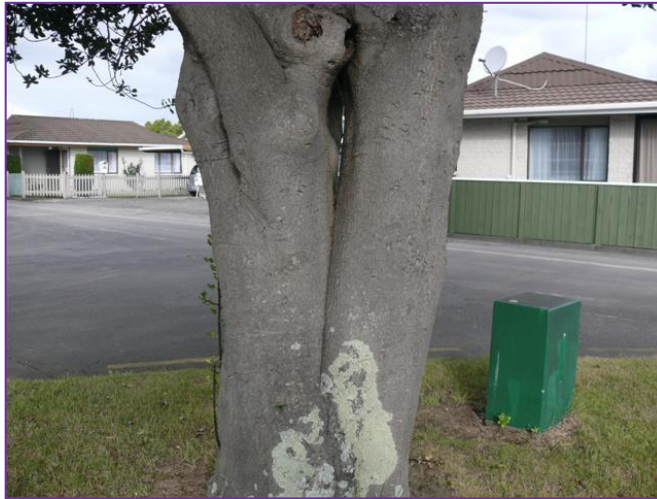
Figure 1 bole and trunk of the holly showing the poor formation of the trunk

Damage (old and recent) : lack of formative pruning has left the tree with long term structural problems. The tree is slow growing and these failings are not likely to become a public danger for many years.

Recommended time lines are remove deadwood, thin crown and lift crown as needed in the next two years, thereafter no more than five yearly intervals. Minor pruning to raise the crown might be necessary more frequently – this secateurs work would not need specialist skills.
