**Ground Contamination
Assessment**

Roxburgh Crescent

Prepared for
Palmerston North City Council

Prepared by
Tonkin & Taylor Ltd

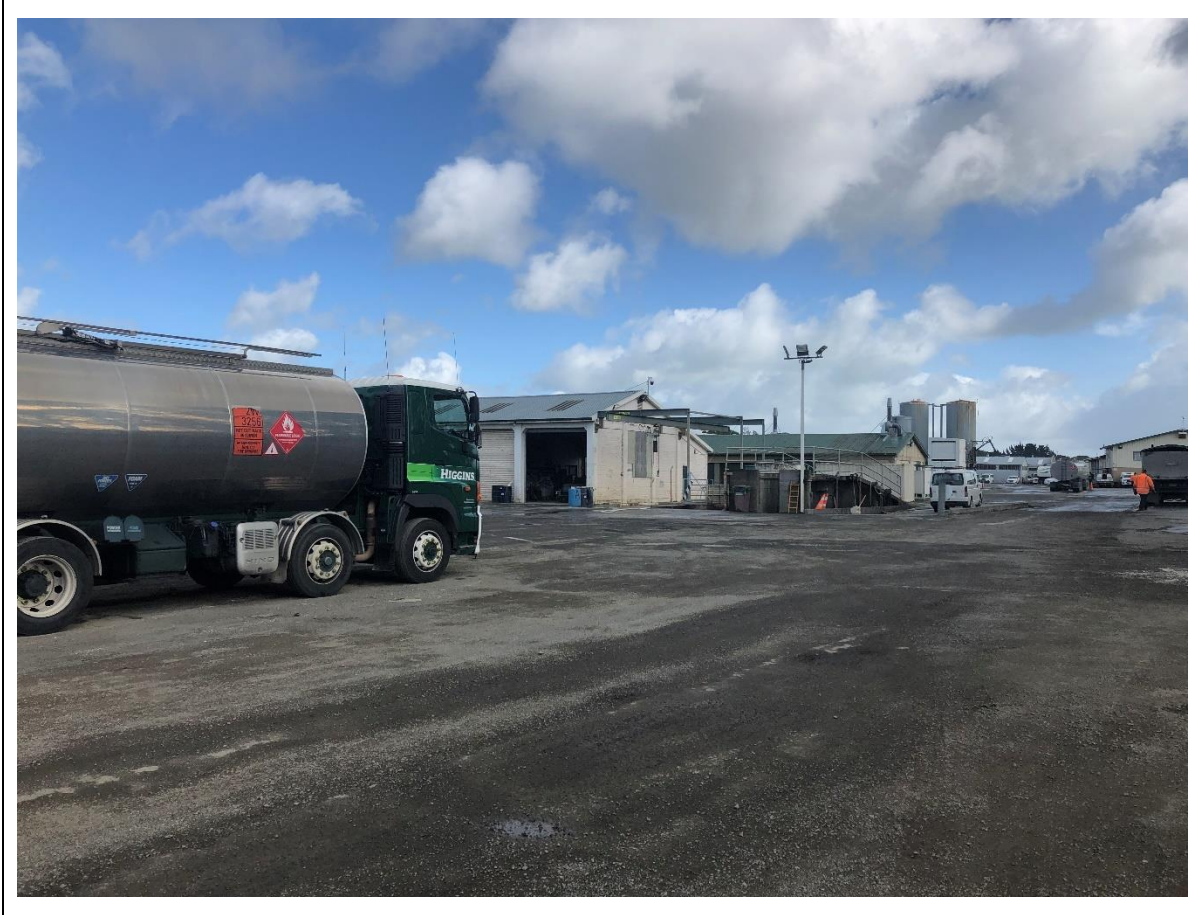
Photograph 1: General Higgins site showing onsite activities

- The Higgins site is an operational transport depot with a high volume of vehicle and machinery movements between the workshops, product storage facilities and vehicle wash facilities (see Photograph 1);

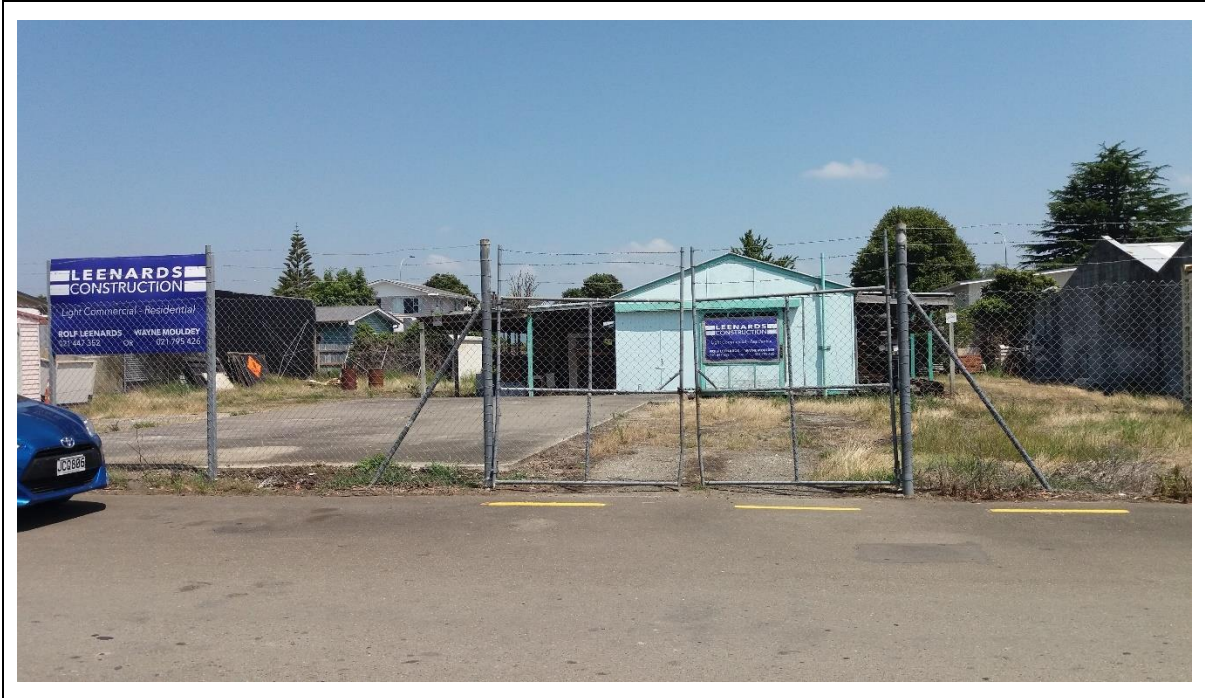
Photograph 2: General site condition, 29-31 Roxburgh Crescent

- There was little activity at 29-31 Roxburgh Crescent at the time of the site visit, but it was evident that it is used as a storage facility for building materials and had vehicle access around the building (see Photograph 2);

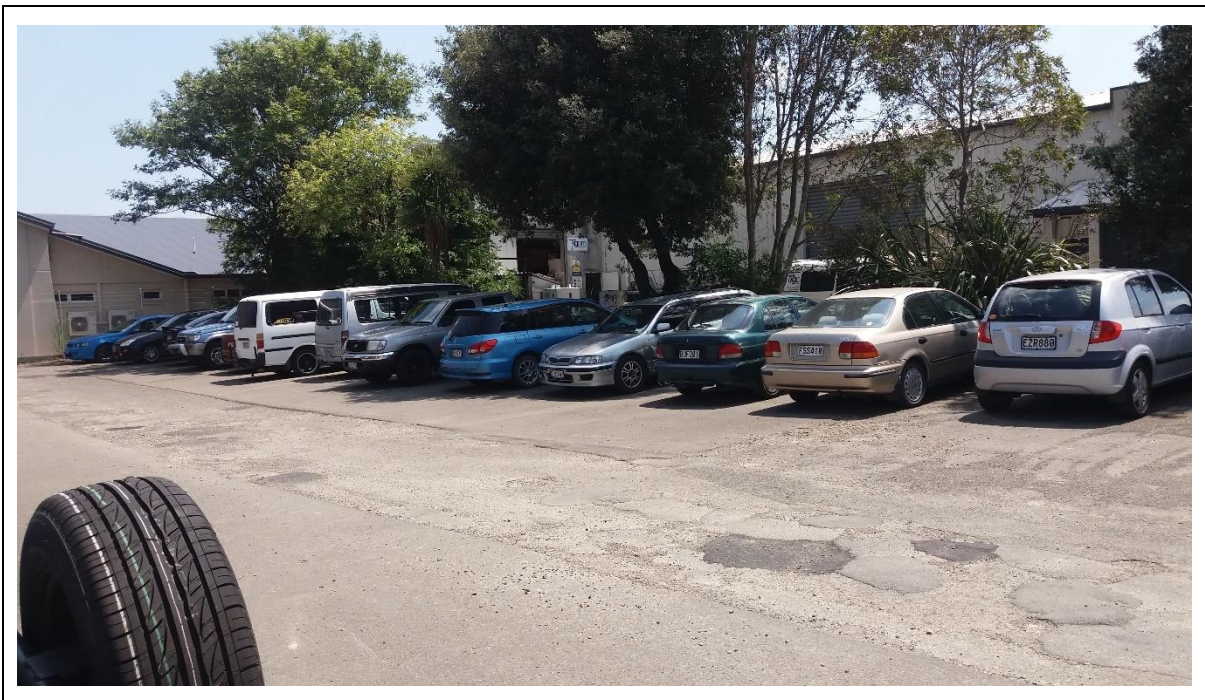
Photograph 3: General site condition, 21 Roxburgh Crescent

- 21 Roxburgh Crescent was observed to be fully paved and is currently used as a staff parking area for Higgins with drainage running through the middle of the property (see Photograph 3);

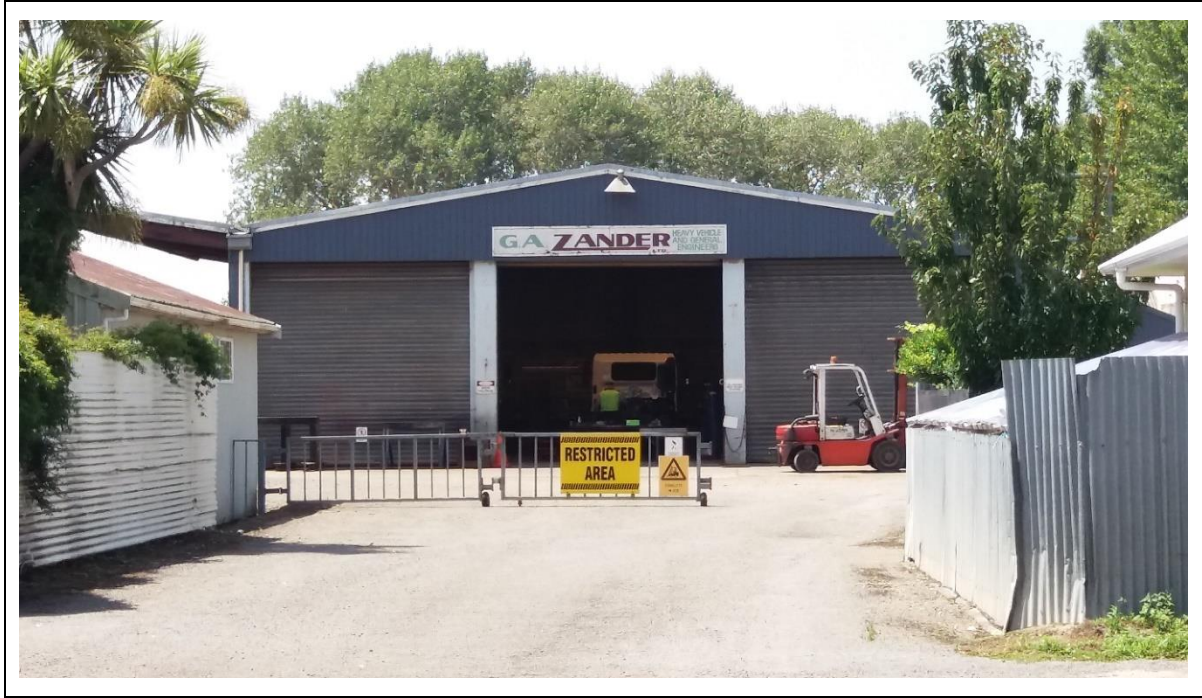
Photograph 4: General site condition, 573-575 Ruahine Street

- 573-575 Ruahine Street is occupied by an operating engineering workshop with large workshop buildings, an office building, a shipping container, and assorted machinery and equipment across the site (see Photograph 4);

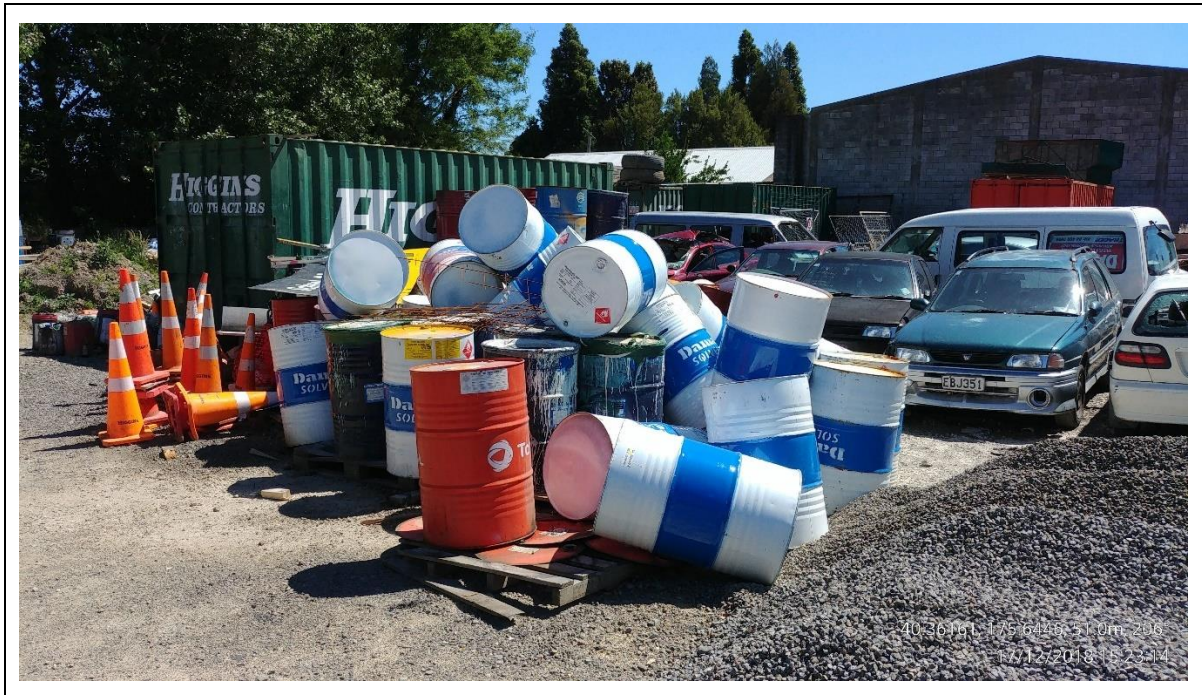
Photograph 5: Example of scrapped vehicles and empty drums on Higgins site

- A number of scrapped vehicles in a deteriorating condition and empty drums were present on the south west portion of the Higgins site (see Photograph 5);

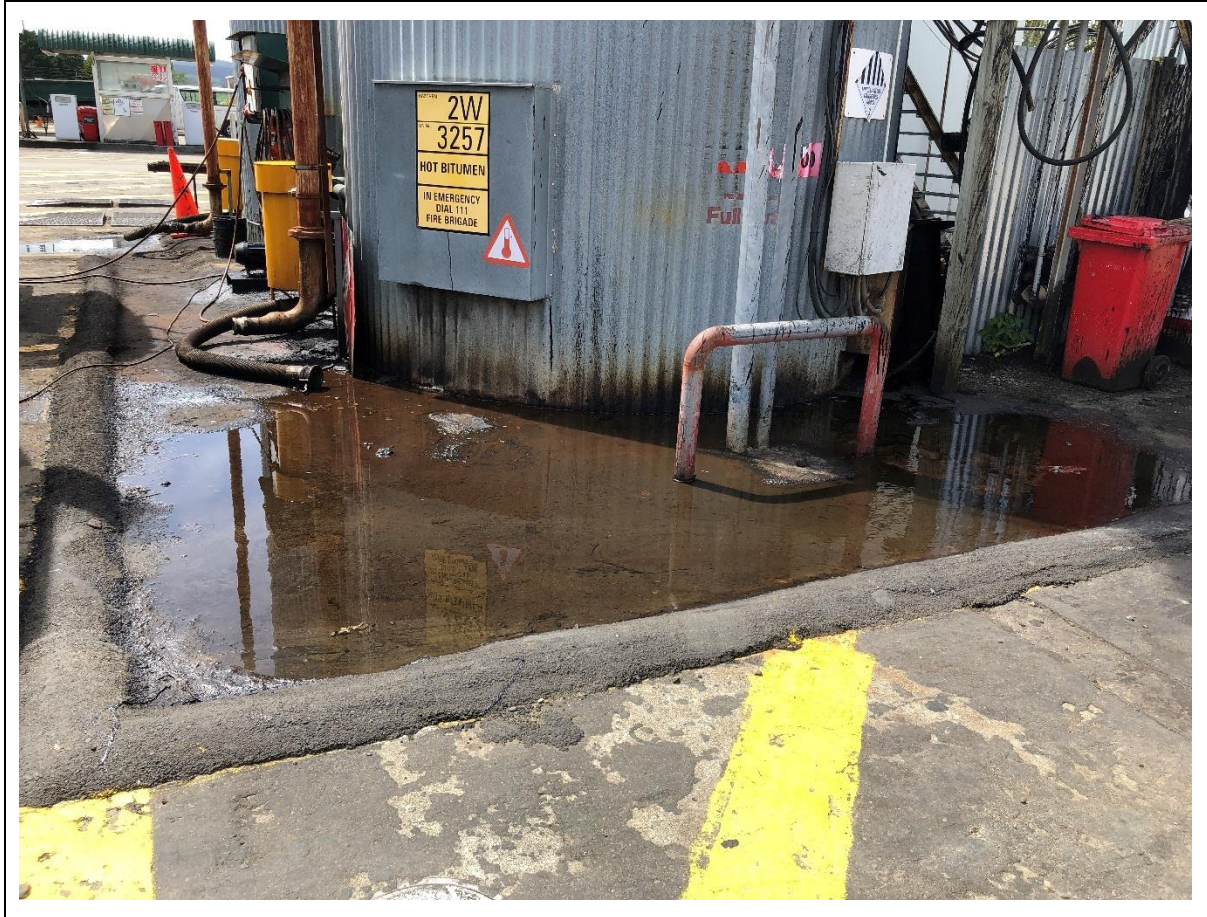
Photograph 9: Bunding surrounding bitumen storage tanks

- The immediate area containing the three above ground bitumen tanks is bunded and there is an interceptor located in the middle of the Higgins site (see Photograph 9);

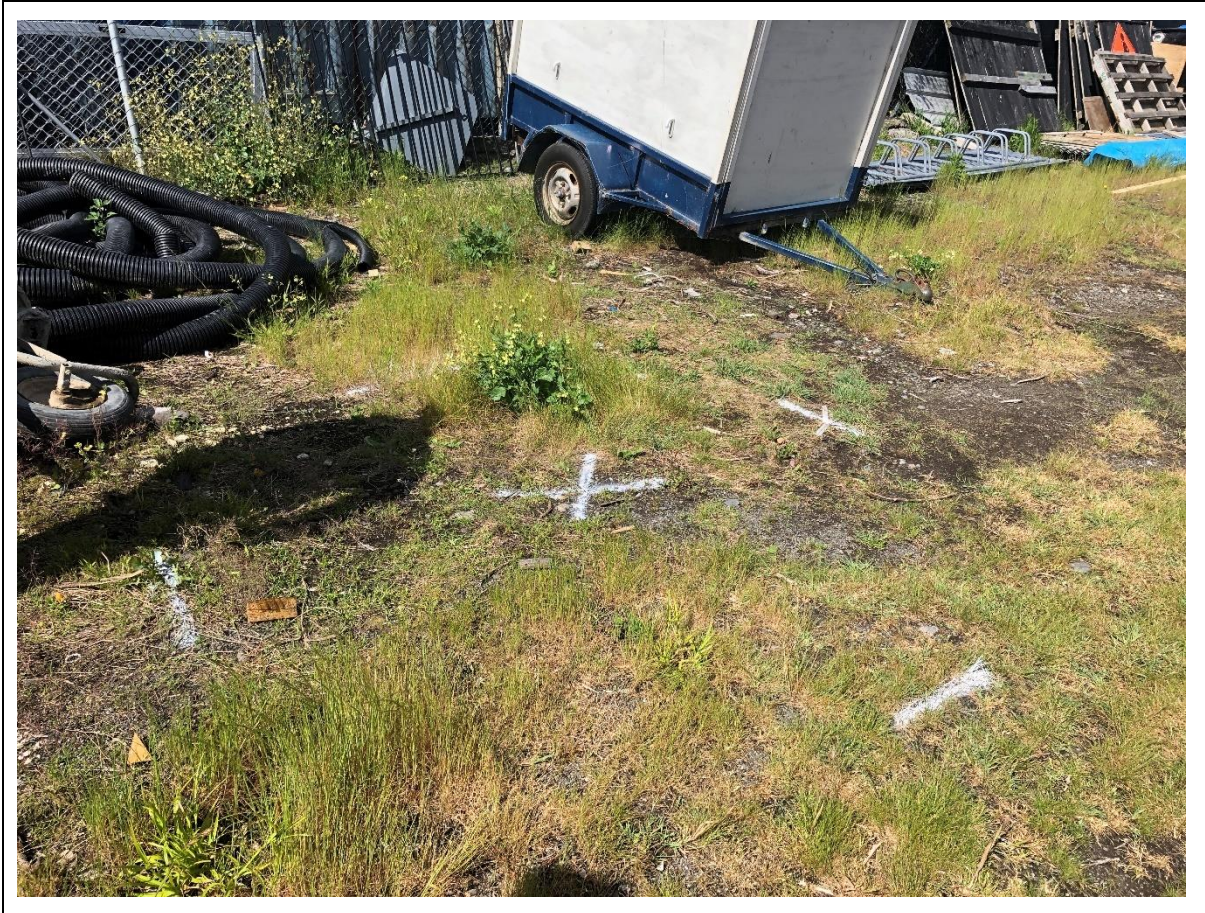
Photograph 10: Example of sparse vegetation at 29-31 Roxburgh Crescent, SS4 location (similar to what was observed at 573-575 Ruahine Street)

- Vegetation was sparse across all properties visited during the walkover and mainly consisted of grasses and weeds (see Photograph 10), there were a number of large trees forming a shelter belt along the south and south eastern boundary of the Higgins site. Some planter boxes were present at the front of the Higgins site and the vegetation within appeared to be in a good condition. The portion of Waterloo park that was visited was fully covered in grass and other vegetation, including large trees;

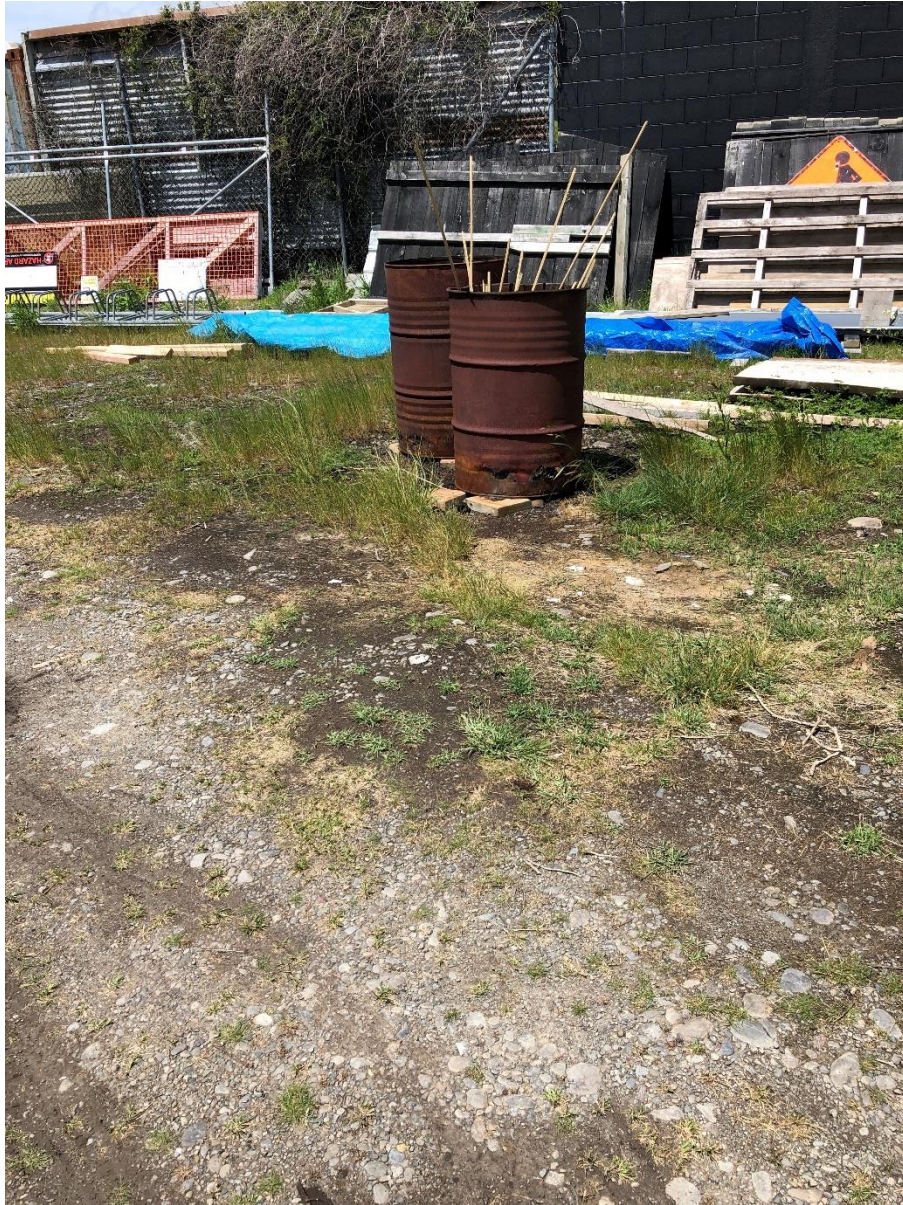
Photograph 11: Drums used for burning at 29-31 Roxburgh Crescent

- Discolouration and staining of site surfaces apparent were present on both paved and unpaved areas of the Higgins sites and the other properties. There were areas at 29-31 Roxburgh Crescent that appeared to have been used as burning areas. Two drums containing materials to be burnt were observed in the south west corner of the site (see Photograph 11);

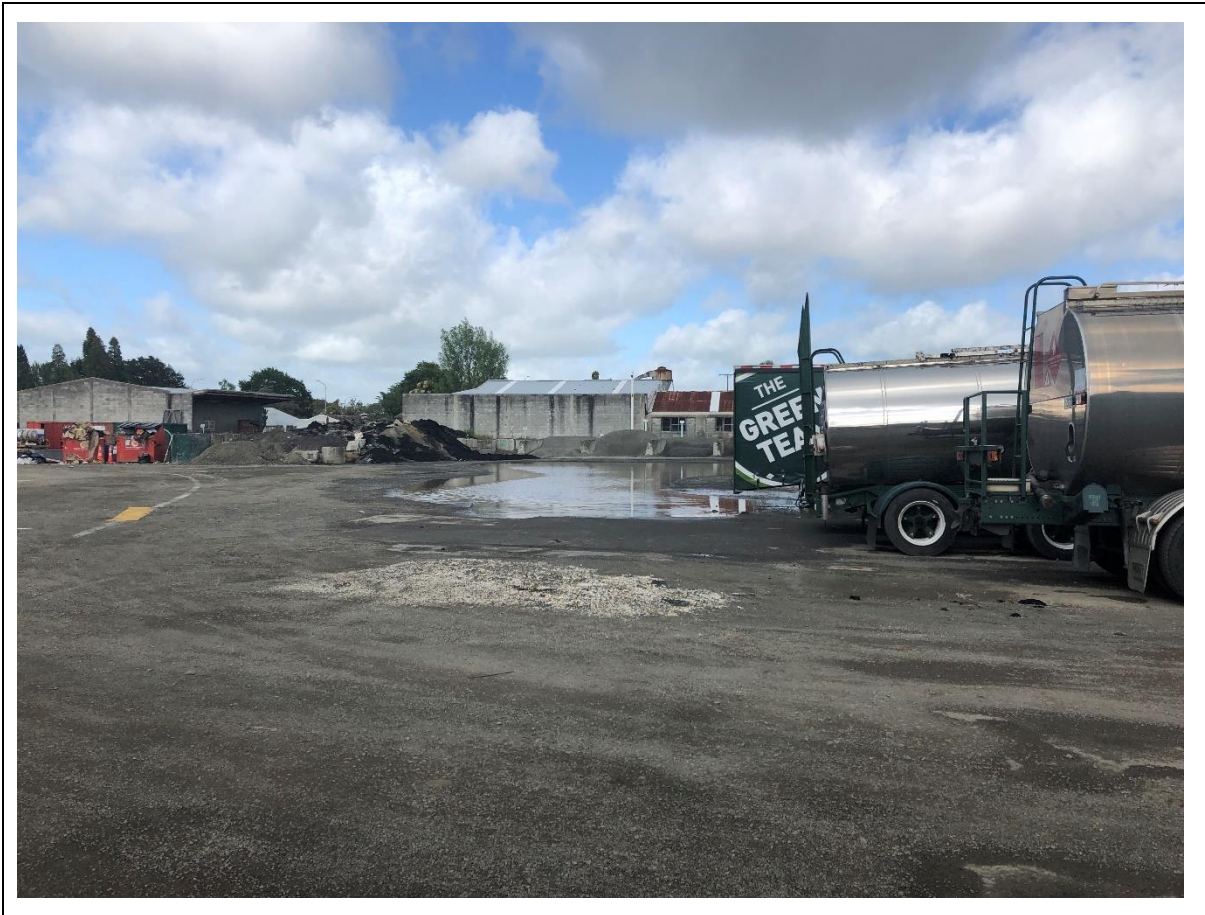
Photograph 12: Ponding of water observed in the middle of the Higgins site

- There was a large volume of water ponded in the middle of the Higgins site in the location of a building that had been removed/demolished between 2015-2017 (see Photograph 12);

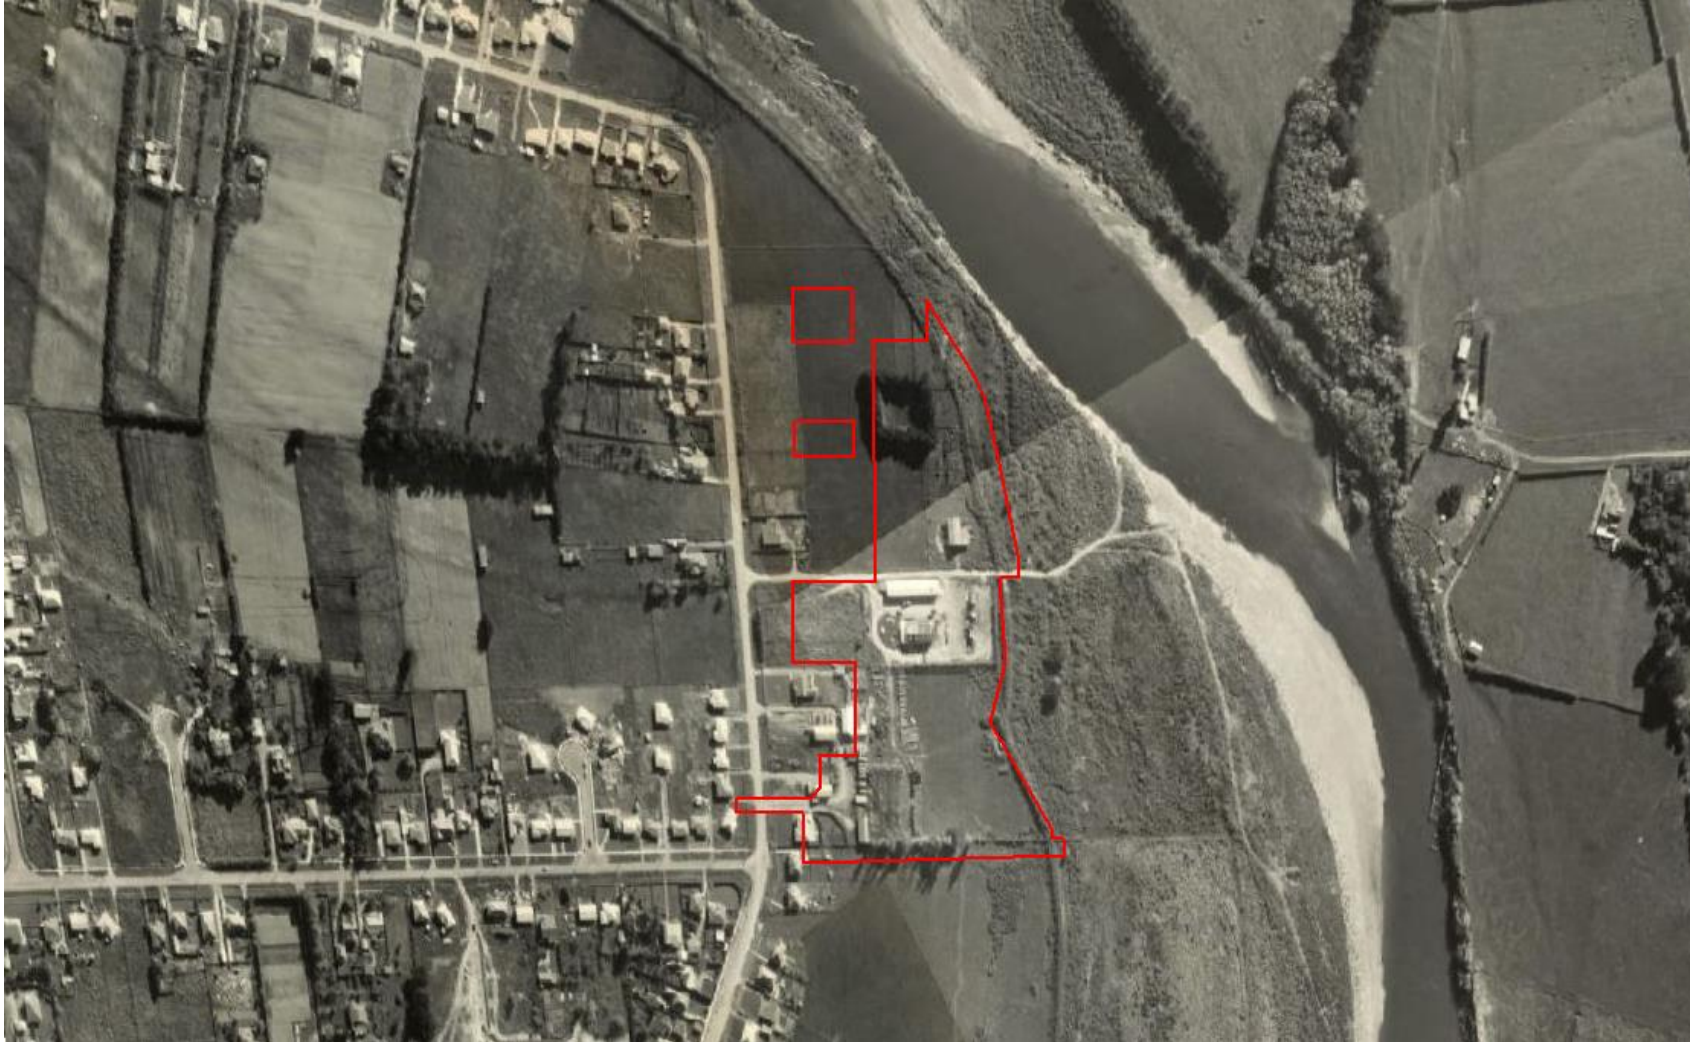
Figure Appendix B.1: 1956 Aerial Image of Hokowhitu Area – sourced from Palmerston North City Council Map Viewer

The PSI reviewed historical information relating to the site that was collected from a variety of sources including council property files and historical aerial images. The information indicated that the site was predominantly pasture and vacant land with few buildings before the early 1950s, after which various industrial activities started on the site. Extensive development commenced from the 1950's and the aerial images from 1966 and 1986 show a number of buildings for workshops, storage sheds and factories present. The PSI noted that market gardening activities were observed in the 1986 aerial image, further review of this image suggests that the activity may be a plantation or a nursery for larger trees, possibly pine trees.

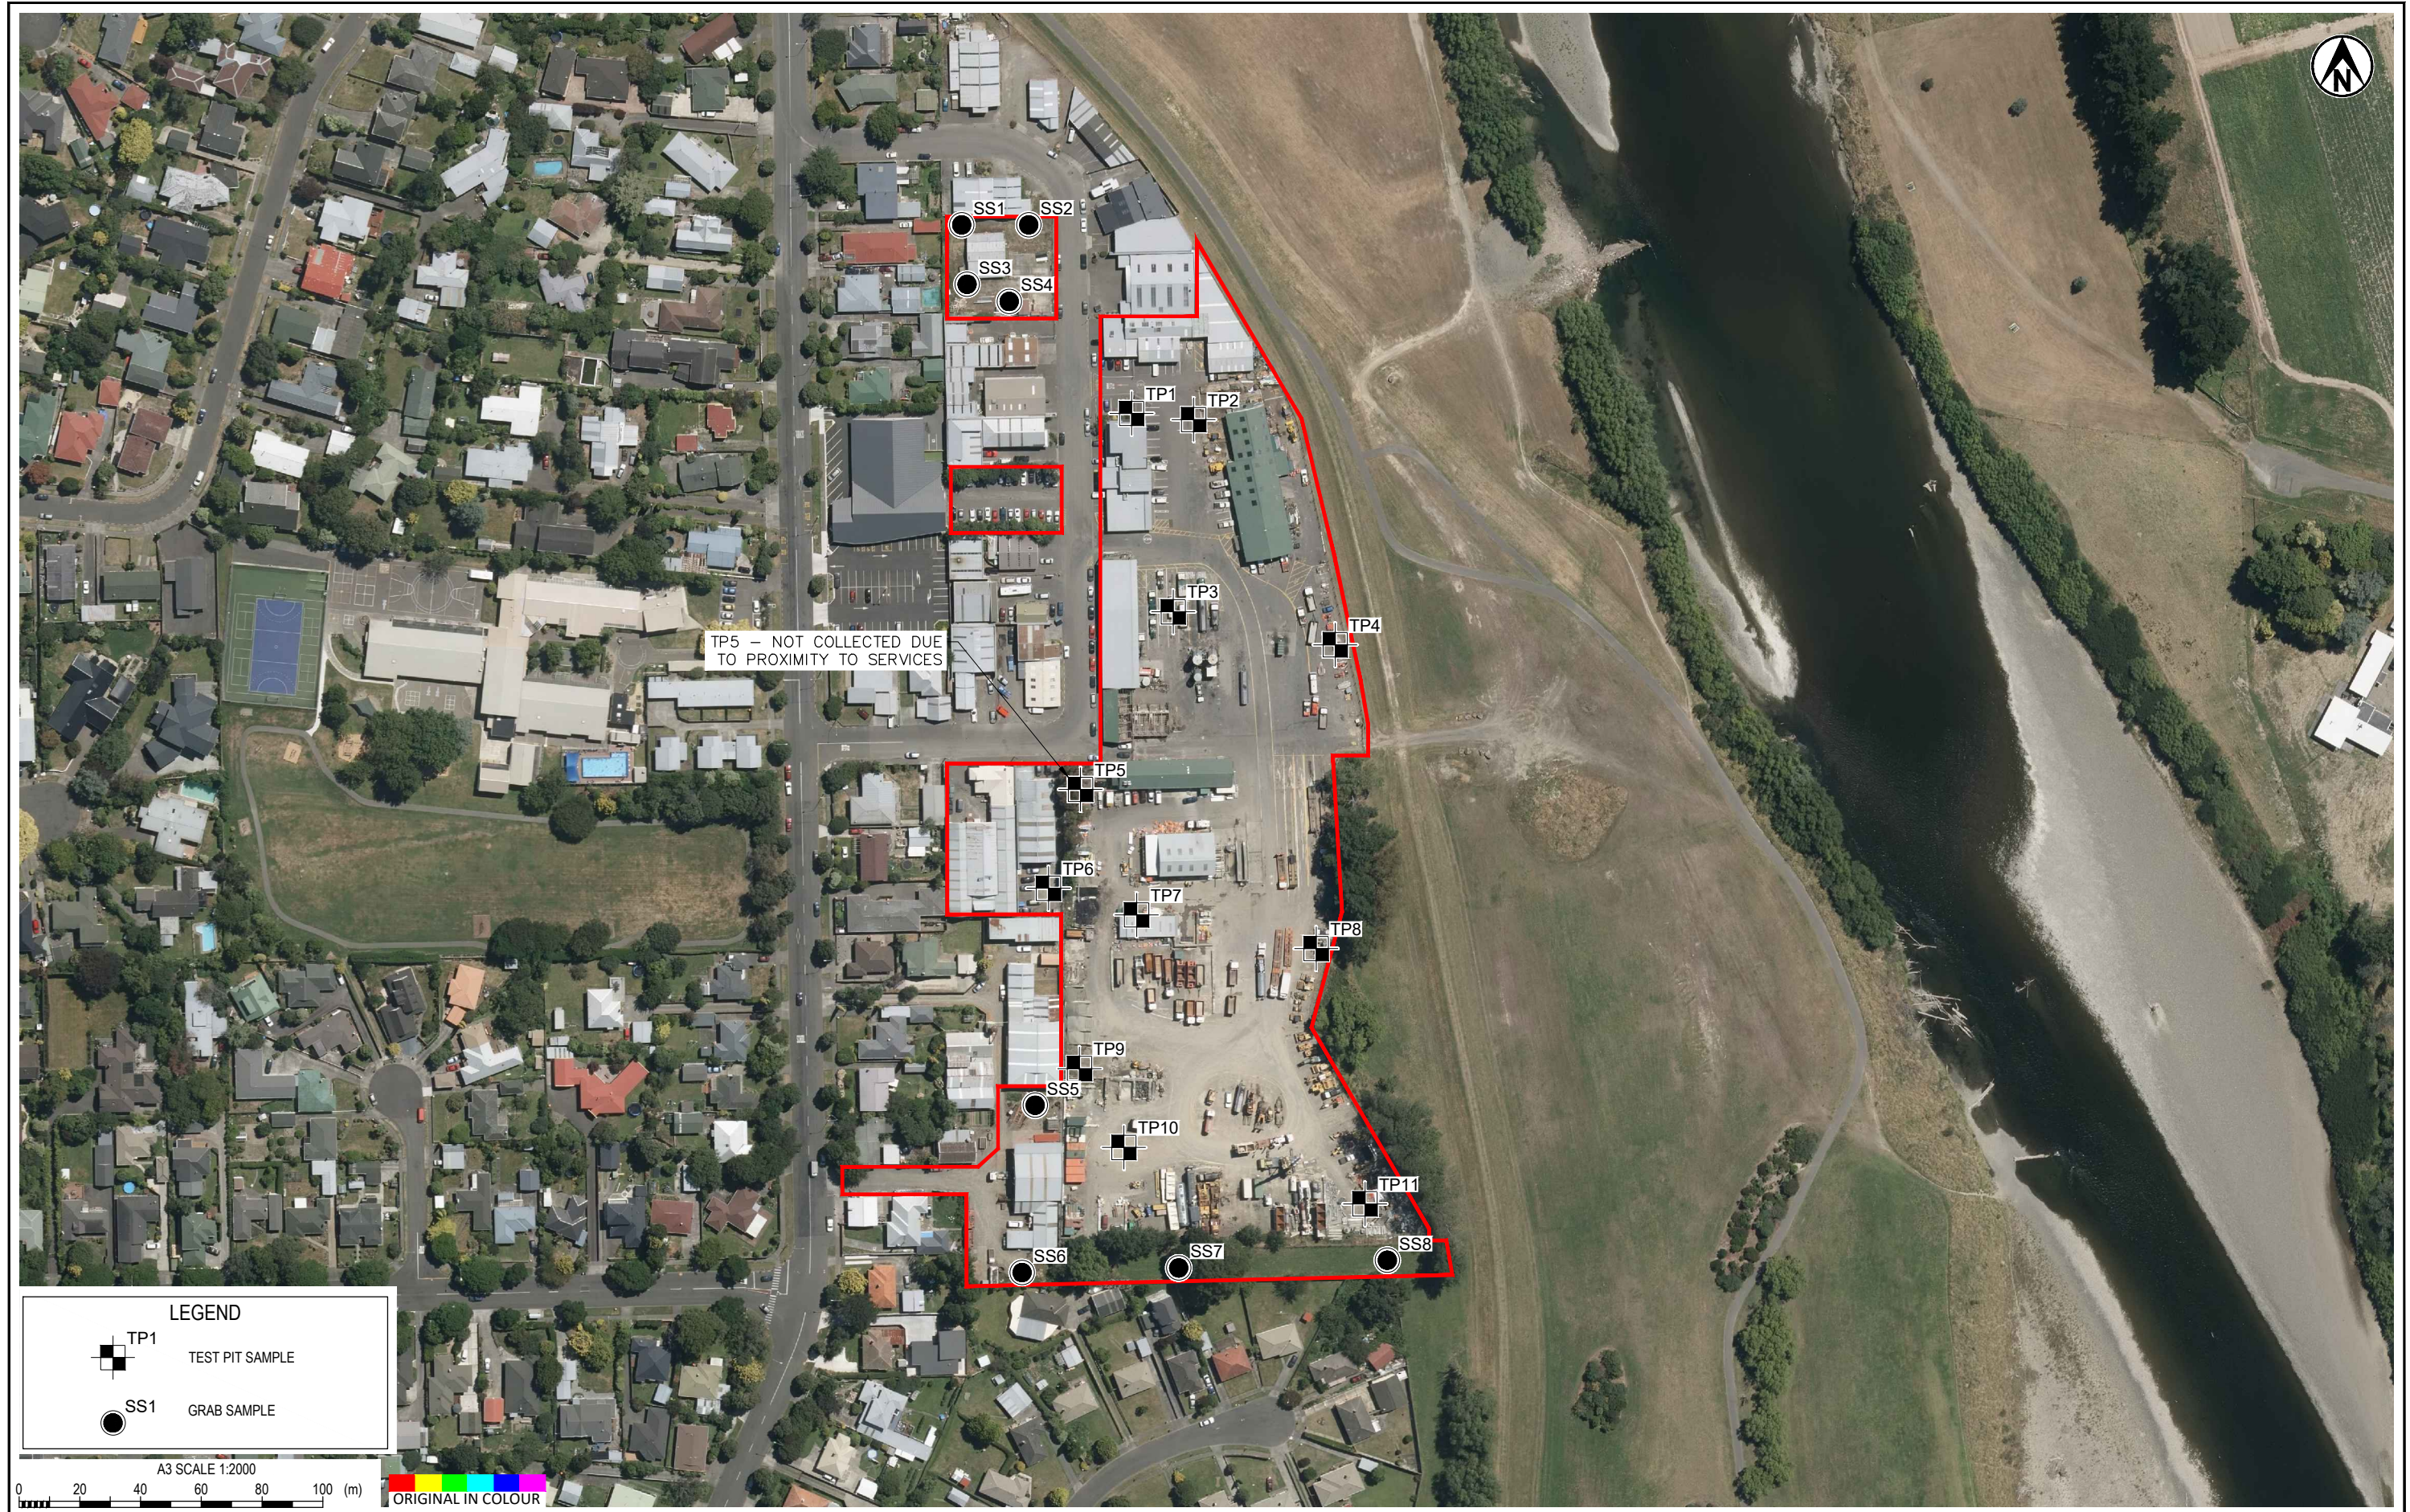
Appendix C: Sample location plan

TP1 TEST PIT SAMPLE
 SS1 GRAB SAMPLE

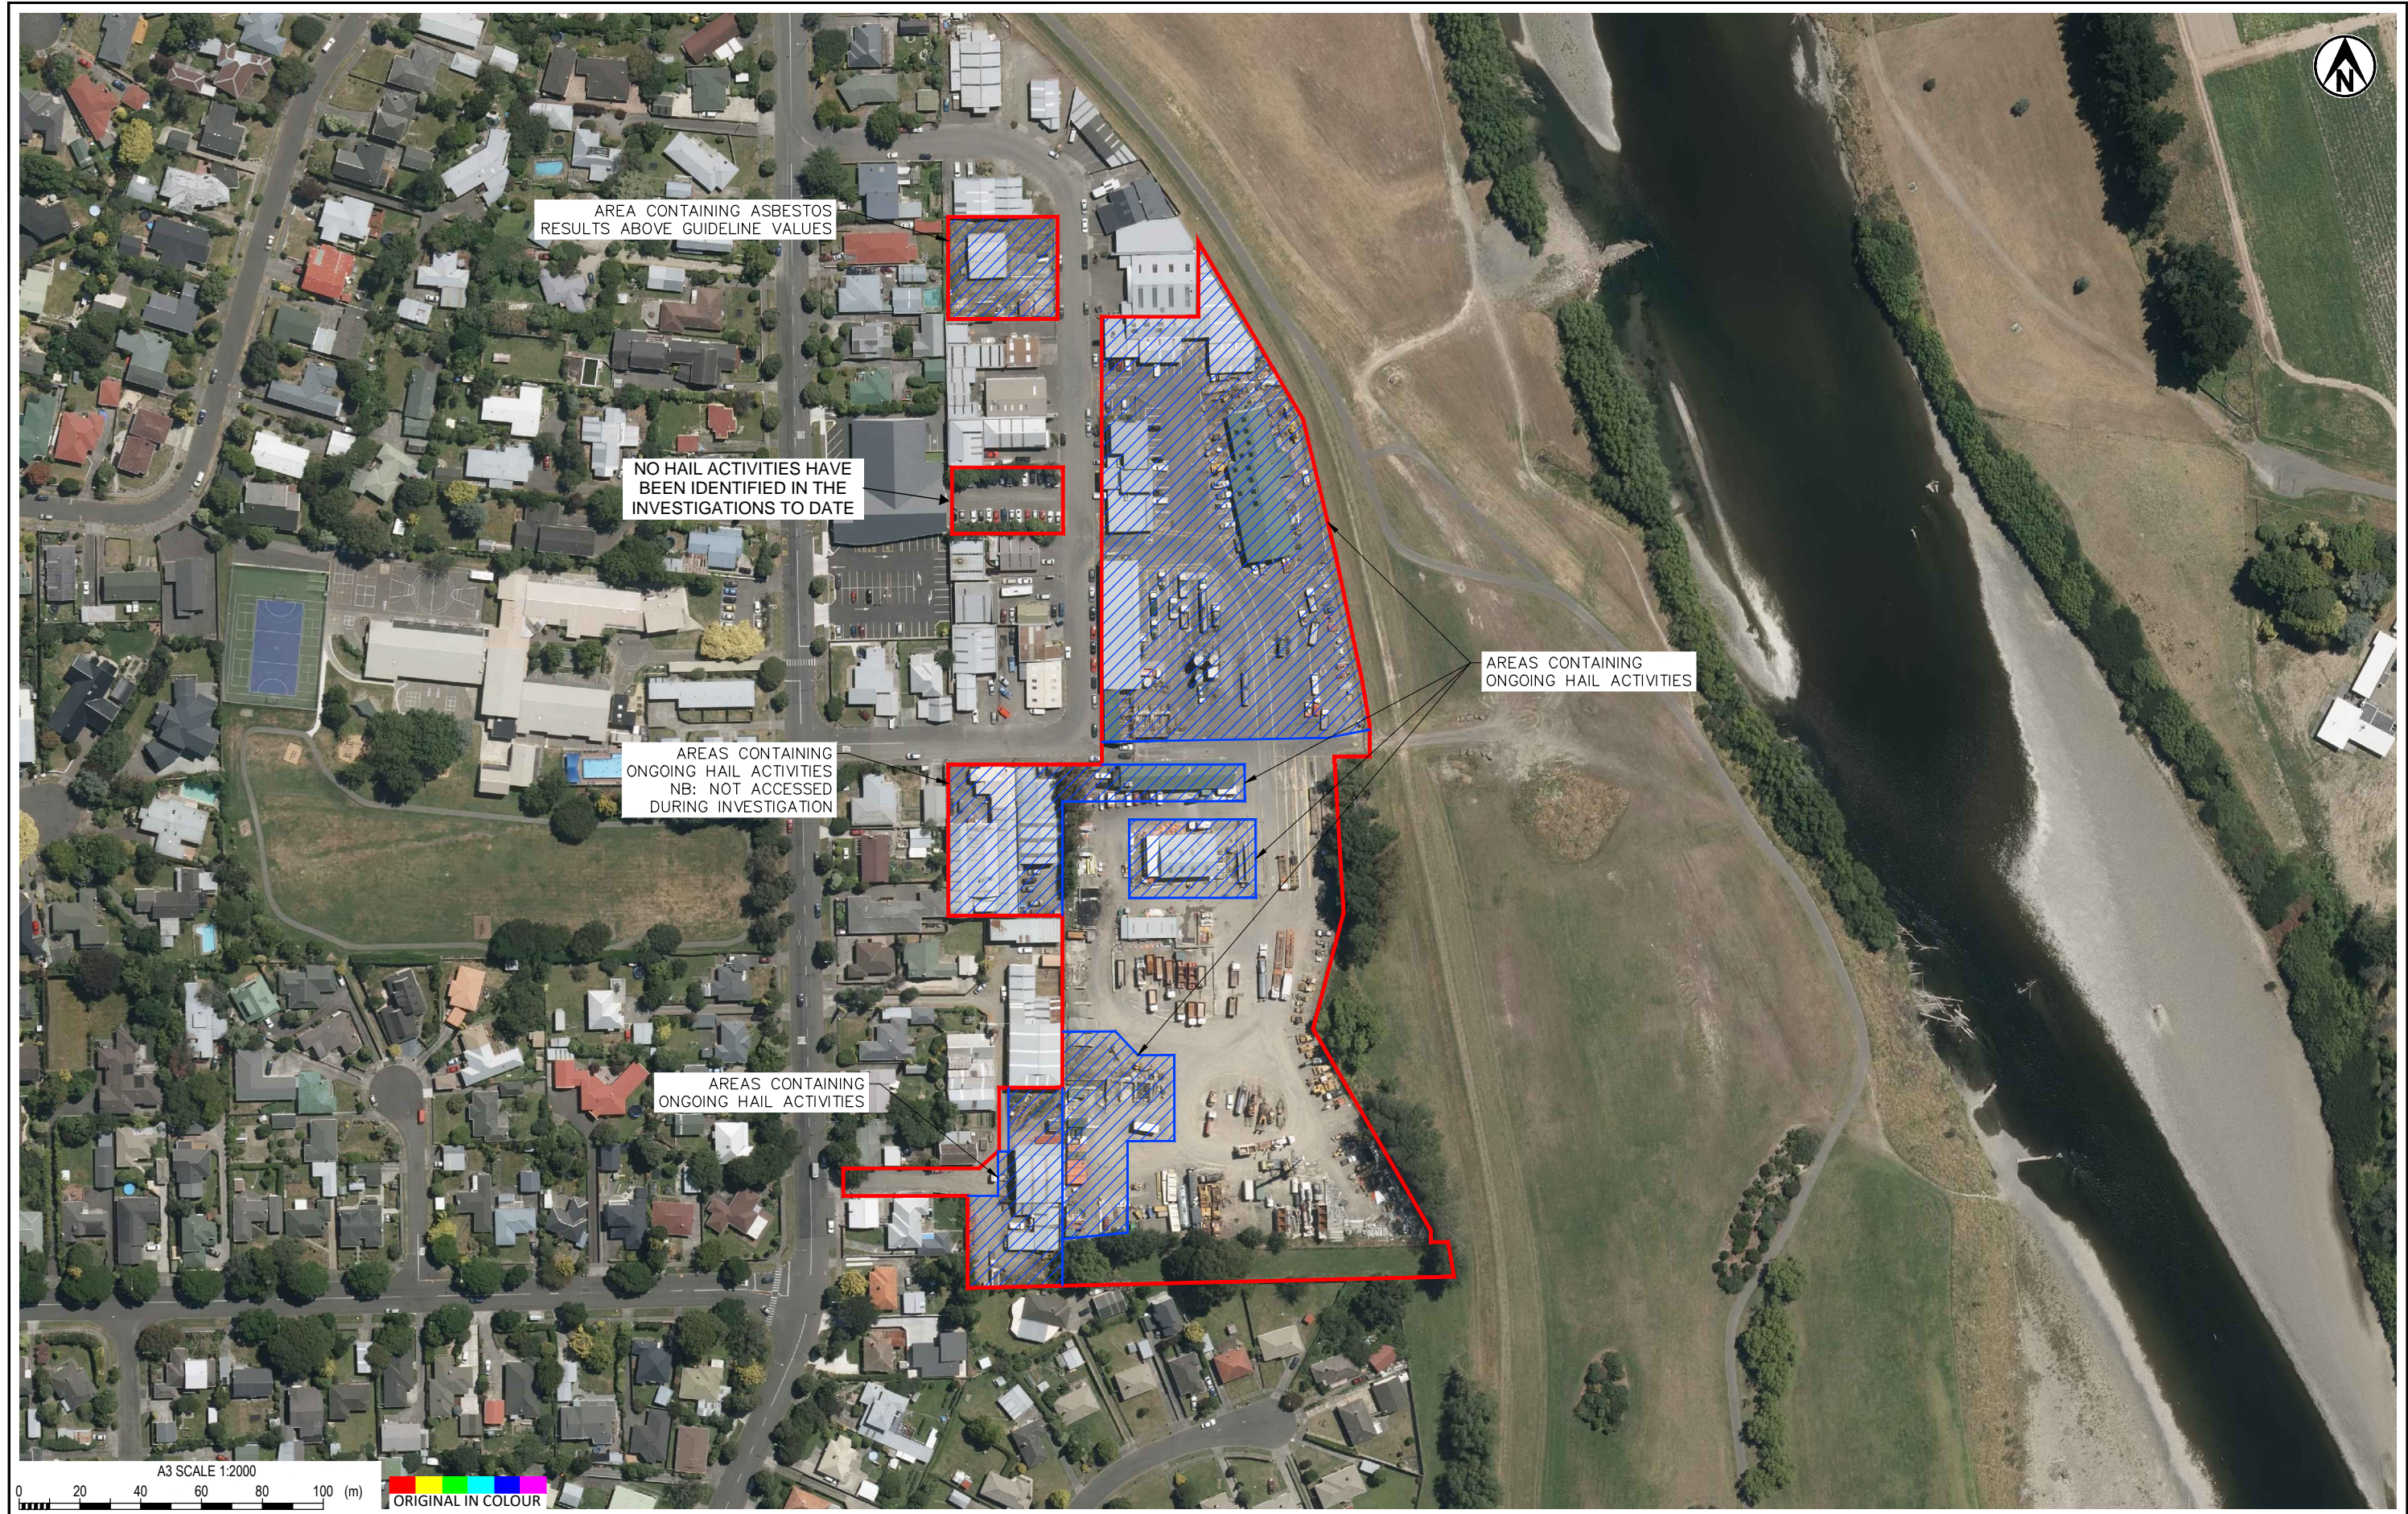
Appendix F: Site plan identifying areas requiring further investigation

CLIENT	PALMERSTON NORTH CITY COUNCIL	
PROJECT	ROXBURGH CRESCENT	
TITLE	GROUND CONTAMINATION ASSESSMENT FURTHER INVESTIGATION AREAS	
SCALE (A3)	AS SHOWN	FIG No. F2
REV	A

While the existing site data is sufficient to inform the current plan change process, further investigations to confirm the extent of asbestos in soils at 29-31 Roxburgh Crescent is recommended prior to any soil disturbance work and prior to the potential redevelopment to a residential use.

As HAIL activities will continue to operate on the site, we recommend that further intrusive investigations be undertaken once the activities have ceased and prior to residential redevelopment.
