# Liquefaction Assessment Report

1-42 Roxburgh Crescent, Palmerston North

Prepared for  
Palmerston North City Council

Prepared by  
Tonkin & Taylor Ltd

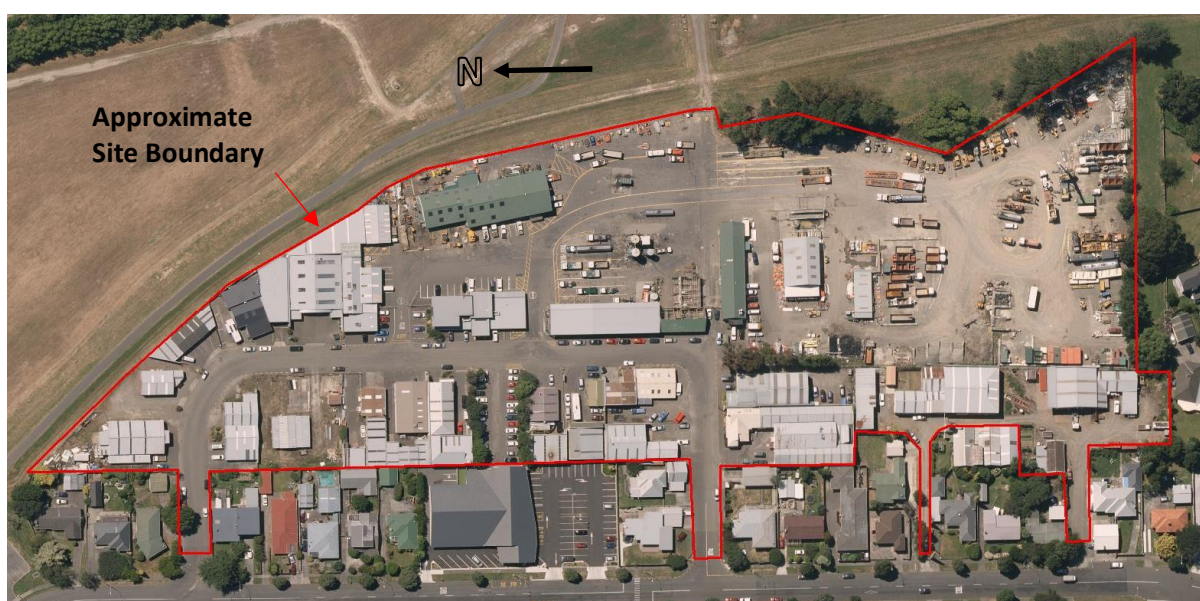
Figure 1 - Aerial photograph with approximate site boundary

The site is located in the south east of Palmerston North along Roxburgh Crescent. It is bordered to the west by Ruahine Street, to the north and east by Fitzroy Bend Reserve and Roxburgh Crescent Reserve and to the south by residential dwellings off Tilbury Avenue. The approximate site boundary is shown on Figure 1 below.

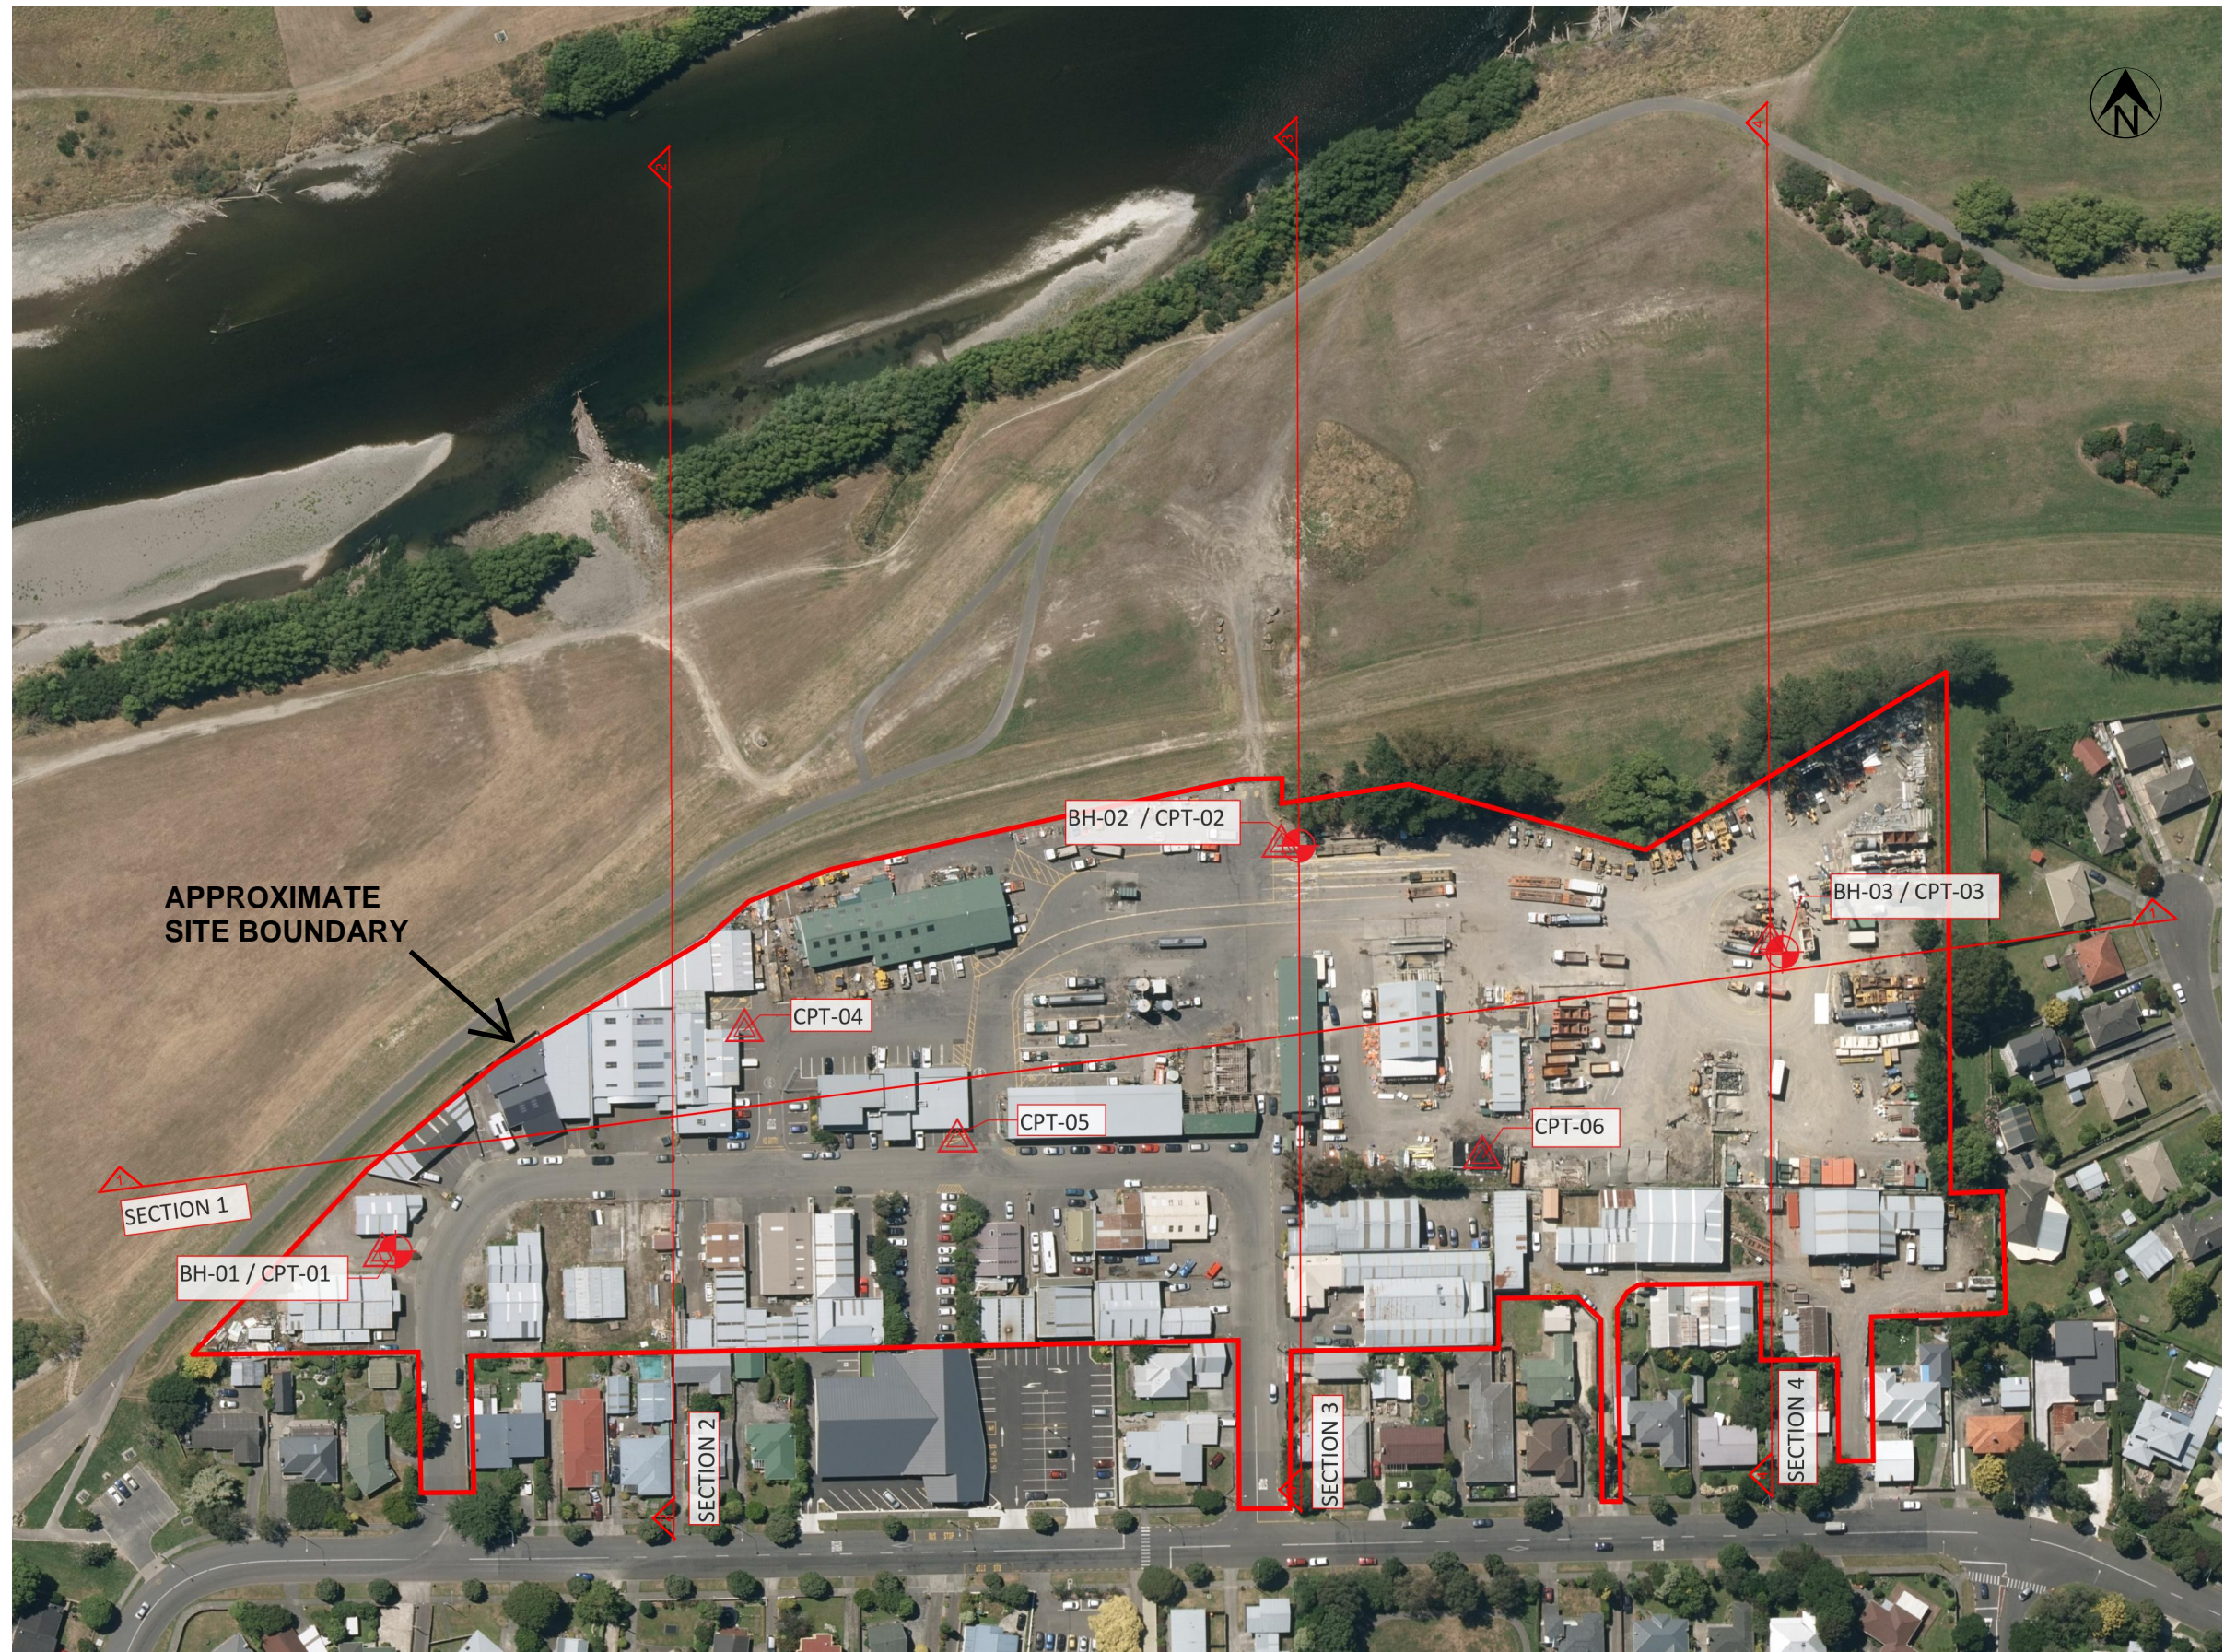
FIG. No. **FIGURE A1**

- BOREHOLE LOCATION
- CPT LOCATION NOTE; CPT-03 NOT CONDUCTED DUE TO ANCHOR FAILURE

The borehole investigation locations are presented in Figure 1, Appendix A. A summary of borehole investigations completed by T+T is presented in Table B1, Appendix B. Borehole logs and core photographs are presented in Appendix B.

The CPT locations are presented in Figure 1, Appendix A. A summary of CPT investigations completed by T+T is presented in Table B2, Appendix B. CPT logs are appended in Appendix B.

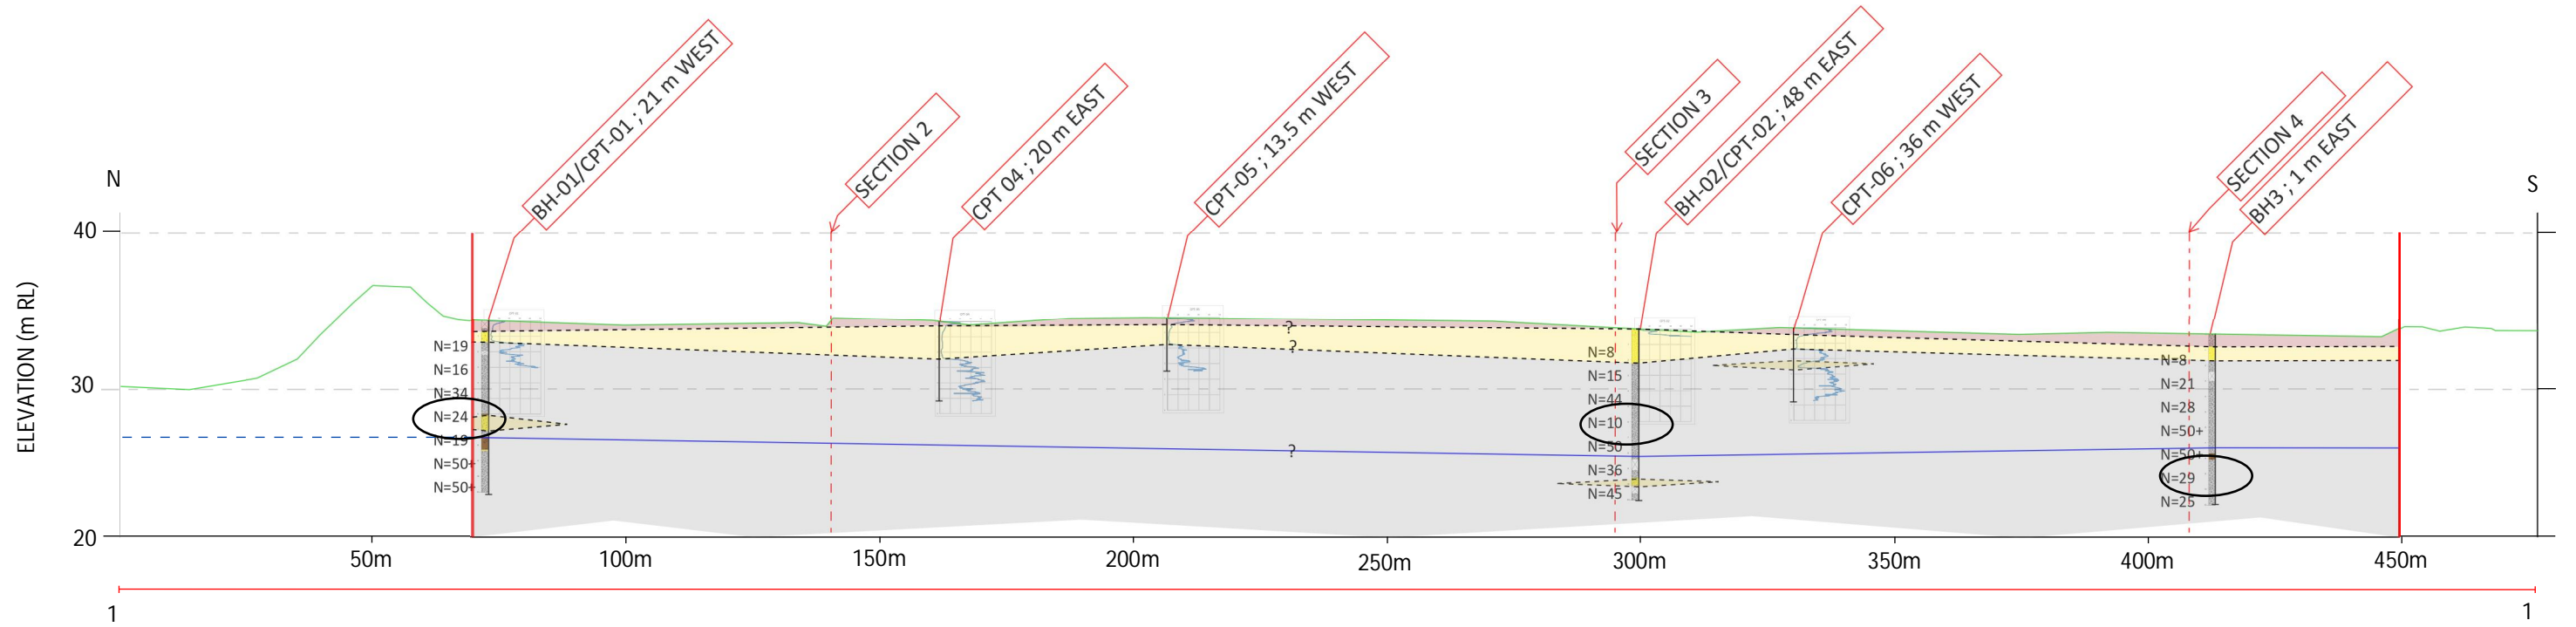
FIG. No. **FIGURE A2** REV. 1

**CROSS SECTION 1**  
**PALMERSTON NORTH CITY COUNCIL**  
 ROXBURGH CRESCENT, PALMERSTON NORTH

Indicative geologic cross sections, Figure A2 and A3 in Appendix A, show that at the Fitzroy Bend Reserve free face location no sandy lenses have been identified below the groundwater table. The absence of continuous liquefiable soil layers at this location suggests that lateral spreading is unlikely to develop at the Fitzroy Bend Reserve free face.

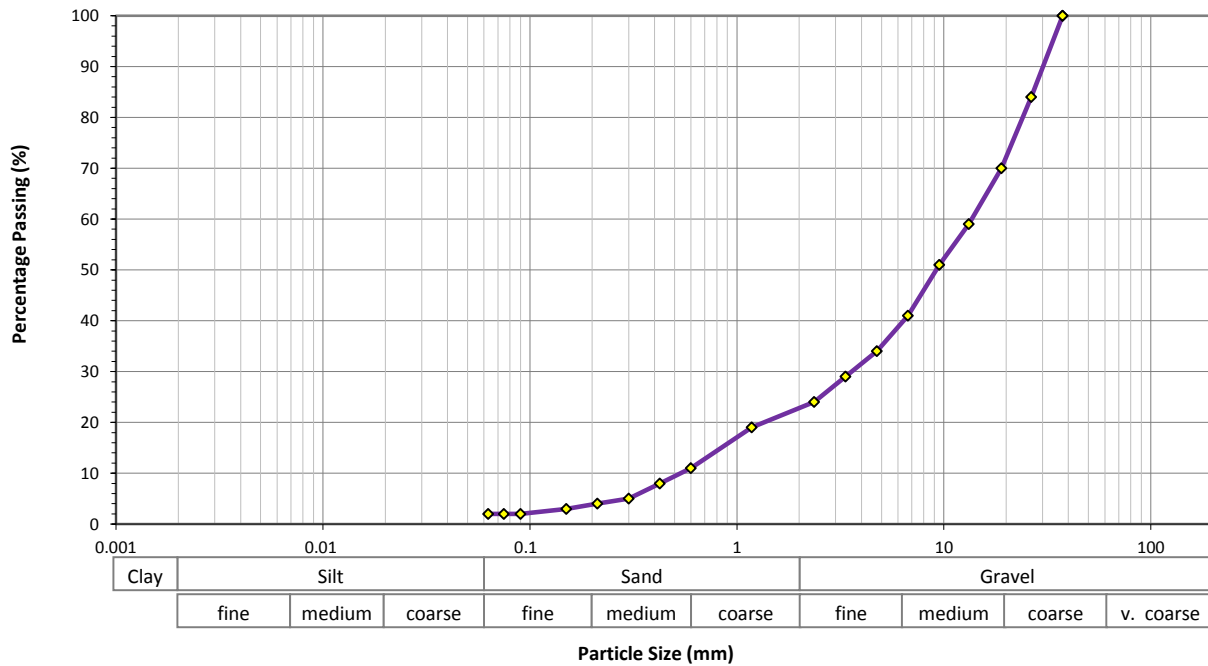
Sieve Size (mm)	Percentage Passing (%)	Sieve Size (mm)	Percentage Passing (%)	Sieve Size (mm)	Percentage Passing (%)	Sieve Size (mm)	Percentage Passing (%)
150	-	26.5	84	4.75	34	0.300	5
100	-	19.0	70	3.35	29	0.212	4
75.0	-	16.0	-	2.36	24	0.150	3
63.0	-	13.2	59	1.18	19	0.090	2
53.0	-	9.50	51	0.600	11	0.075	2
37.5	100	6.70	41	0.425	8	0.063	2

Laboratory test are summarised in Table B5, Appendix B and laboratory test results are presented in Appendix B.

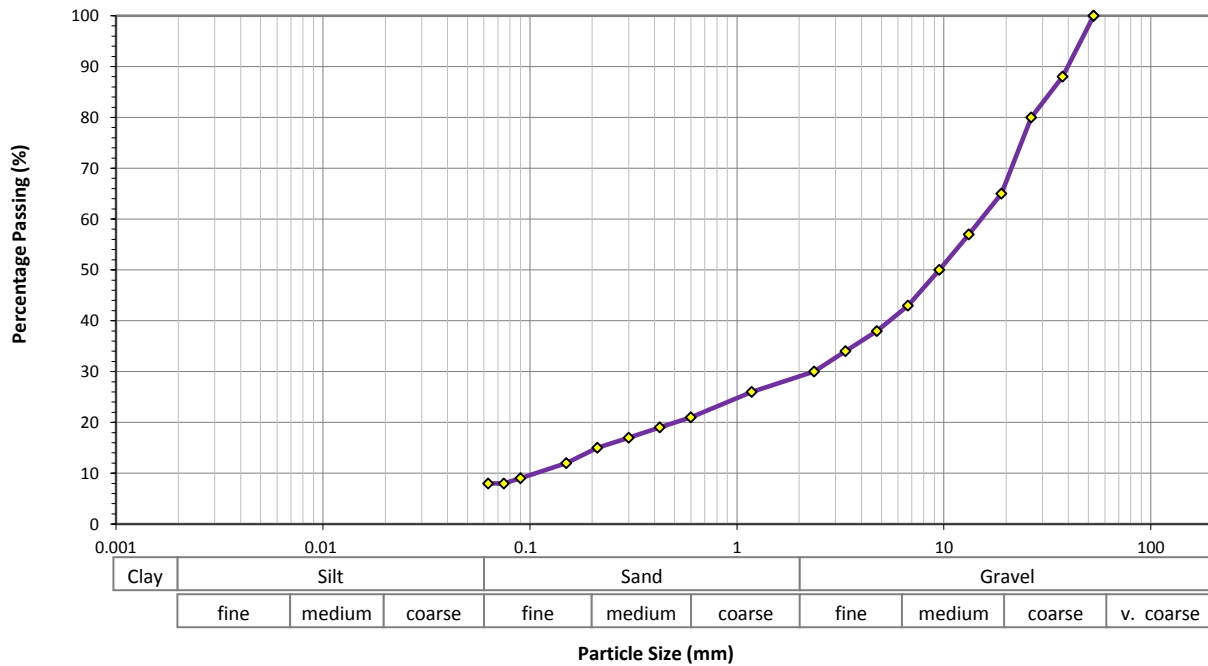
Sieve Size (mm)	Percentage Passing (%)	Sieve Size (mm)	Percentage Passing (%)	Sieve Size (mm)	Percentage Passing (%)	Sieve Size (mm)	Percentage Passing (%)
150	-	26.5	80	4.75	38	0.300	17
100	-	19.0	65	3.35	34	0.212	15
75.0	-	16.0	-	2.36	30	0.150	12
63.0	-	13.2	57	1.18	26	0.090	9
53.0	100	9.50	50	0.600	21	0.075	8
37.5	88	6.70	43	0.425	19	0.063	8

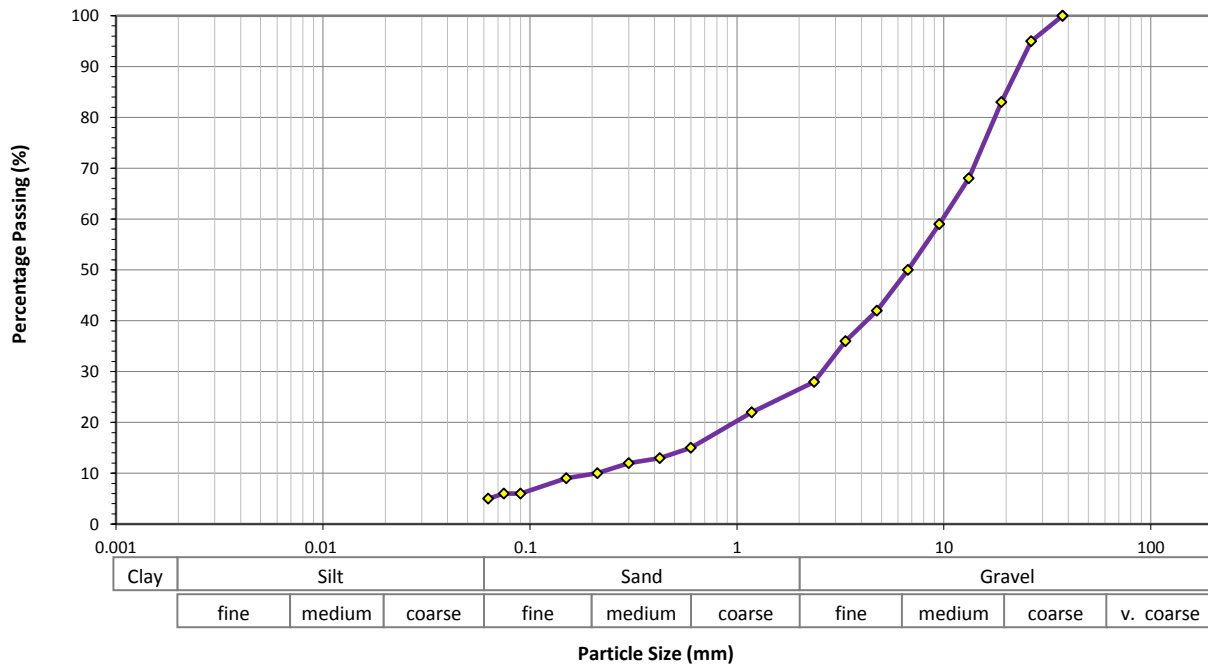
Sieve Size (mm)	Percentage Passing (%)	Sieve Size (mm)	Percentage Passing (%)	Sieve Size (mm)	Percentage Passing (%)	Sieve Size (mm)	Percentage Passing (%)
150	-	26.5	95	4.75	42	0.300	12
100	-	19.0	83	3.35	36	0.212	10
75.0	-	16.0	-	2.36	28	0.150	9
63.0	-	13.2	68	1.18	22	0.090	6
53.0	-	9.50	59	0.600	15	0.075	6
37.5	100	6.70	50	0.425	13	0.063	5
